STREAM BIOLOGICAL CONDITIONS ENVIRONMENTAL AUDITOR REPORT

| Stream ID: S-B21 | Crossing Start Date: 11/25/2023 | Crossing Completion Date: 12/20/2023 |
| Milepost: 245.9 | Pre-Con Assessment Date: 11/24/2023 | Post-Con Assessment Date: 12/20/2023 |

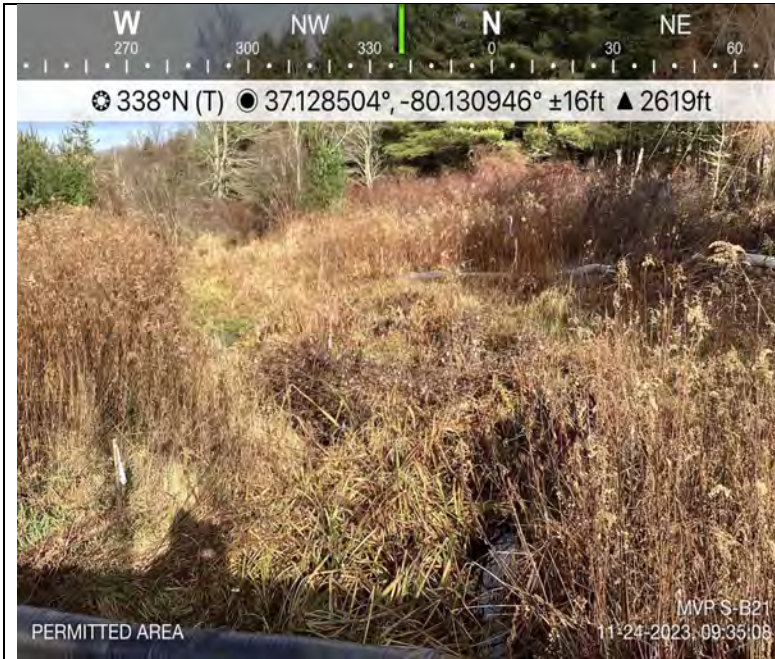
Photo Description: Downstream view of permitted impact area during pre-construction assessment.

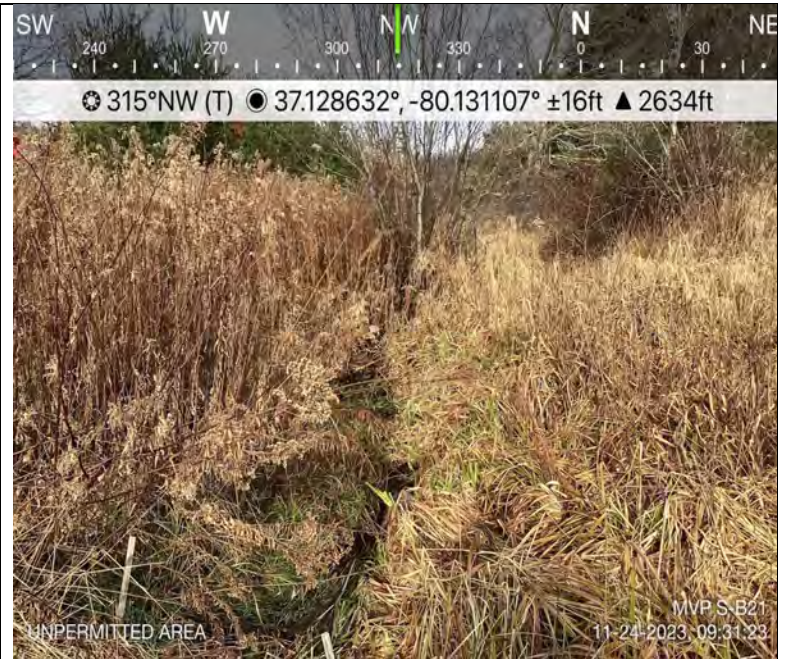
Photo Description: Conditions of the downstream area outside the ROW during pre-construction assessment.

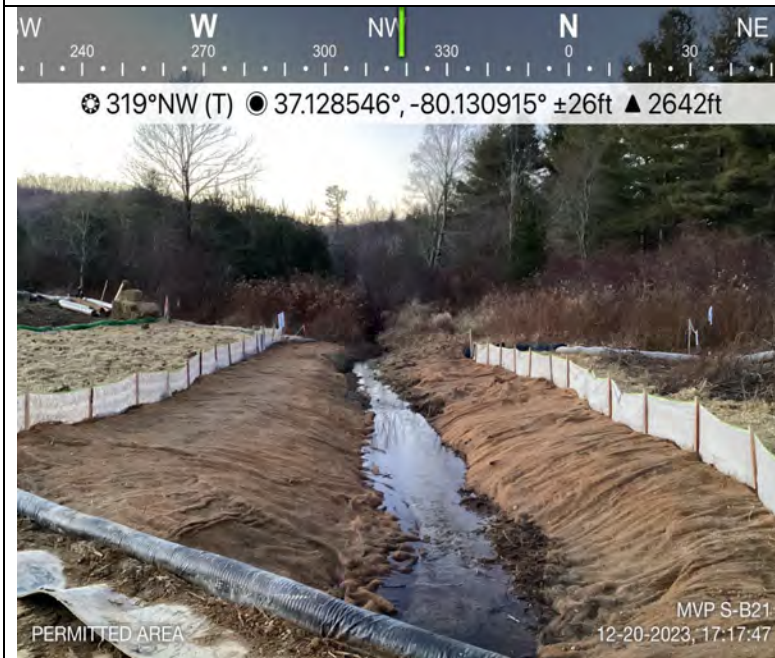
Photo Description: Downstream view of permitted impact area during post-construction assessment.

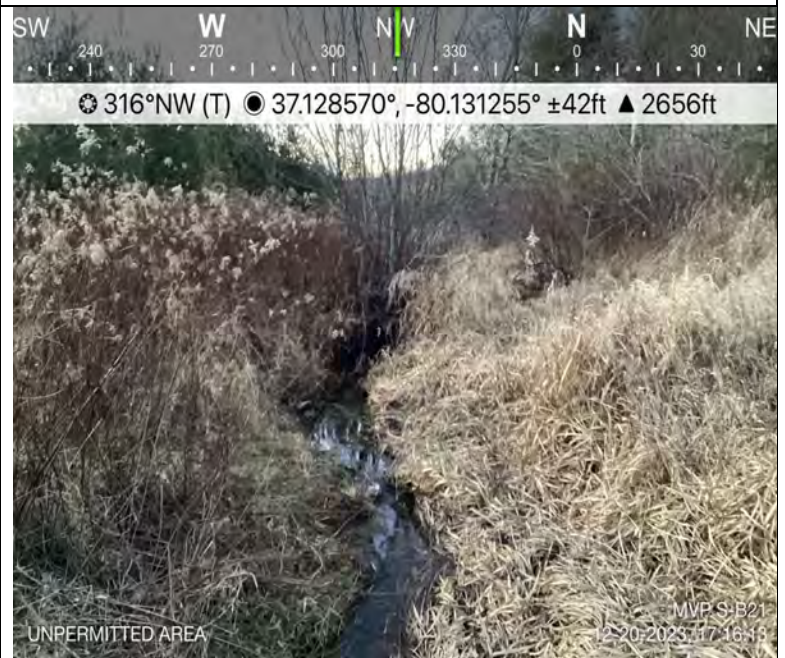
Photo Description: Conditions of the downstream area outside the ROW during post-construction assessment.

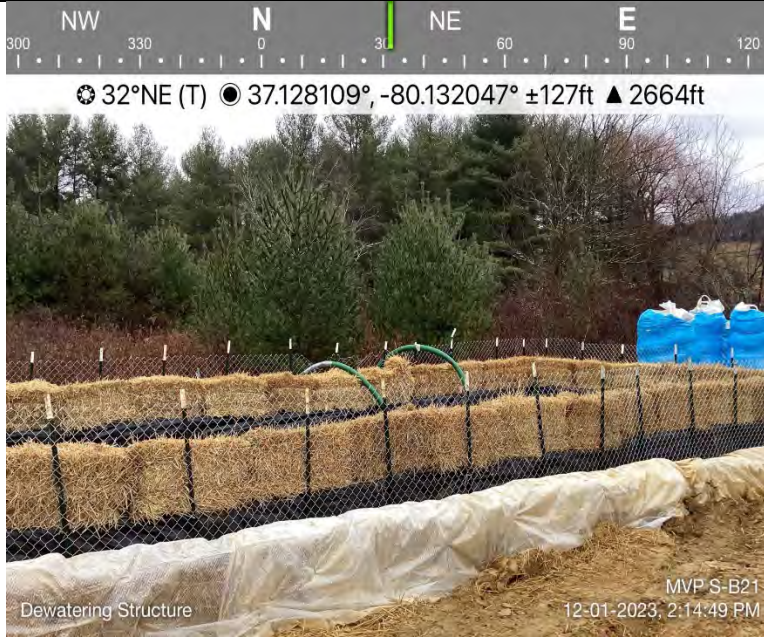
Photo Description: An overview of the dewatering structure.

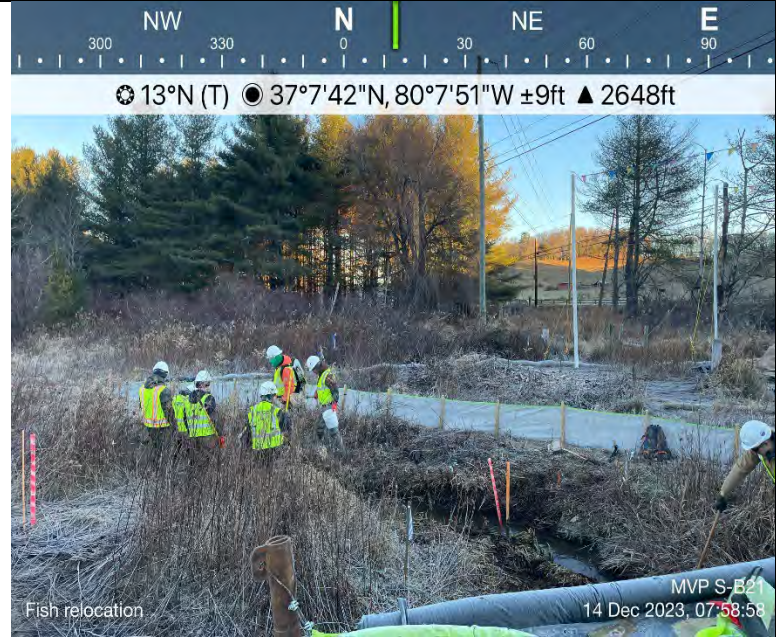
Photo Description: The fish relocation being conducting prior to the resource crossing.

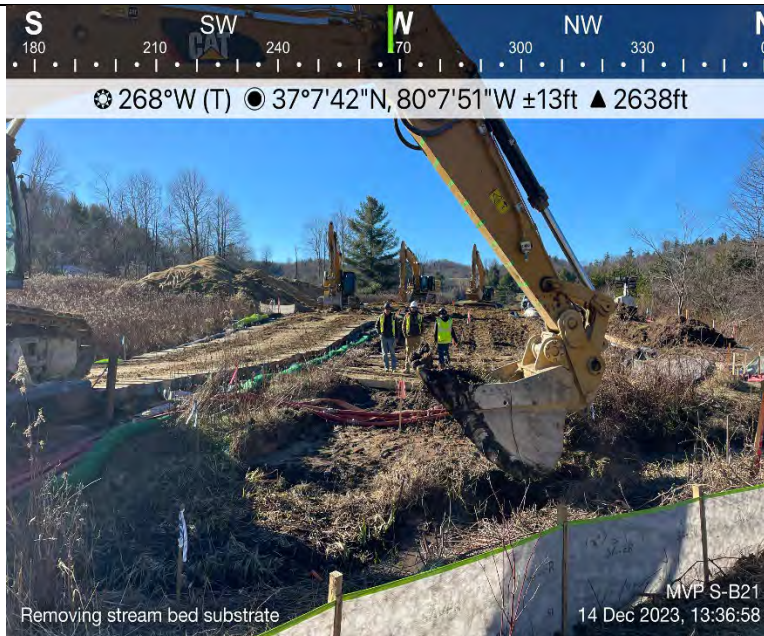
Photo Description: Excavation of the streambed substrate.

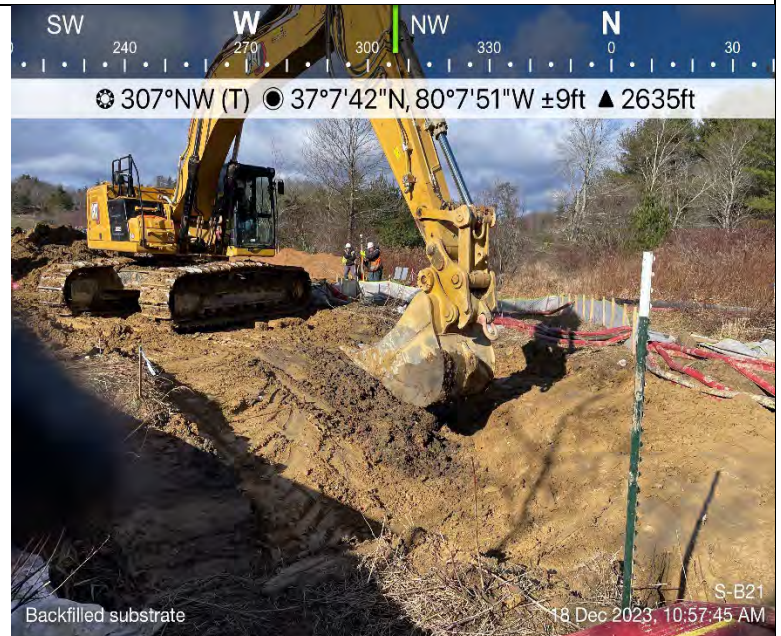
Photo Description: Backfilling of the stream substrate.
