# Stream Biological Conditions EA Report

<b>Project Name</b>	H-600 Pipeline Spread C	<b>AFE</b>	124300131	<b>Spread</b>	H-600 Pipeline Spread C
<b>Contractor</b>	Precision	<b>Report #</b>	446		
<b>Environmental Auditor</b>	Jeffrey Arbogast	<b>Date/Time</b>	12/20/2023 2:52 PM		
<b>Stream ID</b>	S-B36	<b>Crossing Start Date</b>	12/20/2023	<b>Crossing Completion Date</b>	1/2/2024
<b>Milepost</b>	97.86	<b>Pre-Con Assessment Date</b>	12/18/2023	<b>Post-Con Assessment Date</b>	1/3/2024
<b>Station</b>	5166+88	<b>Bankfull Width (ft.)</b>	2.0	<b>Riffle:Pool Complexes Present?</b>	No
<b>State</b>	WV	<b>Stream Classification</b>	Ephemeral		
<b>County</b>	Webster	<b>303(d) Impairment Listing</b>	No

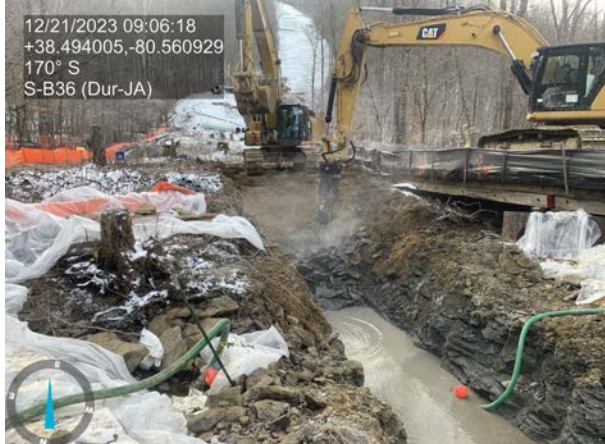
<b>GPS Location</b>	See Caption in Photo	<b>GPS Location</b>	See Caption in Photo
<b>Description</b>	Hammering rock in the bottom of the ditch.	<b>Description</b>	Bentonite trench breaker on the CIS.

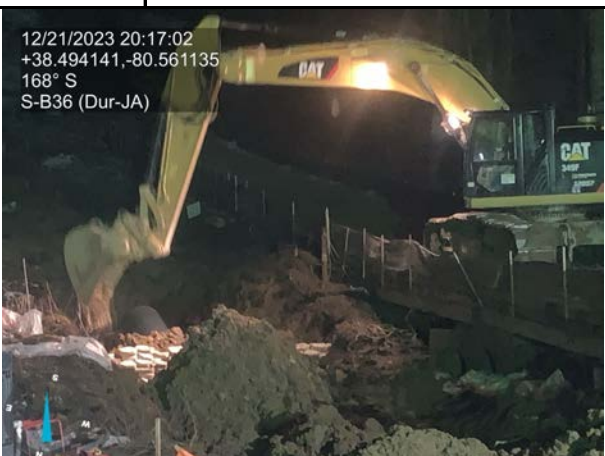
<b>GPS Location</b>	See Caption in Photo	<b>GPS Location</b>	See Caption in Photo
<b>Description</b>	Backfilling the ditch. The GAS bentonite trench breaker in the distance.	<b>Description</b>	Survey checking the subsoil elevation and marking the stream channel location.

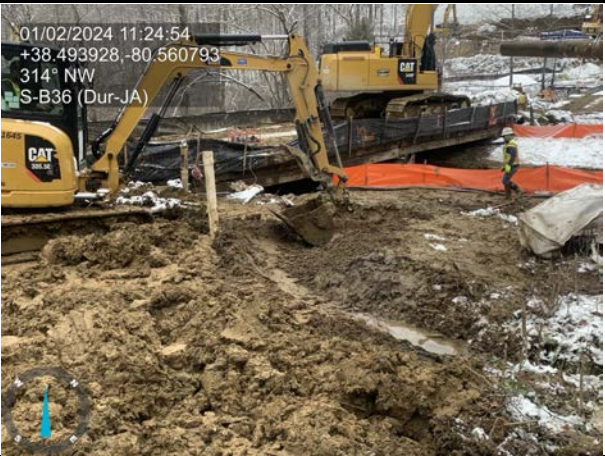
<b>GPS Location</b>	See Caption in Photo	<b>GPS Location</b>	See Caption in Photo
<b>Description</b>	Stream substrate being spread within the channel.	<b>Description</b>	Topsoil being replaced in buffer zone.
