# Stream Biological Conditions EA Report

<b>Project Name</b>	H-600 Pipeline Spread C	<b>AFE</b>	124300131	<b>Spread</b>	H-600 Pipeline Spread C
<b>Contractor</b>	Precision	<b>Report #</b>	470		
<b>Environmental Auditor</b>	Jeffrey Arbogast	<b>Date/Time</b>	12/22/2023 6:51 PM		
<b>Stream ID</b>	S-B37	<b>Crossing Start Date</b>	12/21/2023	<b>Crossing Completion Date</b>	1/2/2024
<b>Milepost</b>	97.86	<b>Pre-Con Assessment Date</b>	12/18/2023	<b>Post-Con Assessment Date</b>	1/3/2024
<b>Station</b>	5167+14	<b>Bankfull Width (ft.)</b>	2.0	<b>Riffle:Pool Complexes Present?</b>	No
<b>State</b>	WV	<b>Stream Classification</b>	Intermittent		
<b>County</b>	Webster	<b>303(d) Impairment Listing</b>	No

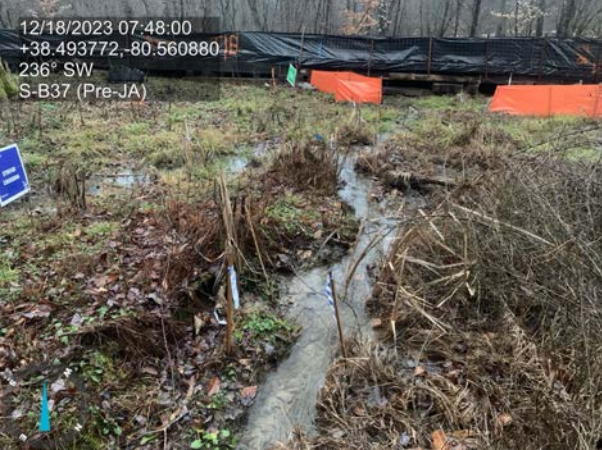
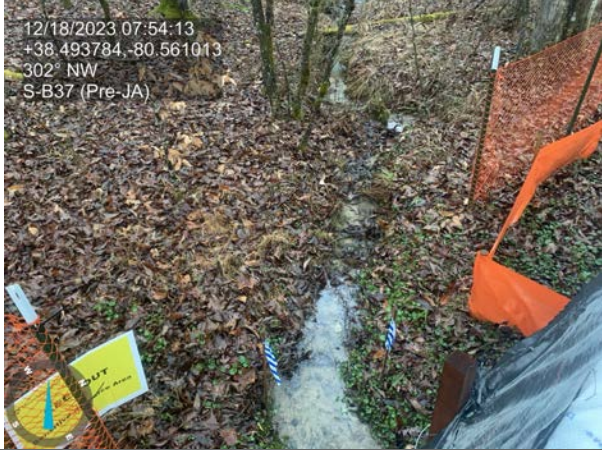
<b>GPS Location</b>	See Caption in Photo	<b>GPS Location</b>	See Caption in Photo
<b>Description</b>	Downstream view of permitted impact area during pre-construction assessment.	<b>Description</b>	Downstream view of unimpacted area during pre-construction assessment. Taken from timber mat bridge.

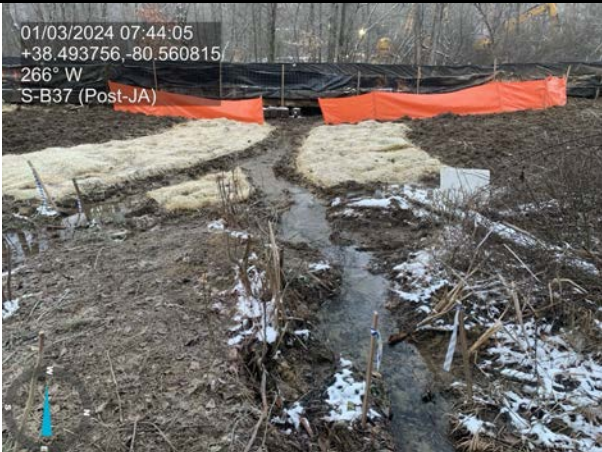
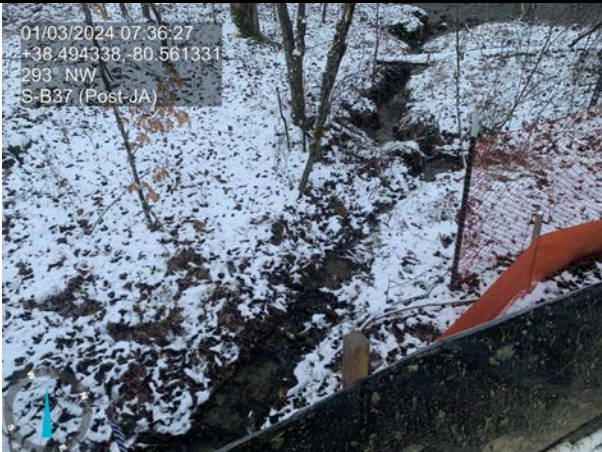
<b>GPS Location</b>	See Caption in Photo	<b>GPS Location</b>	See Caption in Photo
<b>Description</b>	Downstream view of permitted impact area during post-construction assessment.	<b>Description</b>	Downstream view of unimpacted area during post-construction assessment. Taken from timber mat bridge.

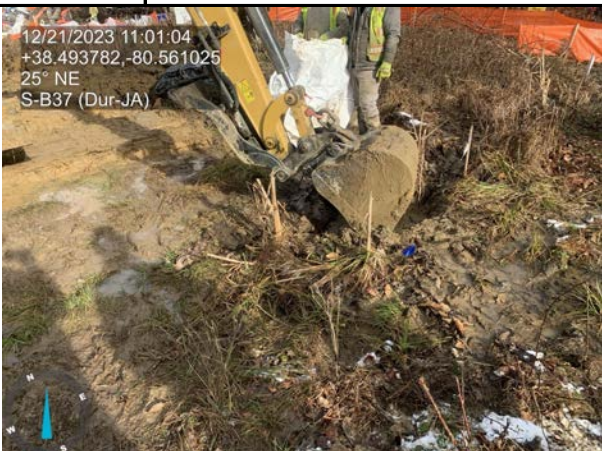
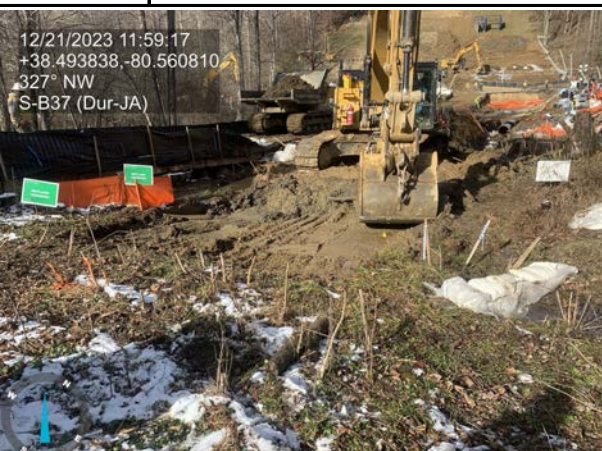
<b>GPS Location</b>	See Caption in Photo	<b>GPS Location</b>	See Caption in Photo
<b>Description</b>	Stream substrate being removed and placed in super sacks.	<b>Description</b>	Buffer area topsoil being removed.

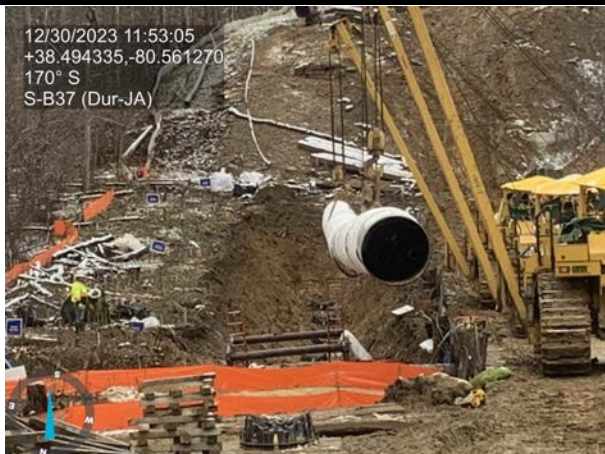
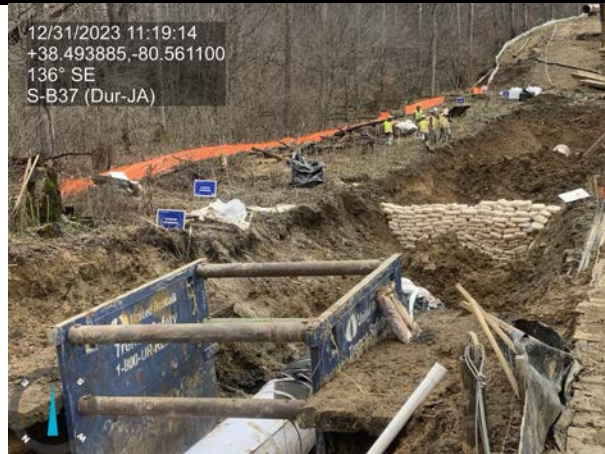
<b>GPS Location</b>	See Caption in Photo	<b>GPS Location</b>	See Caption in Photo
<b>Description</b>	Lowering in.	<b>Description</b>	GAS bentonite breaker.

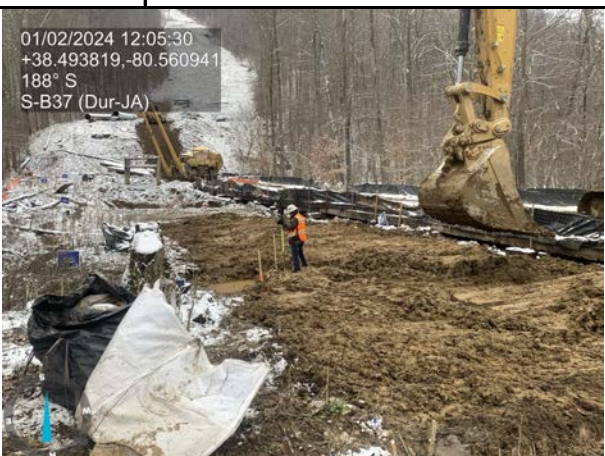
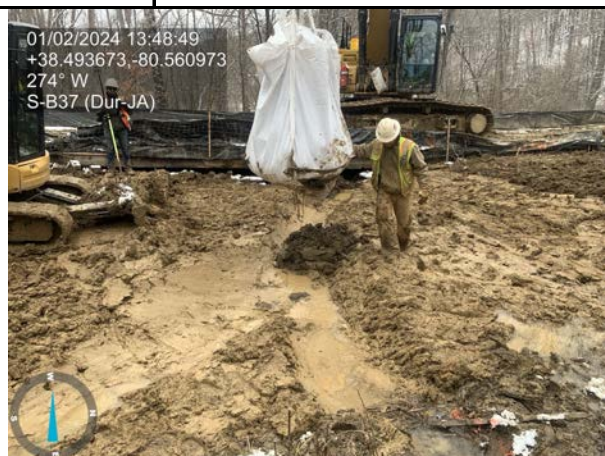
<b>GPS Location</b>	See Caption in Photo	<b>GPS Location</b>	See Caption in Photo
<b>Description</b>	Survey checking subsoil elevation and marking stream channel location.	<b>Description</b>	Stream substrate being returned to the channel.

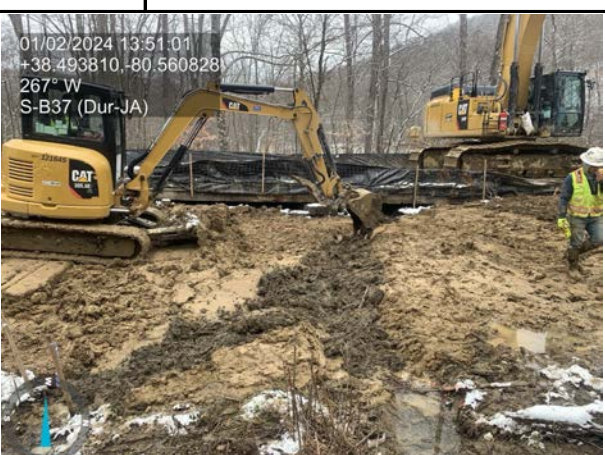
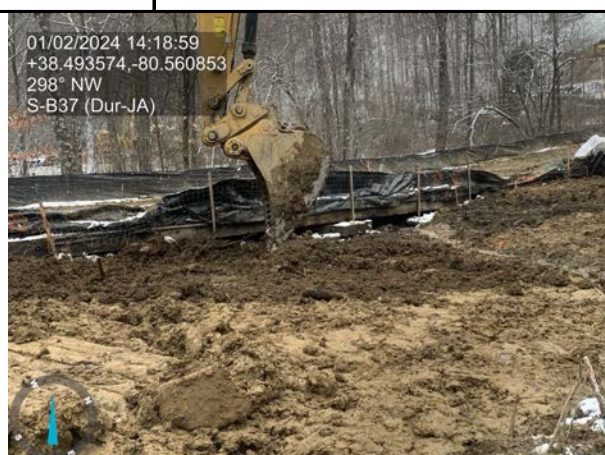
<b>GPS Location</b>	See Caption in Photo	<b>GPS Location</b>	See Caption in Photo
<b>Description</b>	Stream substrate being spread out in the channel.	<b>Description</b>	Buffer zone topsoil being replaced.
