Stream Biological Conditions EA Report

Project Name	H-600 Pipeline Spread C	AFE	124300131	Spread	H-600 Pipeline Spread C
Contractor	Precision	Report #	473		
Environmental Auditor	Jeffrey Arbogast	Date/Time	12/29/2023 12:41 PM		
Stream ID	S-B39A/B46	Crossing Start Date	12/29/2023	Crossing Completion Date	1/5/2024
Milepost	97.89	Pre-Con Assessment Date	12/28/2023	Post-Con Assessment Date	1/6/2024
Station	5168+48	Bankfull Width (ft.)	5.0	Riffle:Pool Complexes Present?	No
State	WV	Stream Classification	Ephemeral		
County	Webster	303(d) Impairment Listing	No

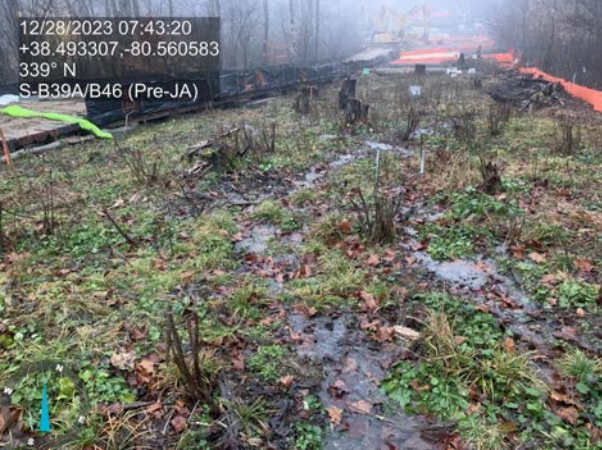
GPS Location	See Caption in Photo	GPS Location	See Caption in Photo
Description	Downstream view of permitted impact area during pre-construction assessment.	Description	Downstream view of unimpacted area during pre-construction assessment. S-B39A/B46 merges with S-B39B under the timber mat travel lane prior to leaving the LOD as S-B39B.

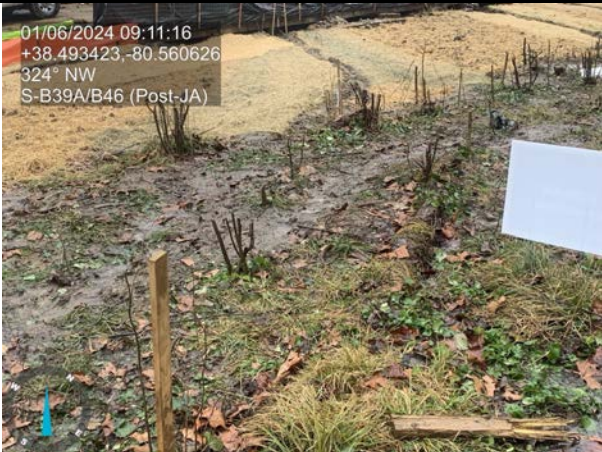
GPS Location	See Caption in Photo	GPS Location	See Caption in Photo
Description	Downstream view of permitted impact area during post-construction assessment.	Description	Downstream view of unimpacted area during post-construction assessment. S-B39A/B46 merges with S-B39B under the timber mat travel lane prior to leaving the LOD as S-B39B.

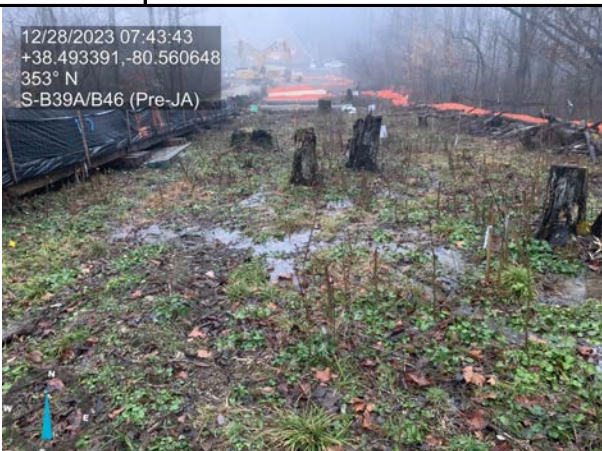
GPS Location	See Caption in Photo	GPS Location	See Caption in Photo
Description	Standing on the GAS facing the CIS pre-construction.	Description	Stream substrate being placed in super sacks.

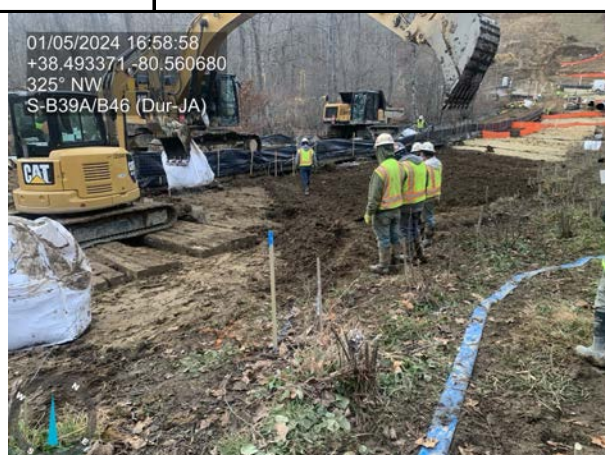
Description Stream substrate being returned.	Description Stream channel reconstruction and buffer zone topsoil replacement.
