Stream Biological Conditions EA Report

Project Name	H-600 Pipeline Spread C	AFE	124300131	Spread	H-600 Pipeline Spread C
Contractor	Precision	Report #	475		
Environmental Auditor	Jeffrey Arbogast	Date/Time	12/29/2023 12:38 PM		
Stream ID	S-B39B	Crossing Start Date	12/29/2023	Crossing Completion Date	1/5/2024
Milepost	97.88	Pre-Con Assessment Date	12/28/2023	Post-Con Assessment Date	1/6/2024
Station	5167+98	Bankfull Width (ft.)	3.0	Riffle:Pool Complexes Present?	No
State	WV	Stream Classification	Ephemeral		
County	Webster	303(d) Impairment Listing	No

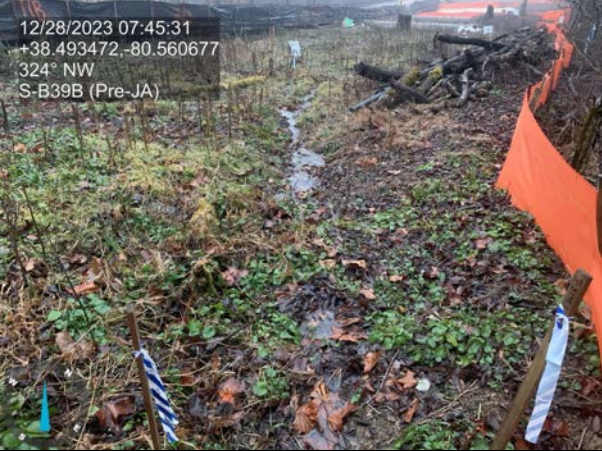
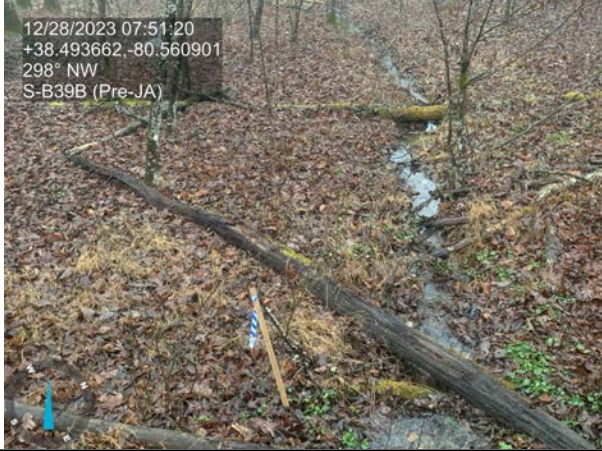
GPS Location	See Caption in Photo	GPS Location	See Caption in Photo
Description	Downstream view of permitted impact area during pre-construction assessment.	Description	Downstream view of unimpacted area during pre-construction assessment.

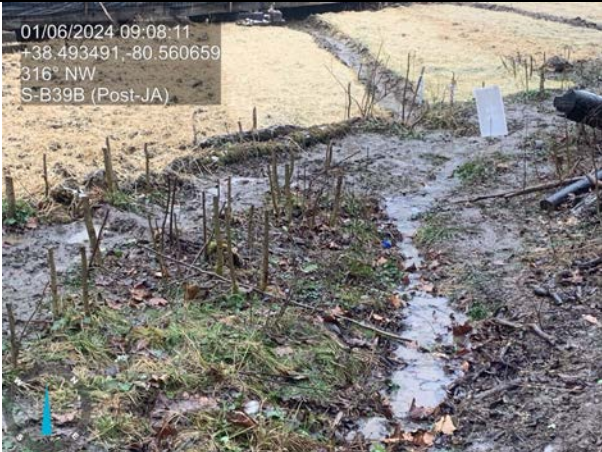
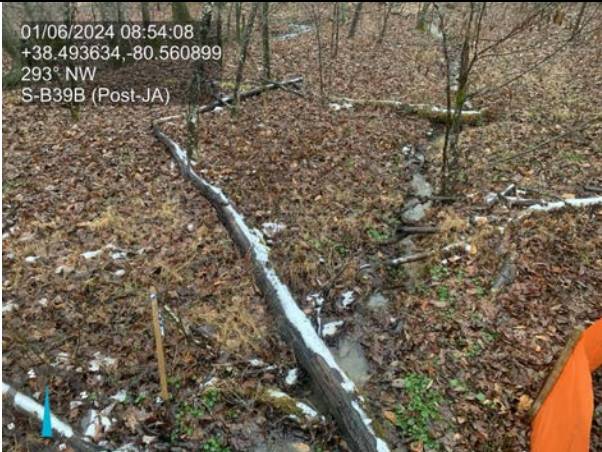
GPS Location	See Caption in Photo	GPS Location	See Caption in Photo
Description	Downstream view of permitted impact area during post-construction assessment.	Description	Downstream view of unimpacted area during post-construction assessment.

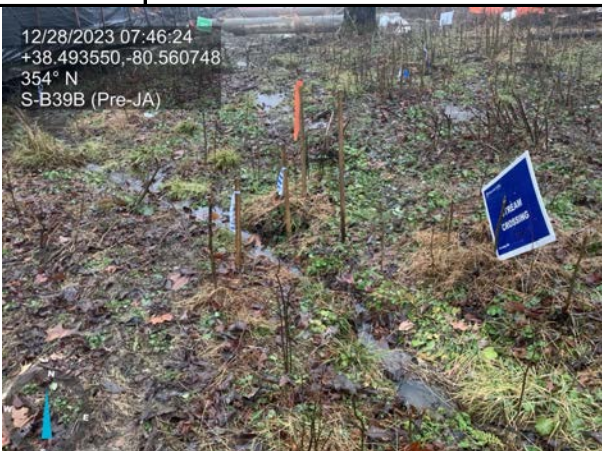
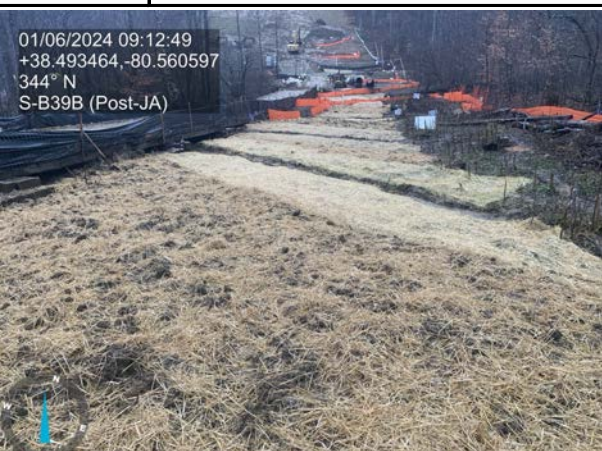
GPS Location	See Caption in Photo	GPS Location	See Caption in Photo
Description	Stream channel standing on GAS facing the CIS pre-construction.	Description	Stream channel standing on GAS facing the CIS post-construction.

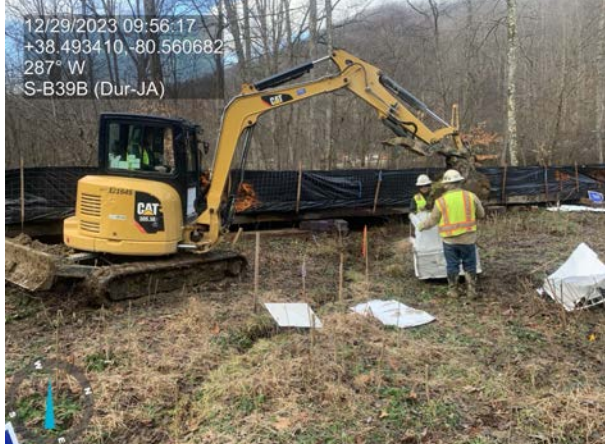
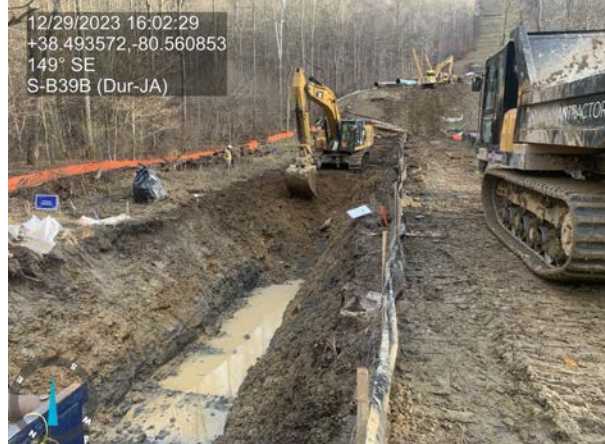
GPS Location	See Caption in Photo	GPS Location	See Caption in Photo
Description	Stream substrate being placed in super sacks.	Description	Stream subsoil being removed and hauled to an upland area.

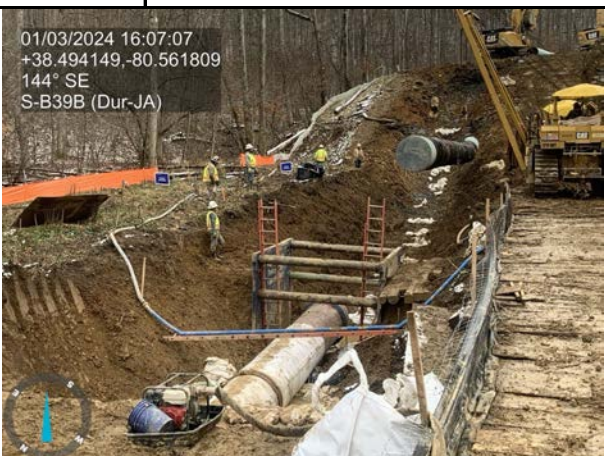
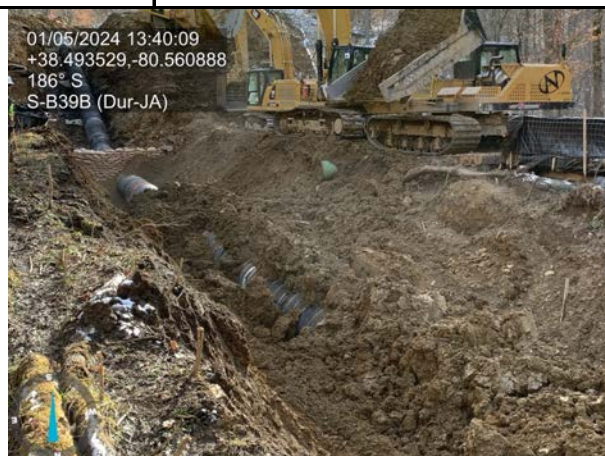
GPS Location	See Caption in Photo	GPS Location	See Caption in Photo
Description	Lowering in.	Description	View of the GAS bentonite breaker. Backfill has started.

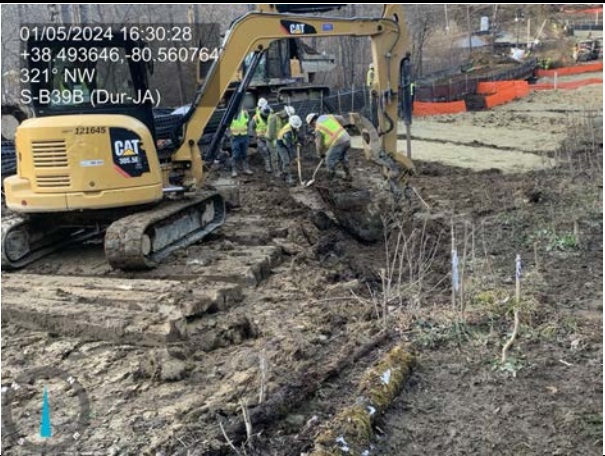
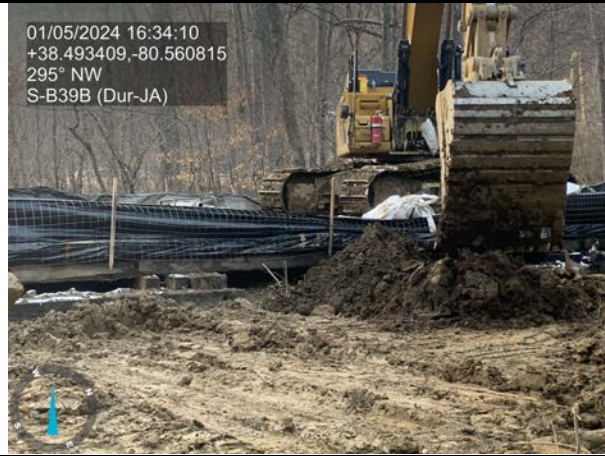
GPS Location	See Caption in Photo	GPS Location	See Caption in Photo
Description	Stream substrate being worked back into the channel.	Description	Topsoil being spread out in the buffer zone.
