# Stream Biological Conditions EA Report

<b>Project Name</b>	H-600 Pipeline Spread C	<b>AFE</b>	124300131	<b>Spread</b>	H-600 Pipeline Spread C
<b>Contractor</b>	Precision	<b>Report #</b>	472		
<b>Environmental Auditor</b>	Jeffrey Arbogast	<b>Date/Time</b>	12/29/2023 12:45 PM		
<b>Stream ID</b>	S-B45	<b>Crossing Start Date</b>	12/29/2023	<b>Crossing Completion Date</b>	1/5/2024
<b>Milepost</b>	97.90	<b>Pre-Con Assessment Date</b>	12/28/2023	<b>Post-Con Assessment Date</b>	1/6/2024
<b>Station</b>	5168+92	<b>Bankfull Width (ft.)</b>	3.0	<b>Riffle:Pool Complexes Present?</b>	No
<b>State</b>	WV	<b>Stream Classification</b>	Ephemeral		
<b>County</b>	Webster	<b>303(d) Impairment Listing</b>	No

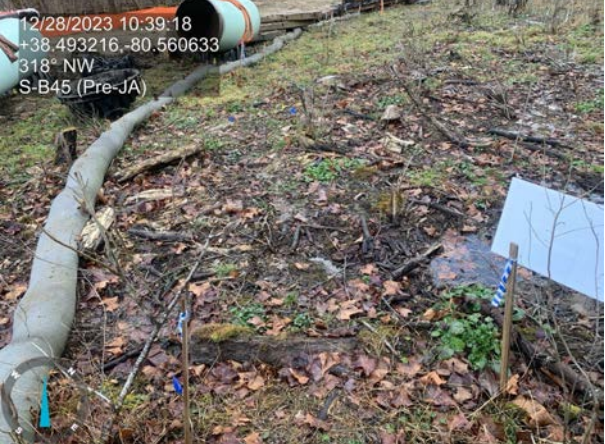
<p>12/28/2023 10:39:18 +38.493216, -80.560633 318° NW S-B45 (Pre-JA)</p>

<p>12/28/2023 07:51:21 +38.493662, -80.560901 293° NW S-B39B (Pre-JA)</p>	
<b>GPS Location</b>	See Caption in Photo	<b>GPS Location</b>	See Caption in Photo
<b>Description</b>	Downstream view of permitted impact area during pre-construction assessment.	<b>Description</b>	Downstream view of unimpacted area during pre-construction assessment. S-B45 merges with S-B39B under the timber mat travel lane prior to leaving the LOD as S-B39B.

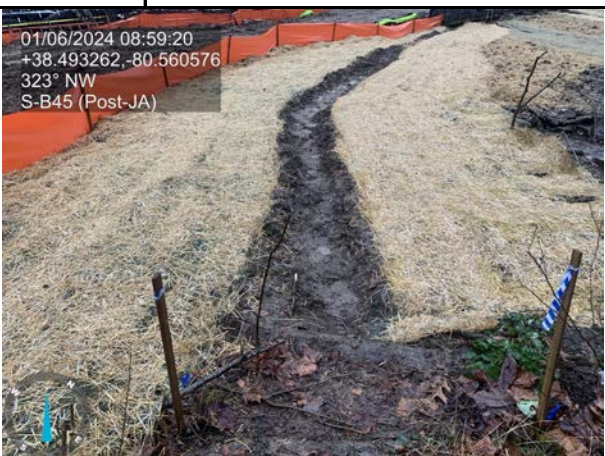
<p>01/06/2024 08:59:20 +38.493262, -80.560576 323° NW S-B45 (Post-JA)</p>

<p>01/06/2024 08:54:08 +38.493634, -80.560899 293° NW S-B39B (Post-JA)</p>	
<b>GPS Location</b>	See Caption in Photo	<b>GPS Location</b>	See Caption in Photo
<b>Description</b>	Downstream view of permitted impact area during post-construction assessment.	<b>Description</b>	Downstream view of unimpacted area during post-construction assessment. S-B45 merges with S-B39B under the timber mat travel lane prior to leaving the LOD as S-B39B.

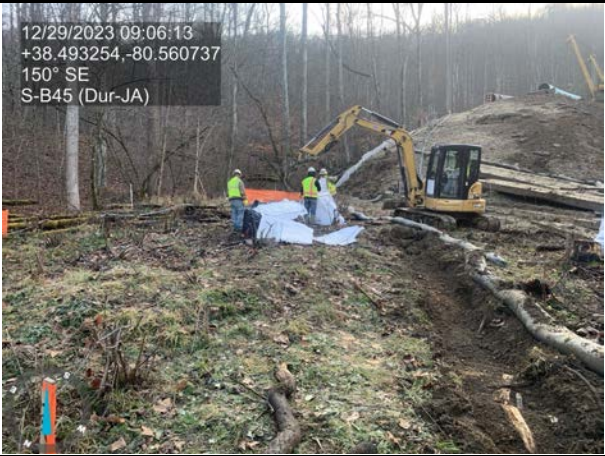
<p>12/29/2023 09:06:13 +38.493254, -80.560737 150° SE S-B45 (Dur-JA)</p>

<p>12/29/2023 11:23:15 +38.493232, -80.560859 318° NW S-B45 (Dur-JA)</p>	
<b>GPS Location</b>	See Caption in Photo	<b>GPS Location</b>	See Caption in Photo
<b>Description</b>	Stream substrate being placed in super sacks.	<b>Description</b>	10' buffer topsoil being removed.
