STREAM BIOLOGICAL CONDITIONS ENVIRONMENTAL AUDITOR REPORT

Stream ID: S-CC3	Crossing Start Date: 11/25/2023	Crossing Completion Date: 11/27/2023
Milepost: 295.3	Pre-Con Assessment Date: 11/12/2023	Post-Con Assessment Date: 11/28/2023
Station: 15599+81	Stream Classification: Ephemeral (Perennial, Intermittent, Ephemeral)	Bankfull Width (ft.): 8
County: Pittsylvania	303(d) Impairment Listing: Not Impaired	Riffle:Pool Complexes Present? No

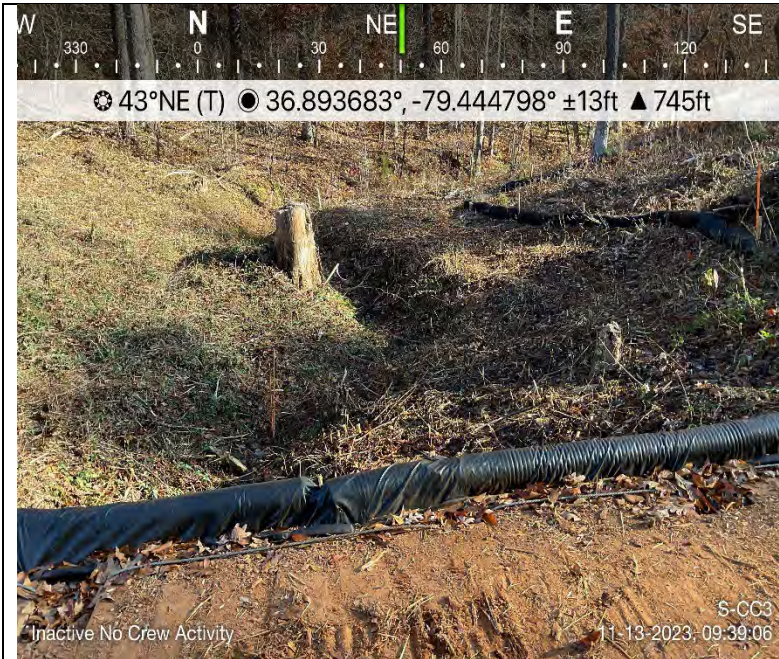
Photo Description: Upstream view of permitted impact area during pre-construction assessment.

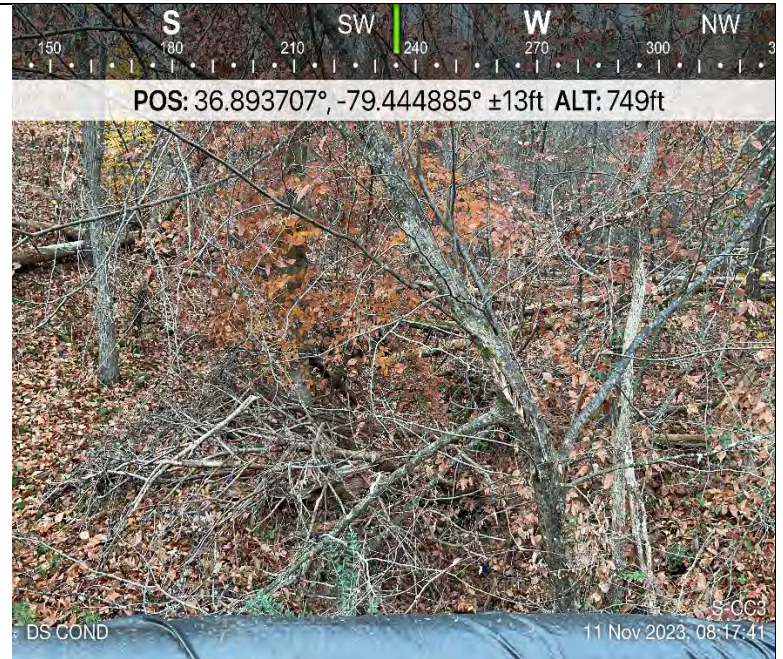
Photo Description: Conditions of the downstream area outside the ROW during pre-construction assessment.

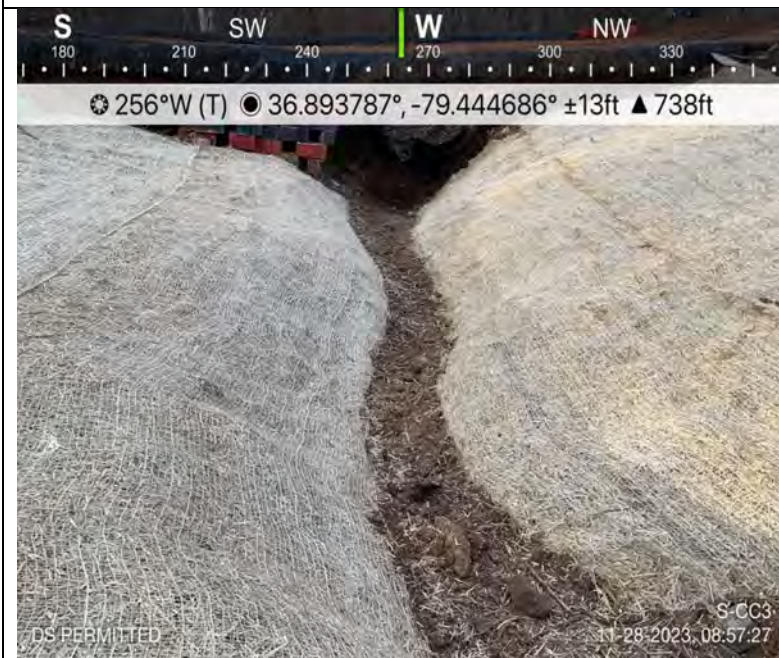
Photo Description: Downstream view of permitted impact area during post-construction assessment.

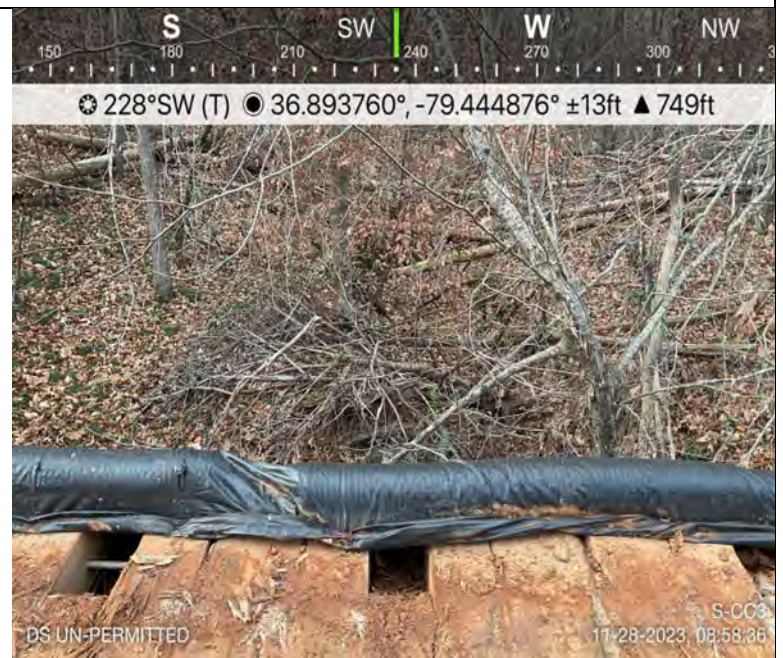
Photo Description: Conditions of the downstream area outside the ROW during post-construction assessment.

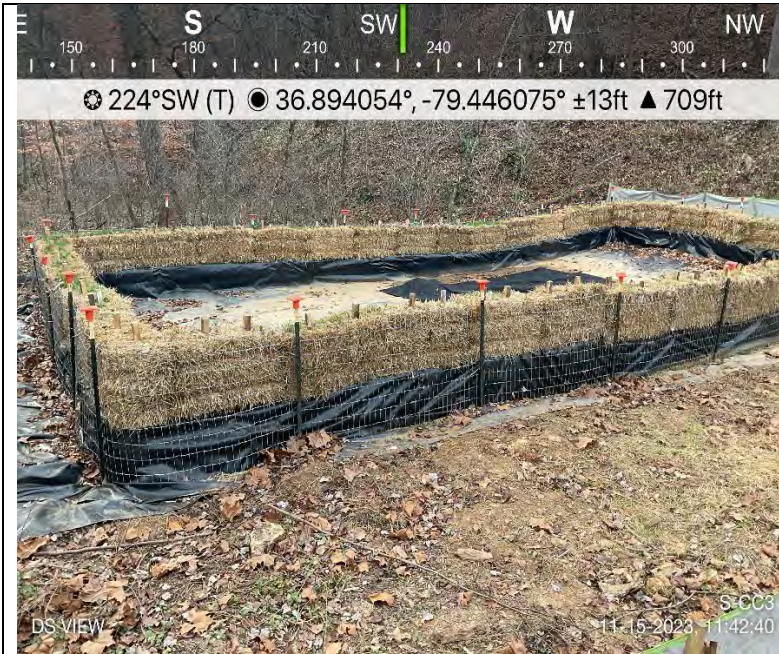
Photo Description: An overview of the dewatering structure.

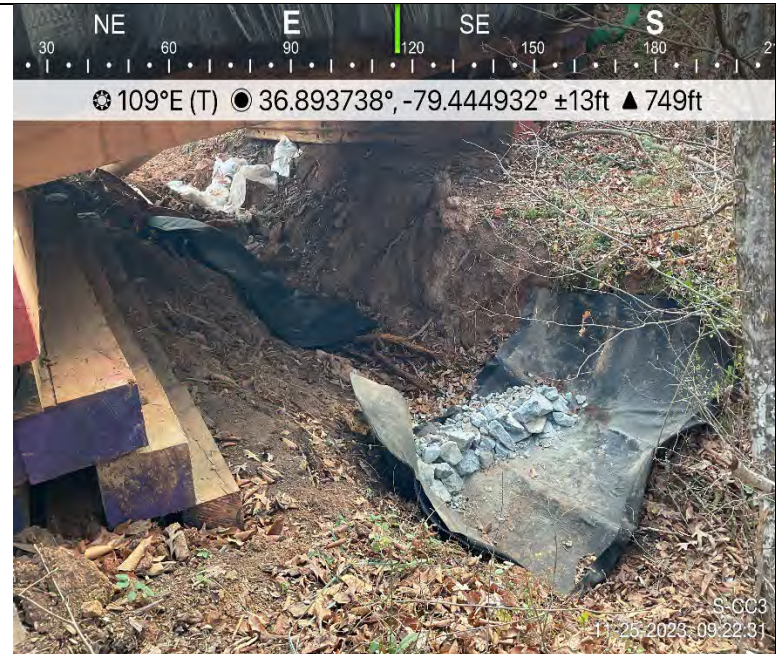
Photo Description: A flume and energy dissipator installed within the resource.

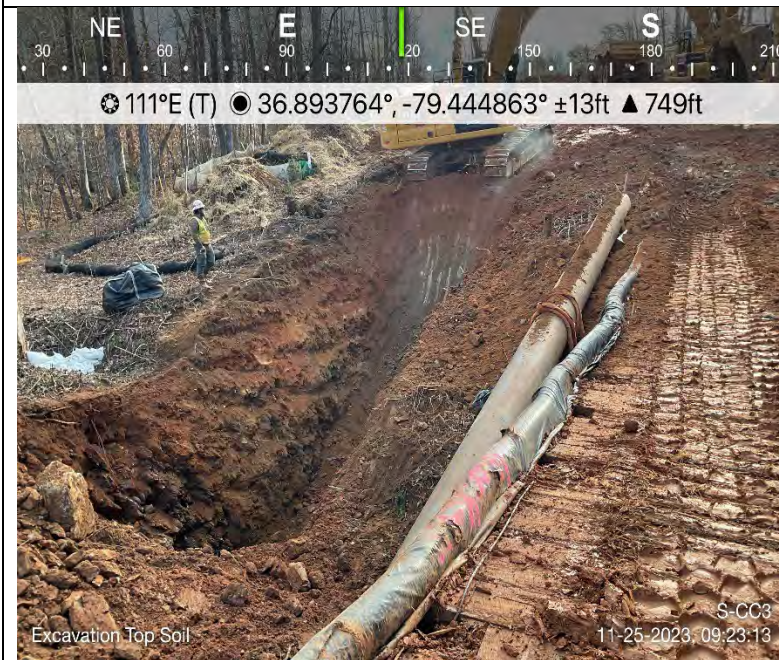
Photo Description: Topsoiling and Trench Excavation

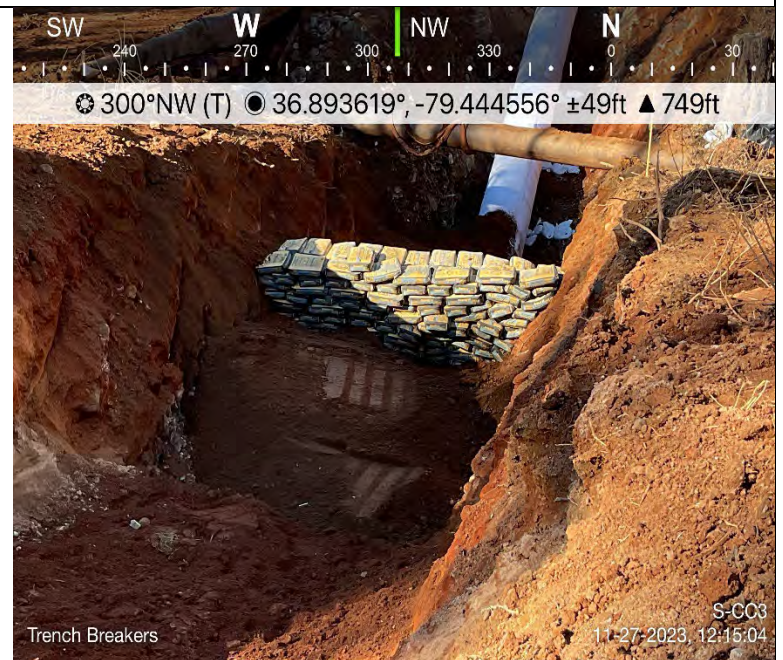
Photo Description: Trench Breakers installed within the trench.
