# STREAM BIOLOGICAL CONDITIONS ENVIRONMENTAL AUDITOR REPORT

<b>Stream ID:</b> S-CD8	<b>Crossing Start Date:</b> 11/03/2023	<b>Crossing Completion Date:</b> 11/8/2023
<b>Milepost:</b> 281.7	<b>Pre-Con Assessment Date:</b> 10/30/2023	<b>Post-Con Assessment Date:</b> 11/9/2023
<b>Station:</b> 14881+45	<b>Stream Classification:</b> Intermittent (Perennial, Intermittent, Ephemeral)	<b>Bankfull Width (ft.):</b> 4.5
<b>County:</b> Franklin	<b>303(d) Impairment Listing:</b> Not Impaired	<b>Riffle:Pool Complexes Present?</b> No

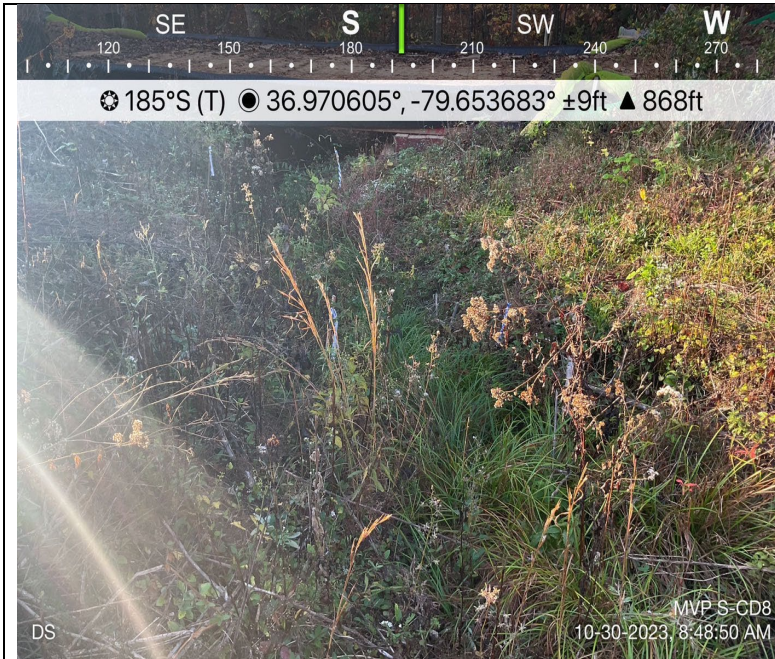
**Photo Description:** Downstream view of permitted impact area during pre-construction assessment.

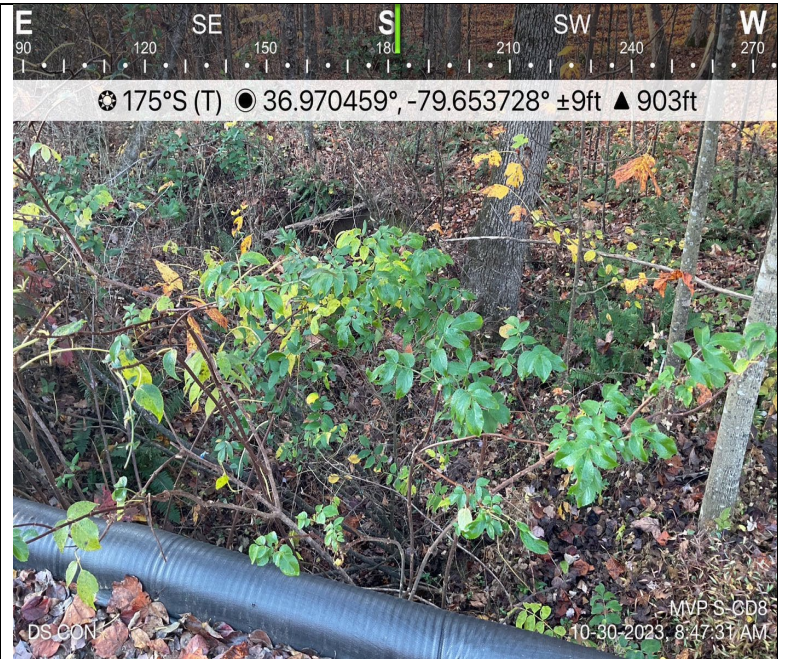
**Photo Description:** Conditions of the downstream area outside the ROW during pre-construction assessment.

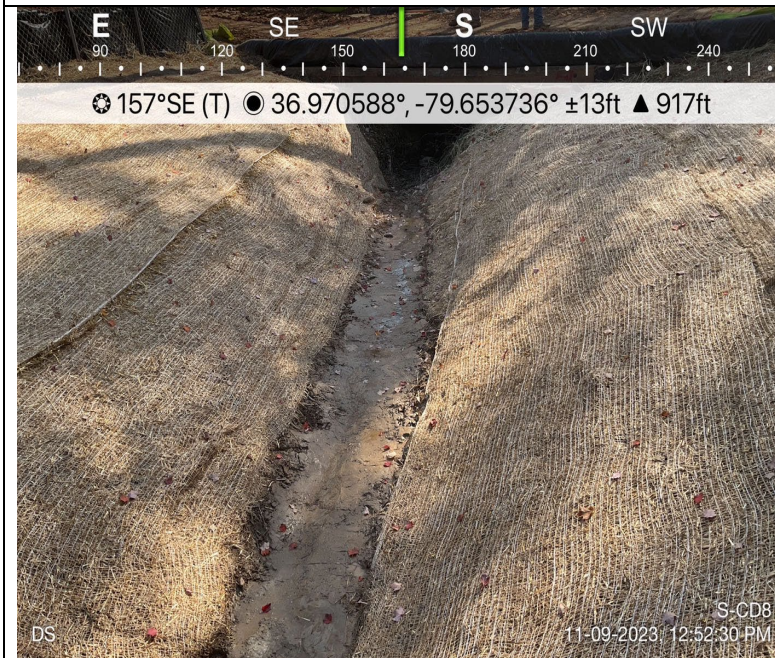
**Photo Description:** Downstream view of permitted impact area during post-construction assessment.

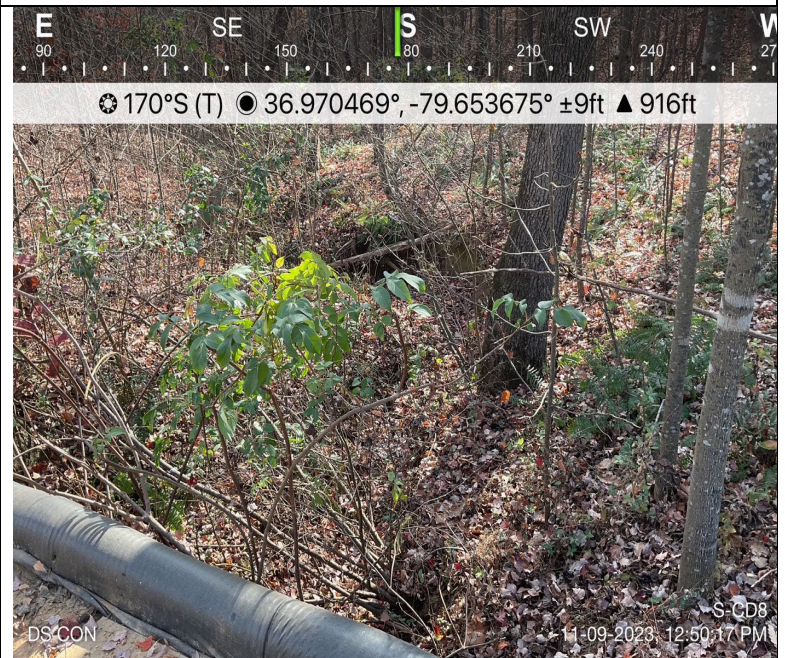
**Photo Description:** Conditions of the downstream area outside the ROW during post-construction assessment.

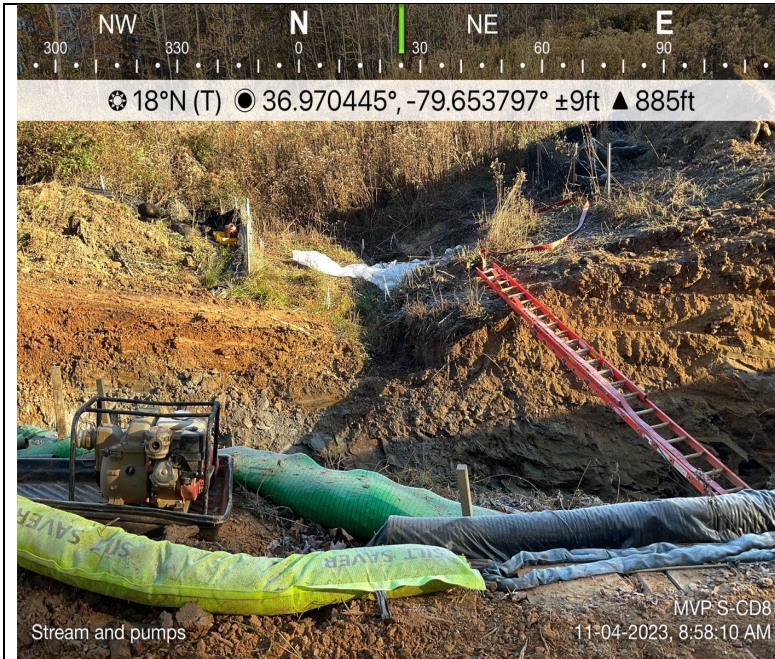
**Photo Description:** An overview of the dam and pump installed onsite.

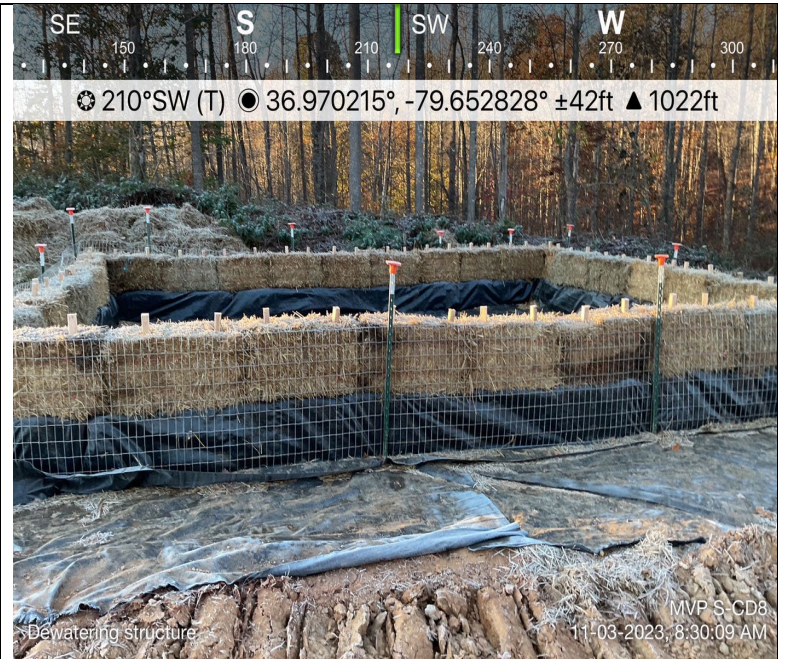
**Photo Description:** An overview of the dewatering structure.

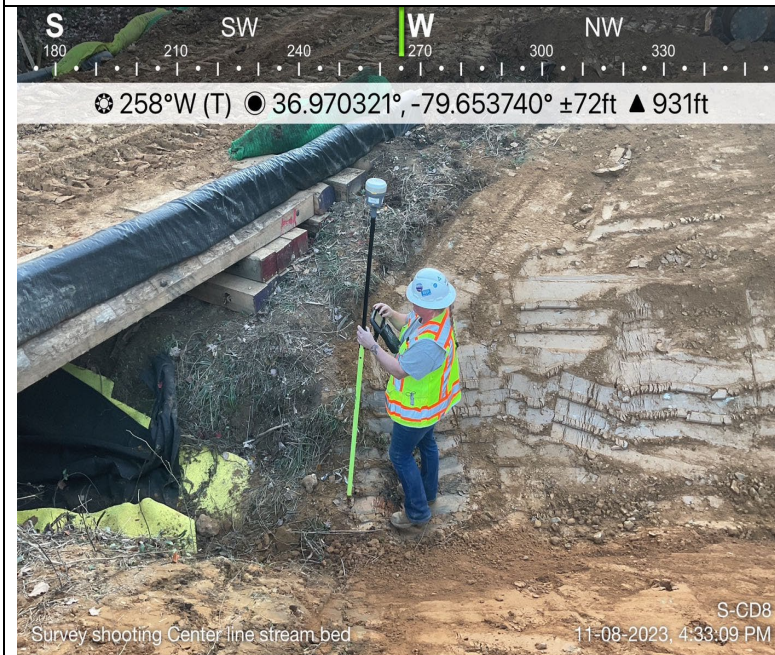
**Photo Description:** Survey onsite for the reconstruction of the stream centerline.

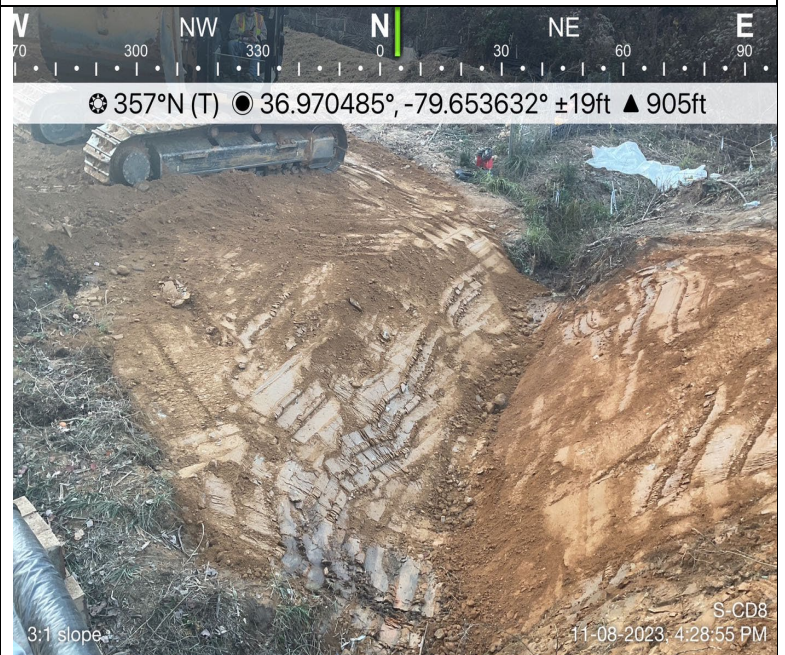
**Photo Description:** A 3:1 slope to the stream bank was achieved during reconstruction.

11-08-23: The pipe was x-rayed, coated and sand blasted. Backfilling began. Two trench breakers were installed on both sides of the stream. Survey was shot for the stream centerline. Bank modification occurred to reconstruction the banks to a more stable slope. Both 50-foot buffer zones were backfilled, filter sock was installed, and seed was applied. Stabilization matting was installed with high velocity screw pins and keyed in 6-inches. The banks inside of the 10-foot buffer were heavily seeded with permanent riparian mix and temporary seed was also applied for stabilization. Flow was restored to the resource and the auditor conducted the post-construction assessment. -D. Fraise
