STREAM BIOLOGICAL CONDITIONS ENVIRONMENTAL AUDITOR REPORT

Stream ID: S-D12	Crossing Start Date: 12/12/2023	Crossing Completion Date: 12/16/2023
Milepost: 248.8	Pre-Con Assessment Date: 12/04/2023	Post-Con Assessment Date: 12/20/2023
Station: 13146+56	Stream Classification: Intermittent (Perennial, Intermittent, Ephemeral)	Bankfull Width (ft.): 6
County: Franklin	303(d) Impairment Listing: Not Impaired	Riffle:Pool Complexes Present? No

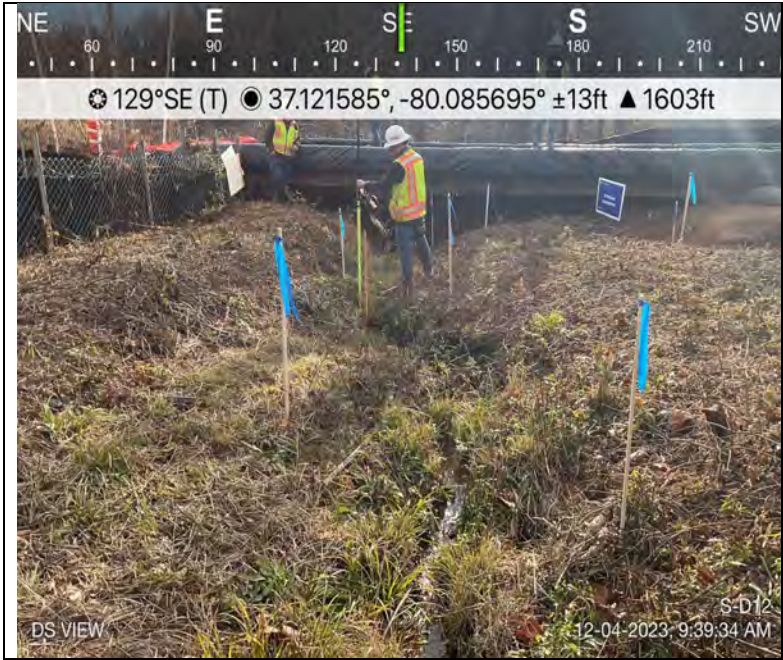
Photo Description: Downstream view of permitted impact area during pre-construction assessment.

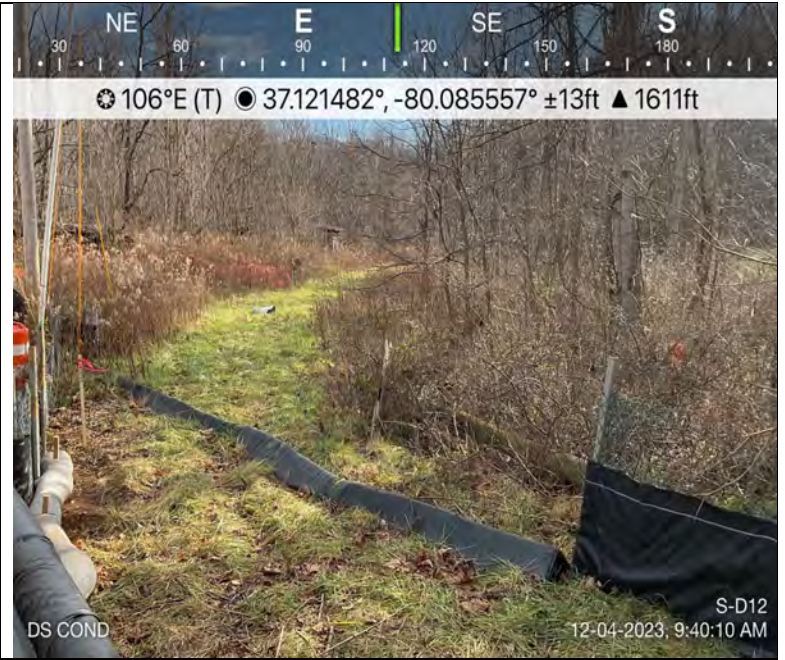
Photo Description: Conditions of the downstream area outside the ROW during pre-construction assessment.

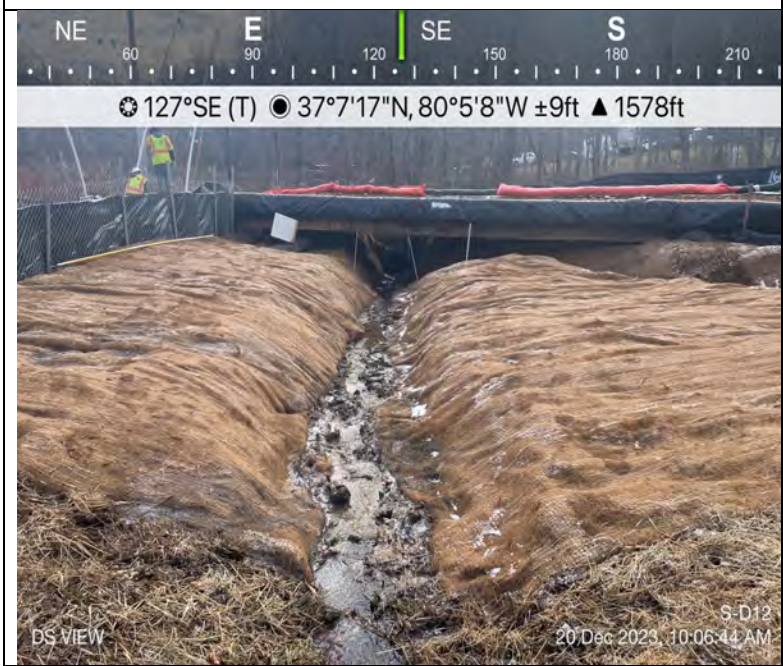
Photo Description: Downstream view of permitted impact area during post-construction assessment.

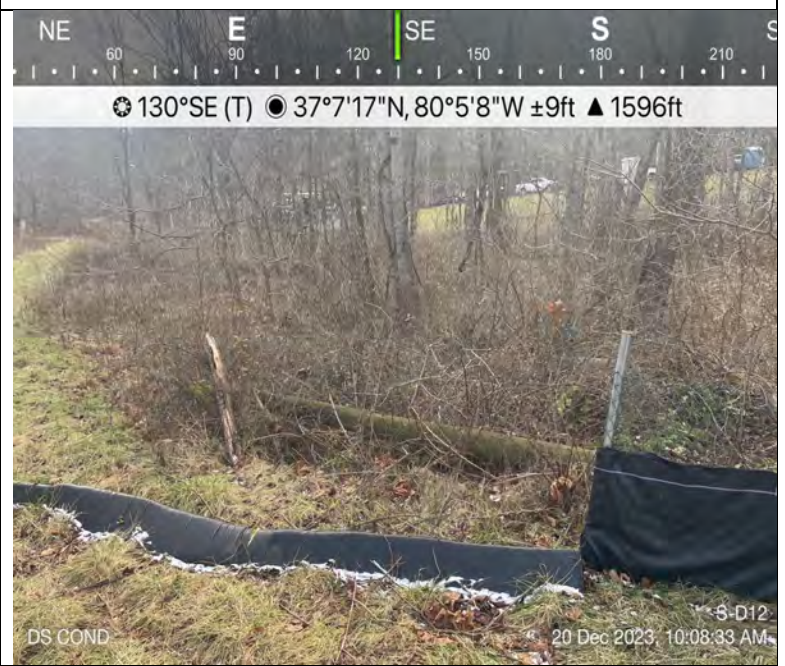
Photo Description: Conditions of the downstream area outside the ROW during post-construction assessment.

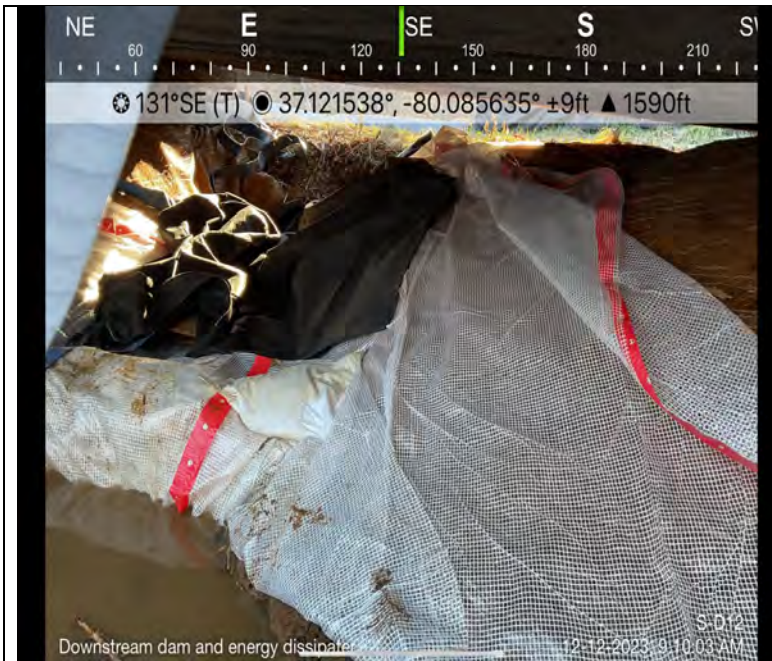
Photo Description: An overview of the downstream dam and energy dissipater.

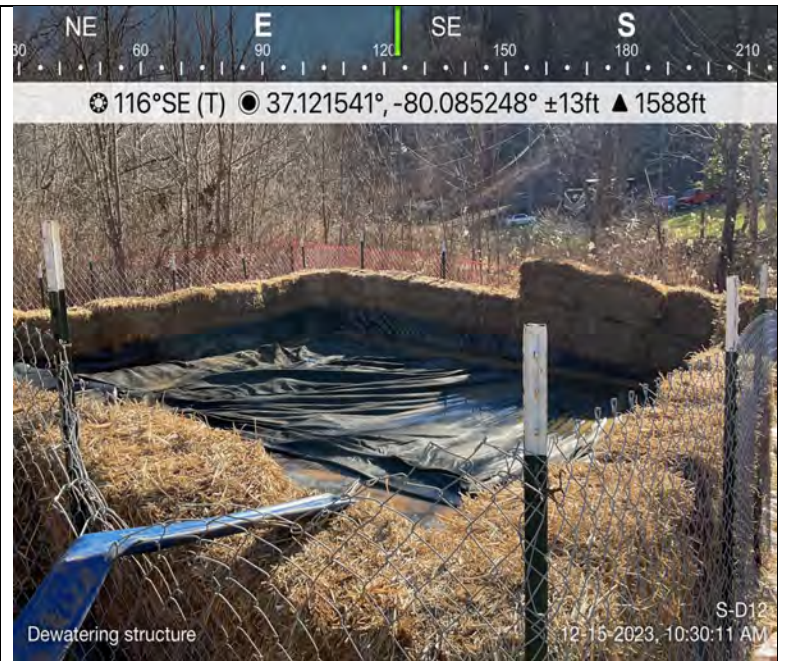
Photo Description: An overview of the dewatering structure functioning as designed.

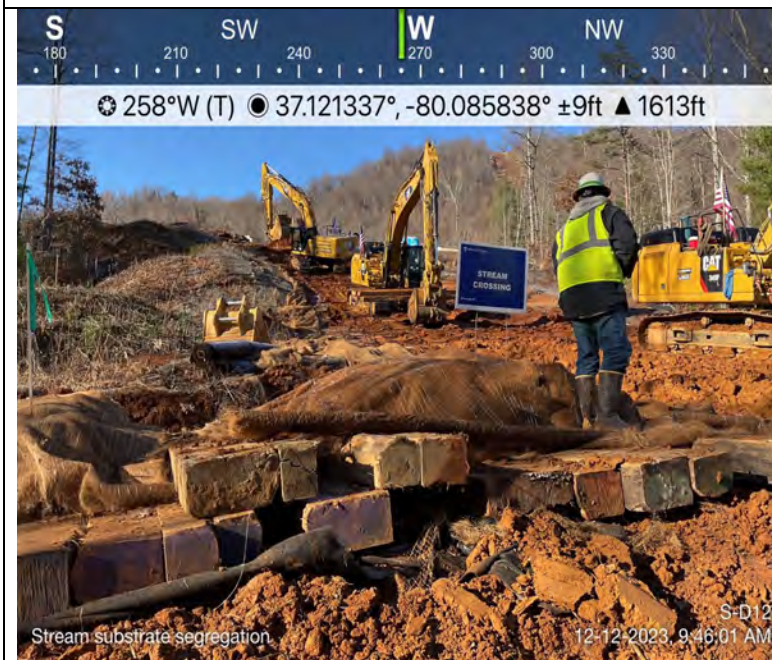
Photo Description: Stream substrate was segregated and stabilized.

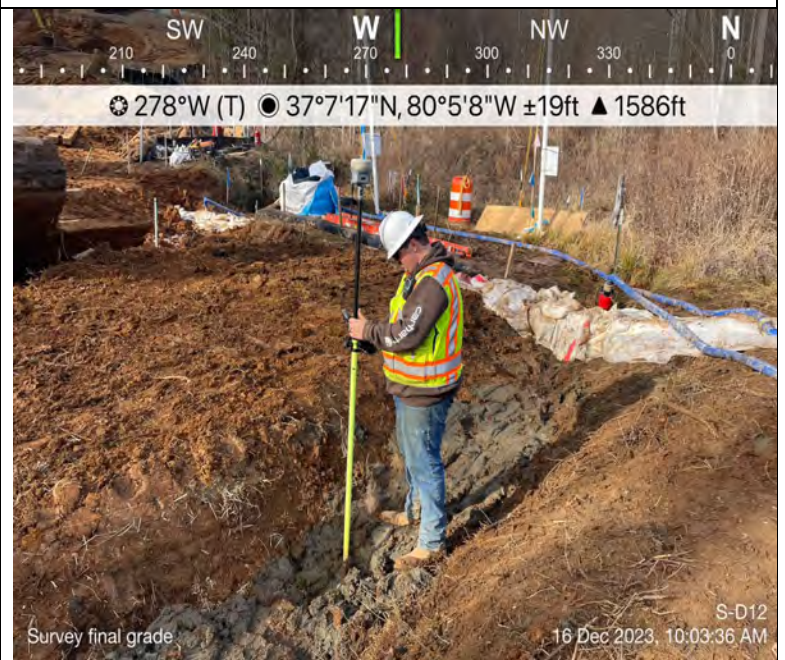
Photo Description: Survey shooting the final grade for the stream bed elevation.
