STREAM BIOLOGICAL CONDITIONS ENVIRONMENTAL AUDITOR REPORT

Stream ID: S-D13	Crossing Start Date: 12/12/2023	Crossing Completion Date: 12/16/2023
Milepost: 248.8	Pre-Con Assessment Date: 12/04/2023	Post-Con Assessment Date: 12/20/2023
Station: 13146+39	Stream Classification: Intermittent (Perennial, Intermittent, Ephemeral)	Bankfull Width (ft.): 4
County: Franklin	303(d) Impairment Listing: Not Impaired	Riffle:Pool Complexes Present? No

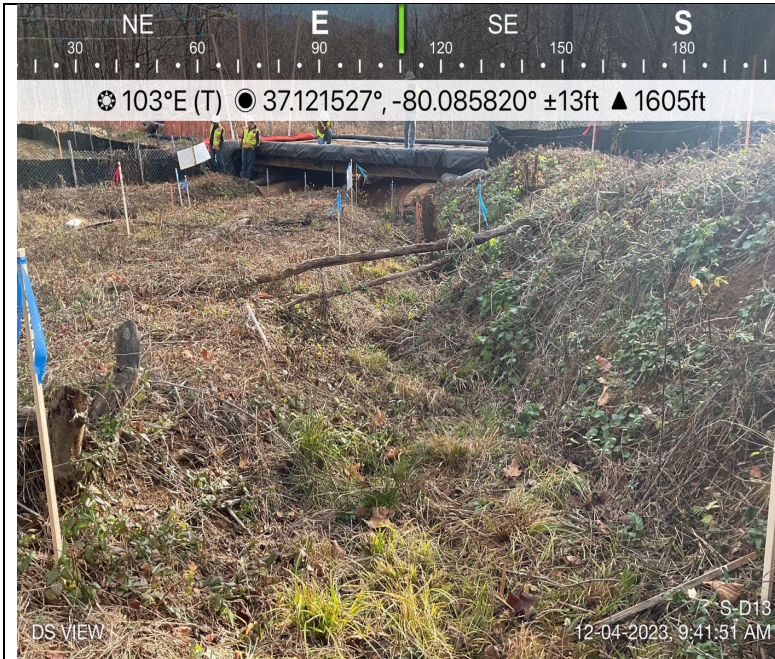
Photo Description: Downstream view of permitted impact area during pre-construction assessment.

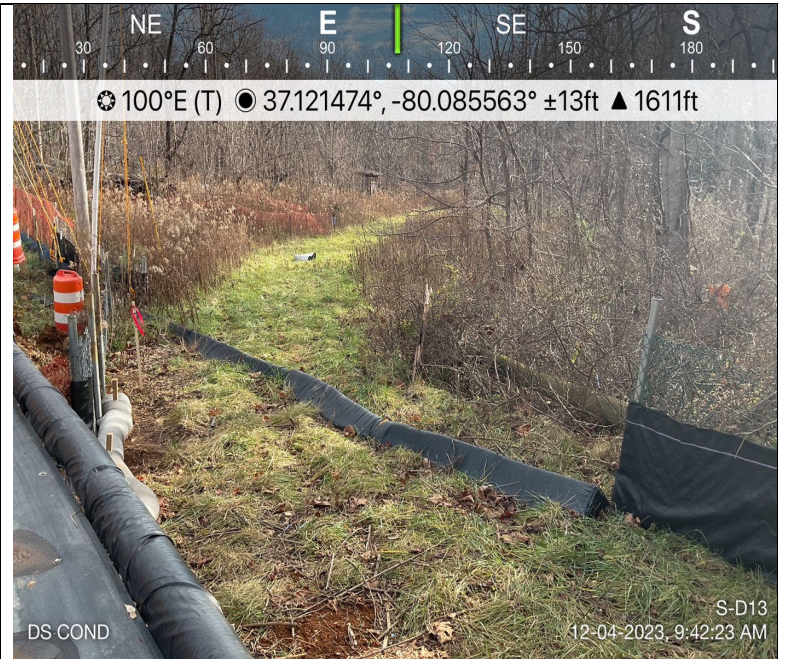
Photo Description: Conditions of the downstream area outside the ROW during pre-construction assessment.

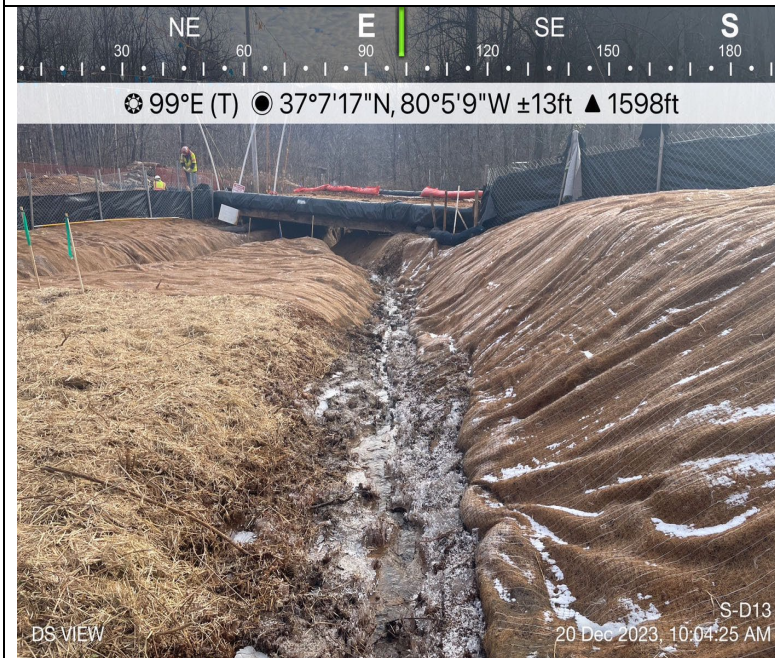
Photo Description: Downstream view of permitted impact area during post-construction assessment.

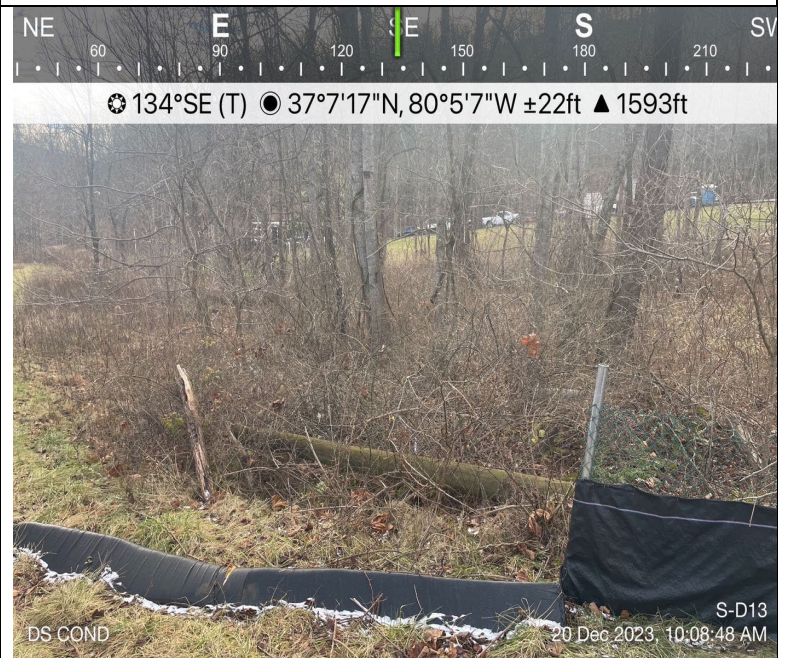
Photo Description: Conditions of the downstream area outside the ROW during post-construction assessment.

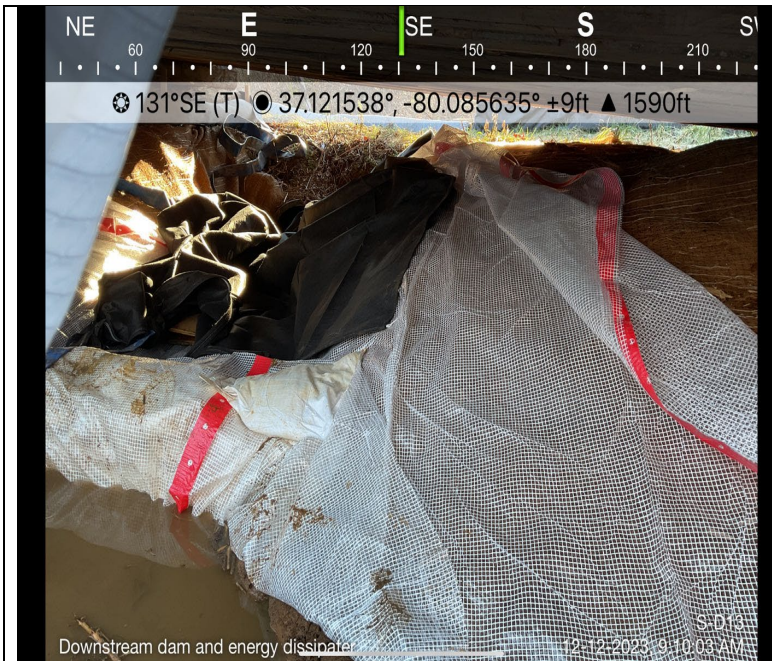
Photo Description: An overview of the downstream dam and energy dissipater.

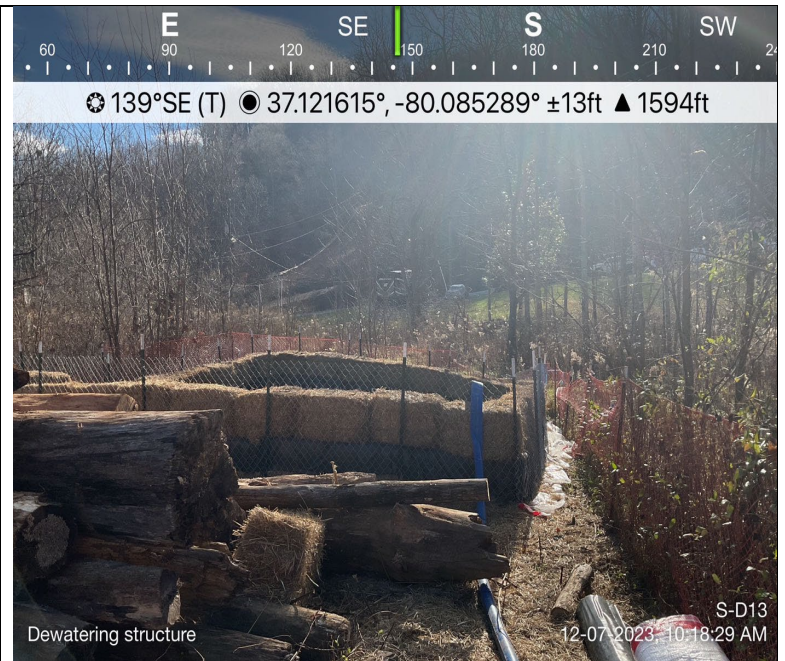
Photo Description: An overview of the dewatering structure functioning as designed.

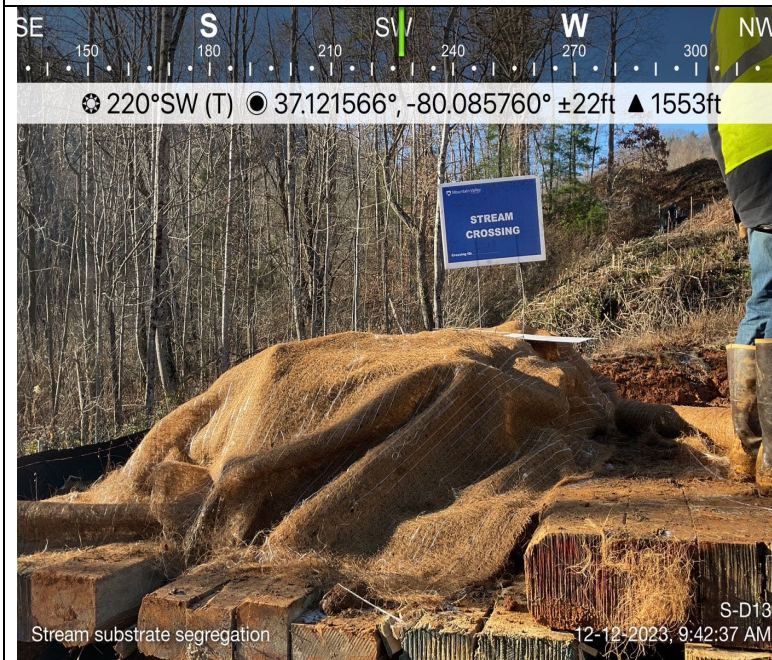
Photo Description: The top 12-inches of stream substrate was segregated and stabilized.

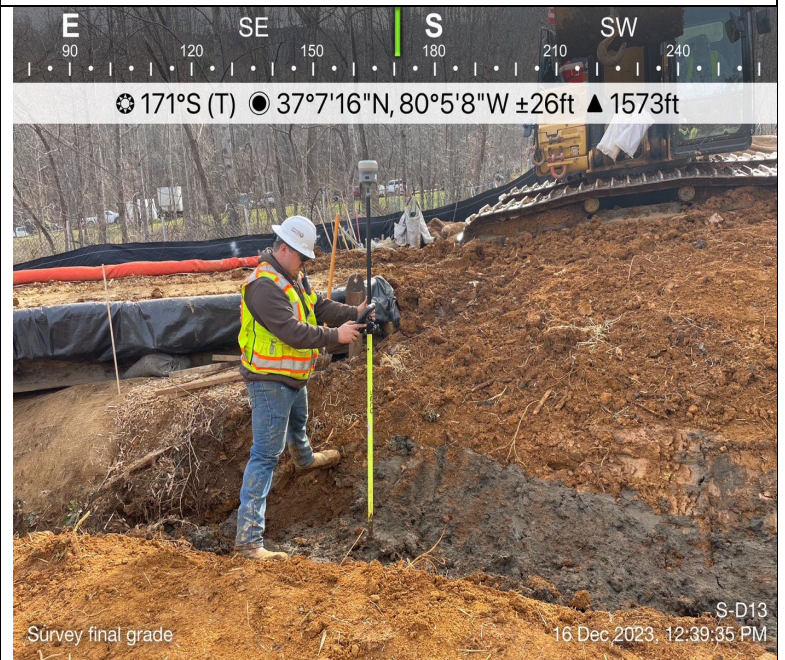
Photo Description: Survey shooting final grade for the stream bed elevation.
