STREAM BIOLOGICAL CONDITIONS ENVIRONMENTAL AUDITOR REPORT

Version 2.3

Stream ID: S-E24	Crossing Start Date: 11/27/2023	Crossing Completion Date: 01/05/2024
Milepost: 207.9	Pre-Con Assessment Date: 11/20/2023	Post-Con Assessment Date: 01/05/2024
Station: 10985+92	Stream Classification: Perennial (Perennial, Intermittent, Ephemeral)	Bankfull Width (ft.): 20
County: Giles	303(d) Impairment Listing: Not Impaired	Riffle:Pool Complexes Present? No

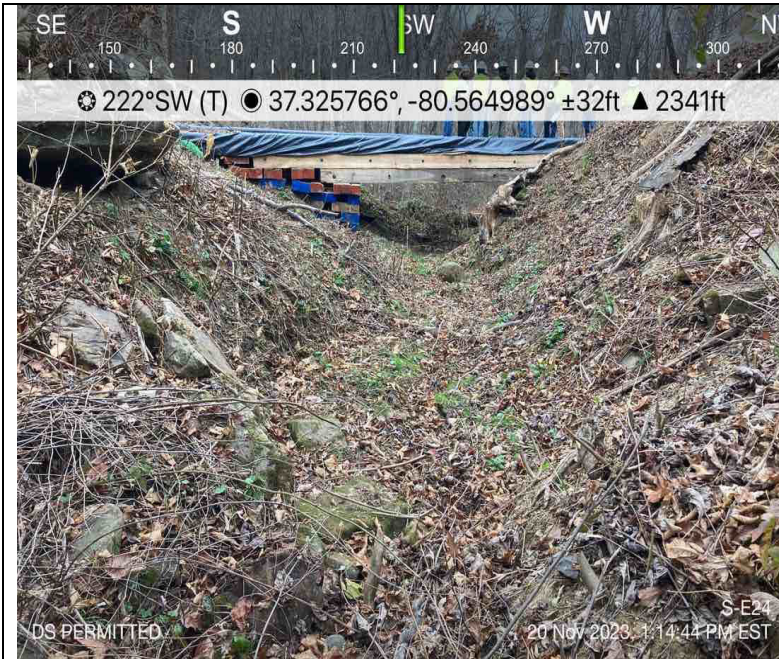
Photo Description: Downstream view of permitted impact area during pre-construction assessment.

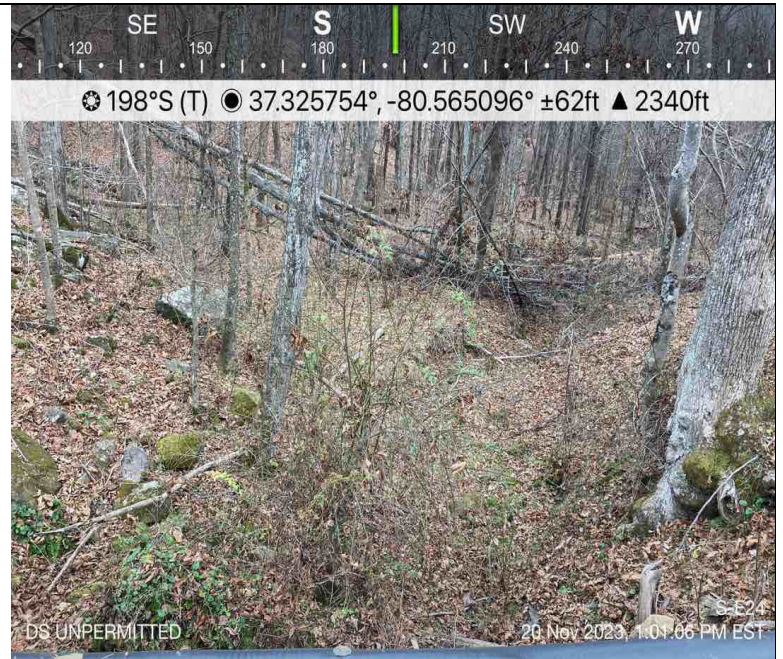
Photo Description: Conditions of the downstream area outside the ROW during pre-construction assessment.

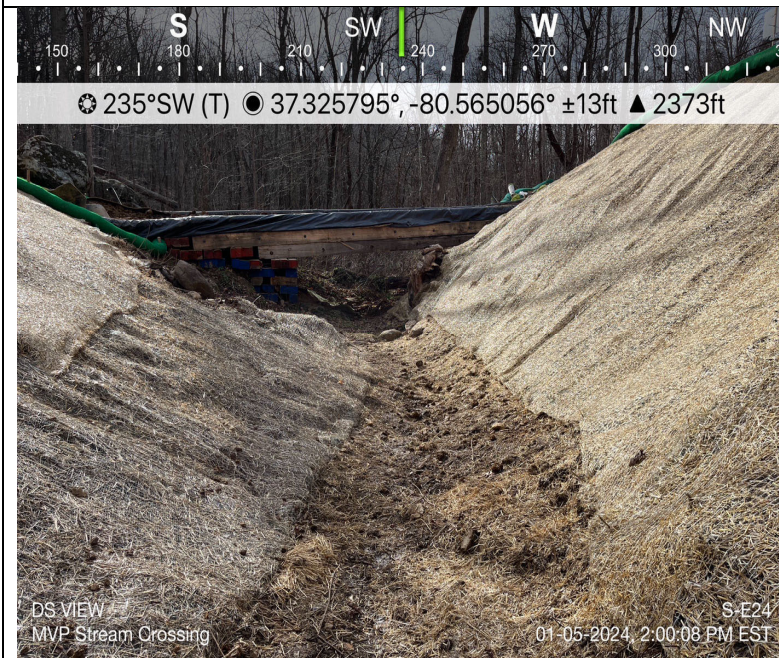
Photo Description: Downstream view of permitted impact area during post-construction assessment.

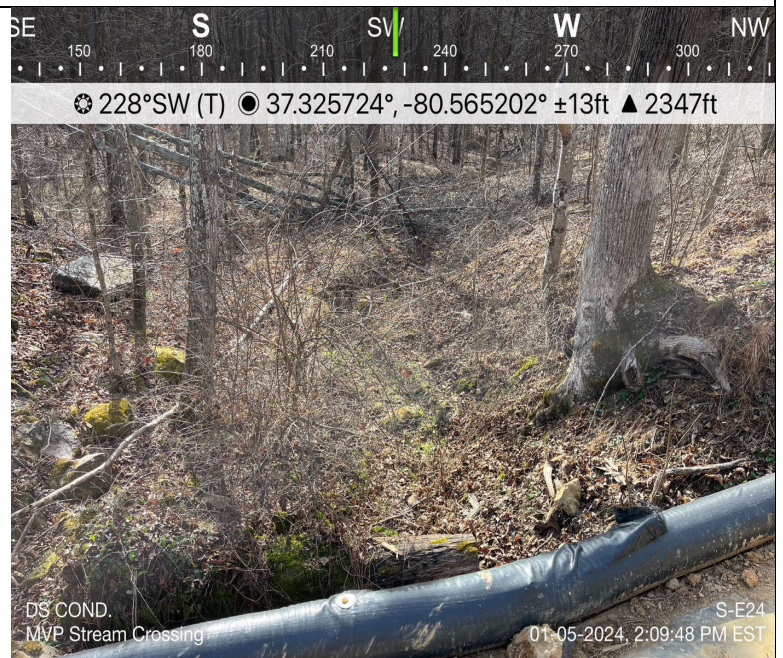
Photo Description: Conditions of the downstream area outside the ROW during post-construction assessment.

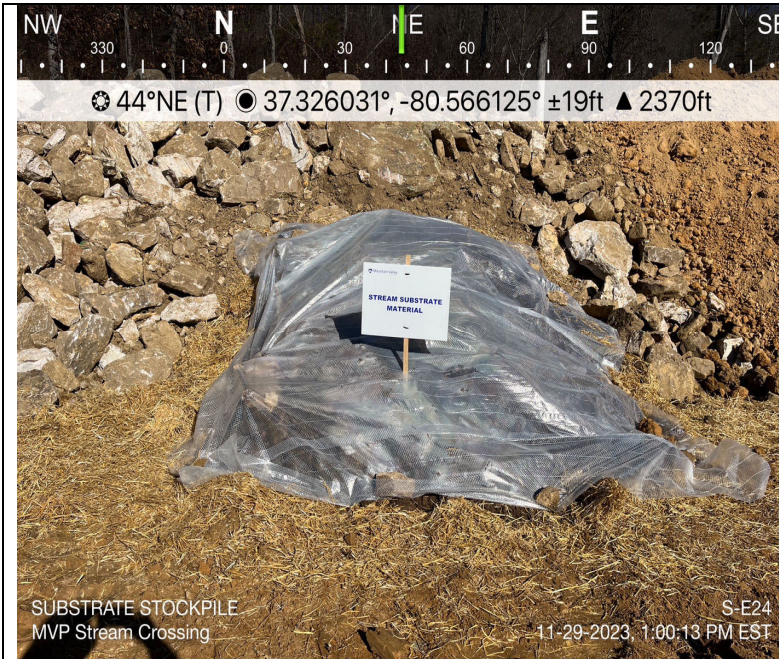
11/29/2023- Removed top 12in. of stream substrate. Due to lack of space, stream substrate was segregated and stockpiled in upland area with 6 in. straw barrier to prevent mixing and covered with Visqueen plastic. Began removing subsoil to match grade of travel lane to prepare for trenching operations. Biological conditions remain stable and there were no observed impacts. -A. Burgess

Photo Description: Stream substrate stockpile and stabilization

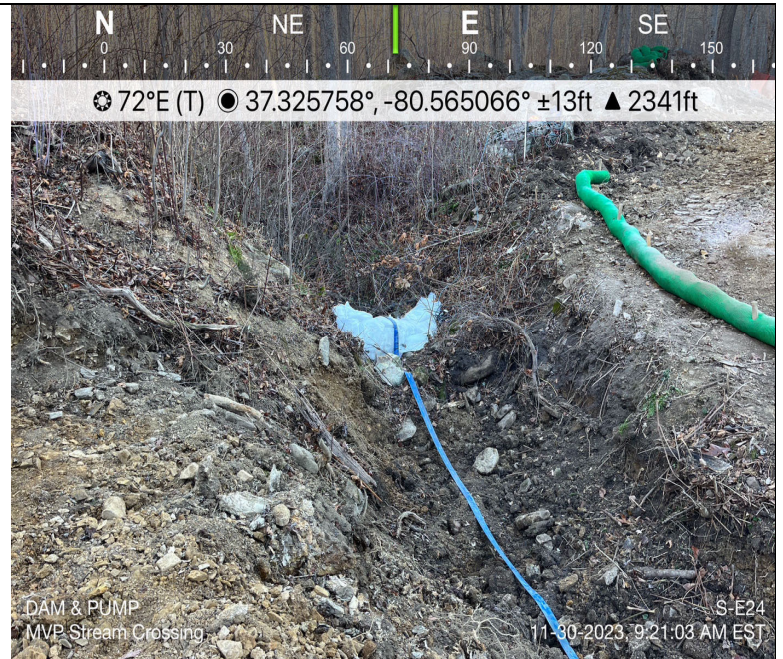
Photo Description: Dam & pump operation maintained throughout construction.

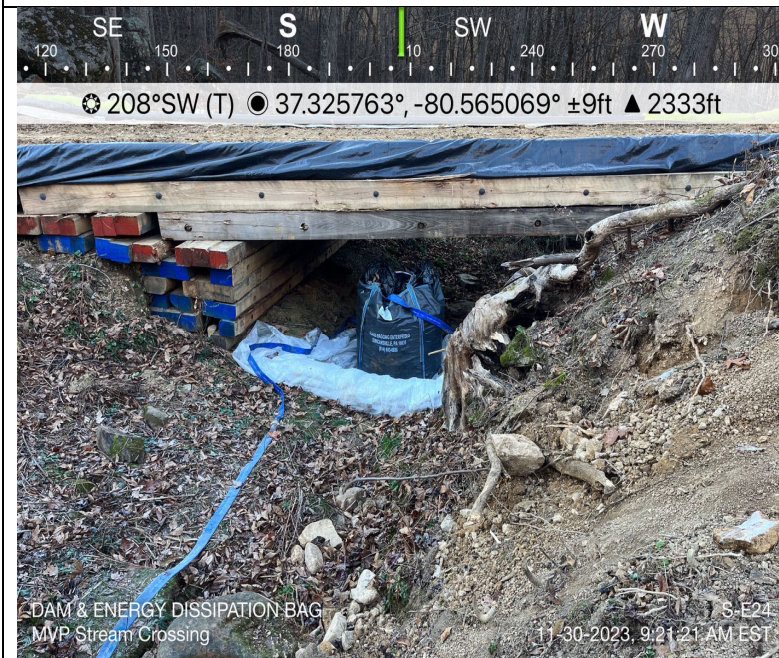
Photo Description: Downstream dam & energy dissipation bag

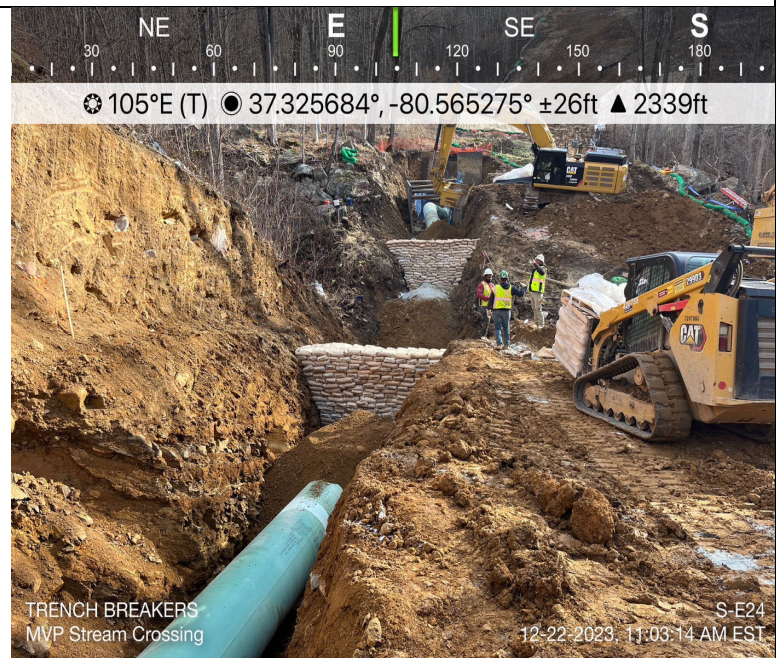
Photo Description: Trench breaker installation and subsoil padding backfill.
