STREAM BIOLOGICAL CONDITIONS ENVIRONMENTAL AUDITOR REPORT

Stream ID: S-G33	Crossing Start Date: 11/26/2023	Crossing Completion Date: 12/08/2023
Milepost: 202.7	Pre-Con Assessment Date: 11/18/2023	Post-Con Assessment Date: 12/08/2023
Station: 10712+73	Stream Classification: Perennial (Perennial, Intermittent, Ephemeral)	Bankfull Width (ft.): 8
County: Giles	303(d) Impairment Listing: Not Impaired	Riffle:Pool Complexes Present? No

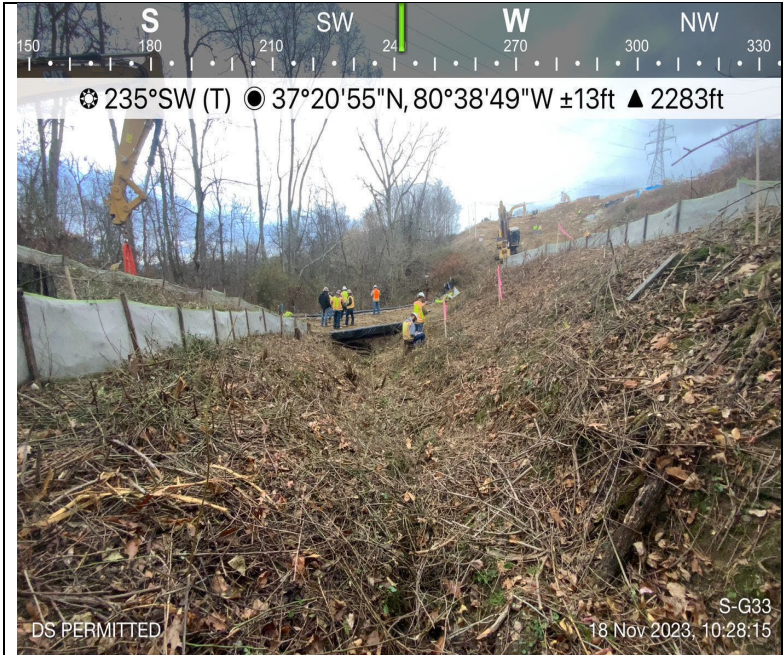
Photo Description: Downstream view of permitted impact area during pre-construction assessment.

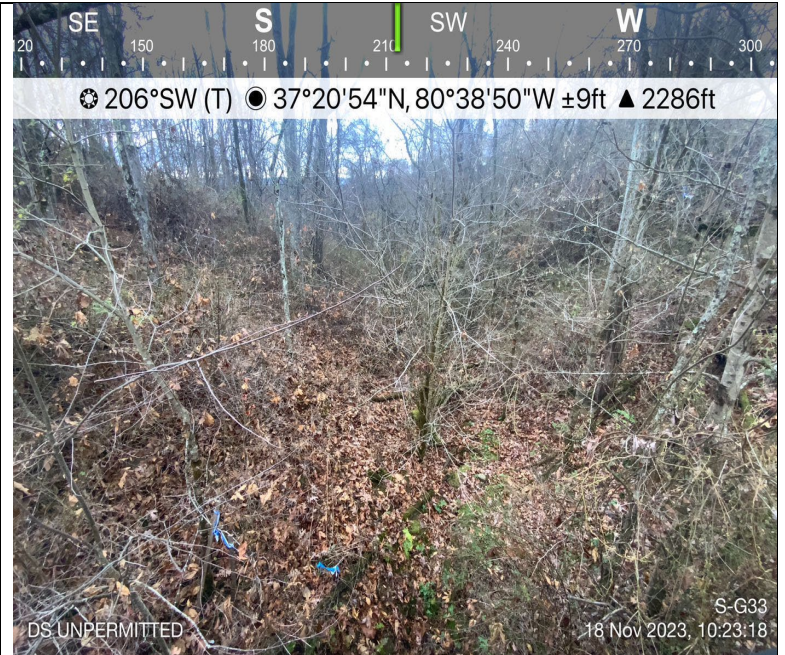
Photo Description: Conditions of the downstream area outside the ROW during pre-construction assessment.

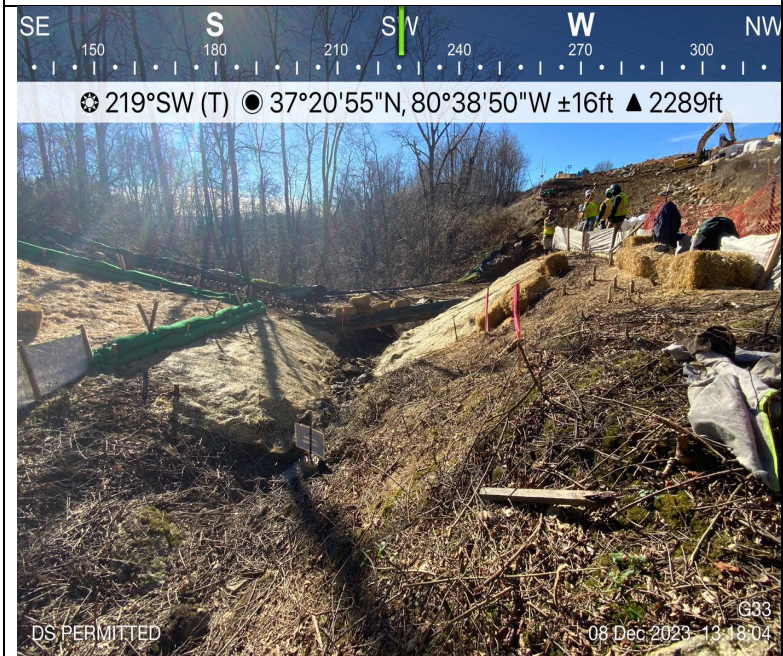
Photo Description: Downstream view of permitted impact area during post-construction assessment.

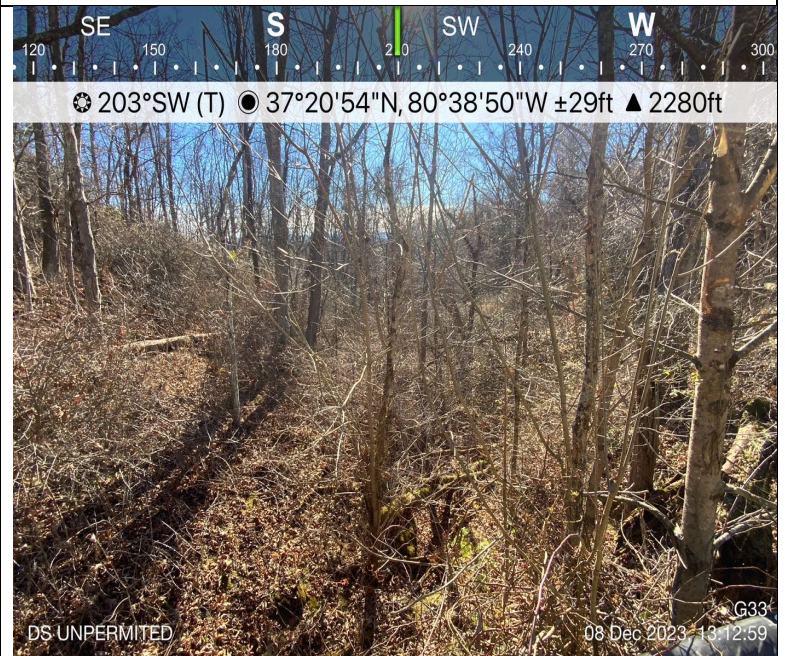
Photo Description: Conditions of the downstream area outside the ROW during post-construction assessment.

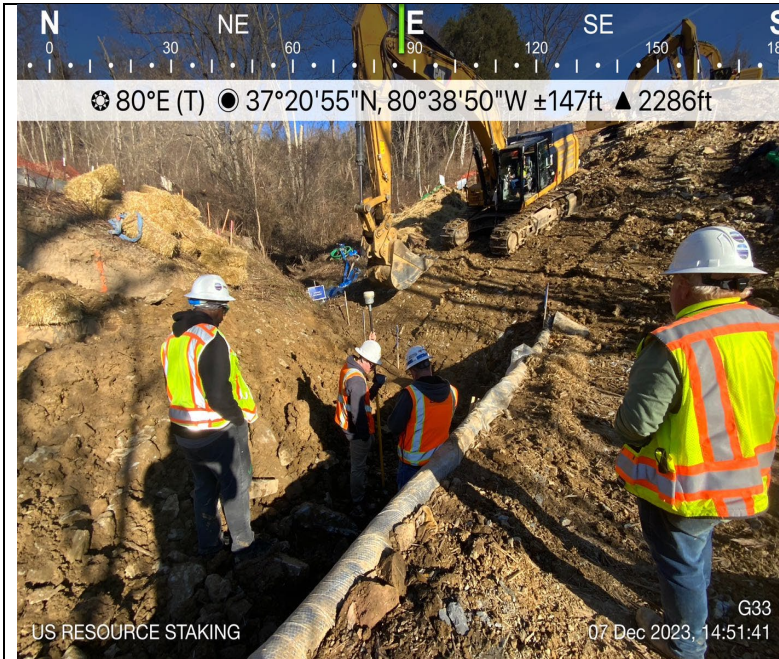
Photo Description: The survey team conducting final contouring of the stream.

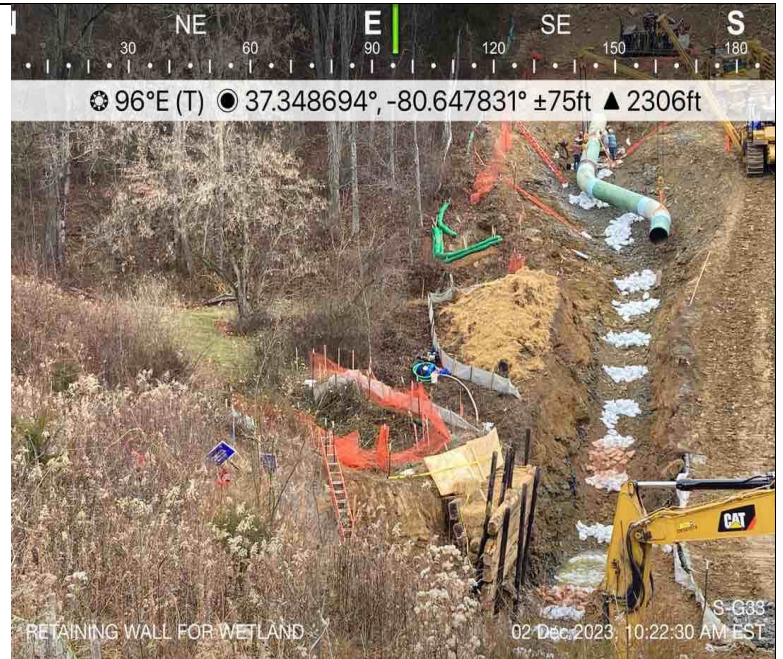
11/30/23- The trench was excavated after blasting activities. Due to the blasting activities, the retaining wall destabilized. The wall is under assessment to be rebuilt. No impact to biological conditions was observed. -D. Coleman

Photo Description: A retaining wall was constructed to prevent sloughing of the adjacent manmade pond into the resource.

12/1/23- Retaining wall was reinforced and is now functioning as intended. The trench excavation was completed. Heavier precipitation began around noon and construction activities have slowed. Pumps and hoses are on standby to be used if needed in the resource. No impact to biological conditions was observed. -D. Coleman

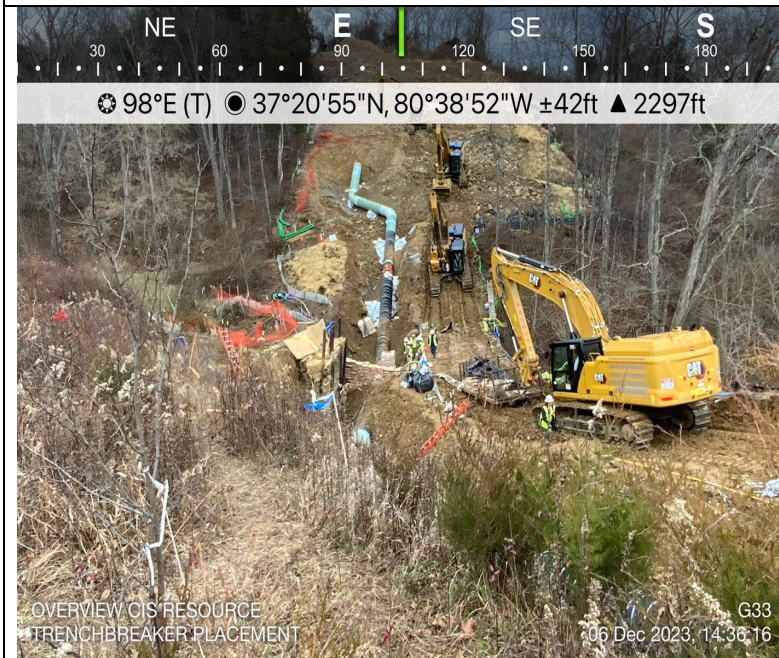
Photo Description: Trench breakers were installed within 25-feet from the top of bank.

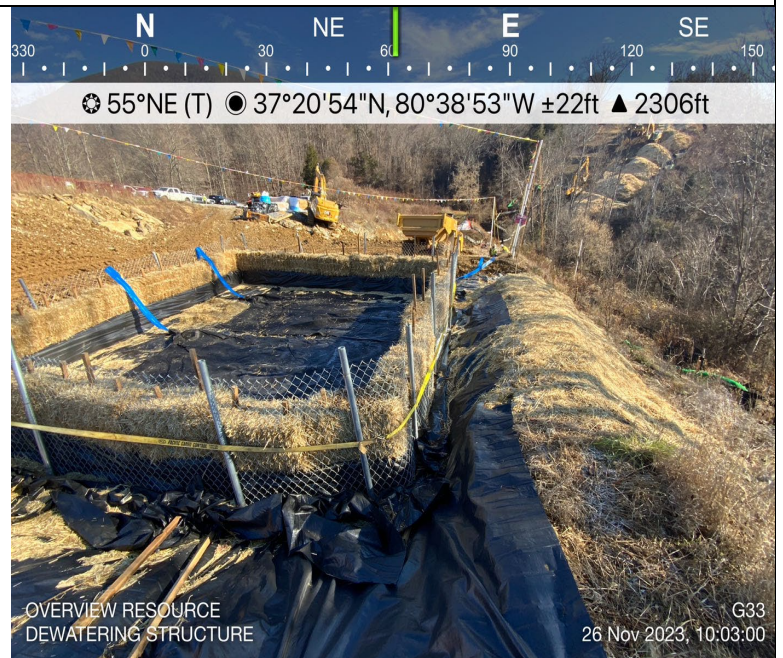
Photo Description: Dewatering structure located within the LOD.
