Stream Biological Conditions EA Report

Project Name	H-600 Pipeline Spread D	AFE	124300132	Spread	H-600 Pipeline Spread D
Contractor	Precision	Report #	443		
Environmental Auditor	Kyle Gillow	Date/Time	12/19/2023 10:47 AM		
Stream ID	S-H99	Crossing Start Date	12/19/2023	Crossing Completion Date	12/21/2023
Milepost	115.99	Pre-Con Assessment Date	12/14/2023	Post-Con Assessment Date	12/21/2023
Station	6124+16	Bankfull Width (ft.)	4.0	Riffle:Pool Complexes Present?	No
State	WV	Stream Classification	Perennial		
County	Nicholas	303(d) Impairment Listing	No

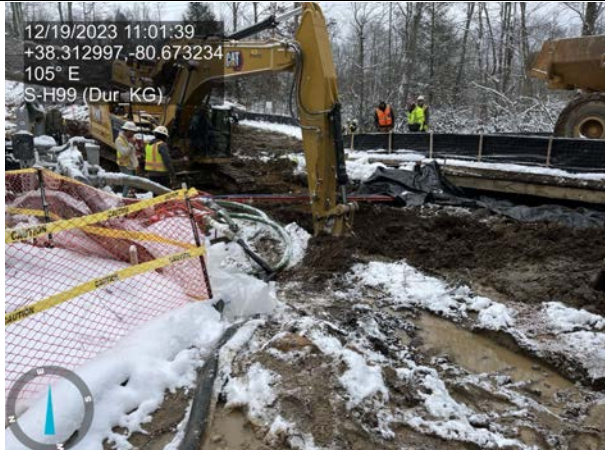
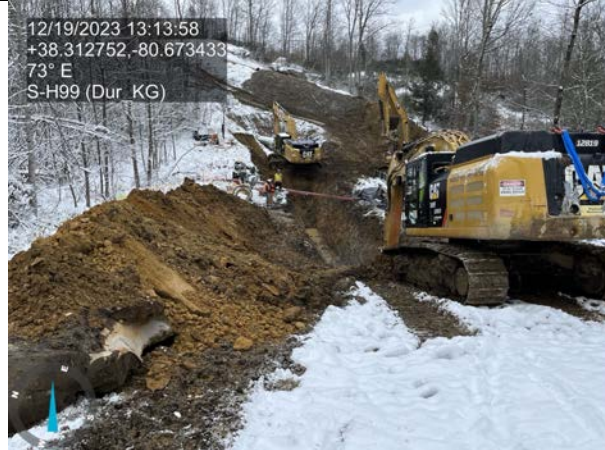
GPS Location	See caption in photo.	GPS Location	See caption in photo.
Description	Crew trenching through feature S-H99.	Description	Crew continuing to dig trench for the stream section.

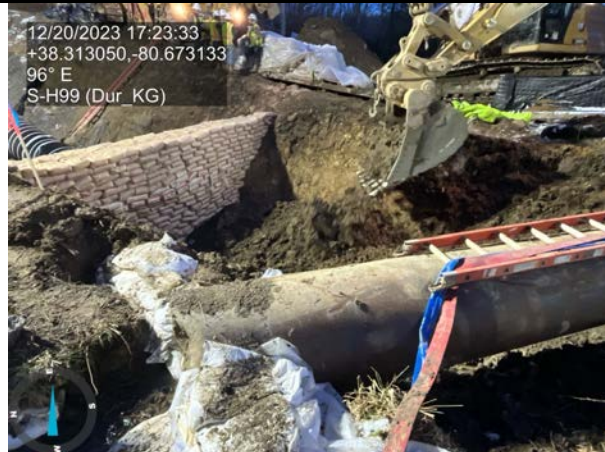
GPS Location	See caption in photo.	GPS Location	See caption in photo.
Description	Lowering in stream section of pipe.	Description	Padding and backfilling feature.

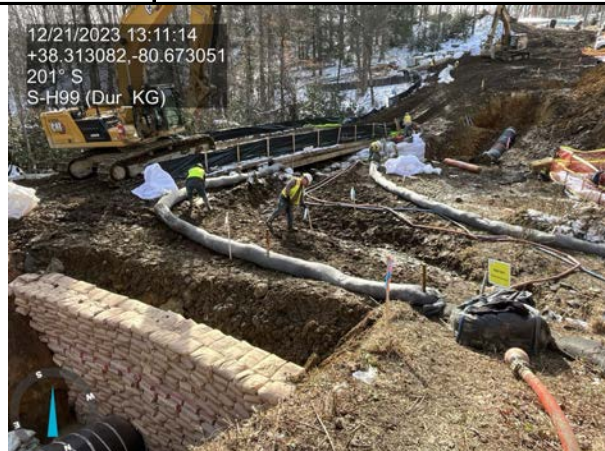
GPS Location	See caption in photo.	GPS Location	See caption in photo.
Description	Crew returning the top 12" of stream substrate back through the feature.	Description	Environmental crew re-establishing the 10' buffer zones.
