STREAM BIOLOGICAL CONDITIONS ENVIRONMENTAL AUDITOR REPORT

Stream ID: S-IJ2	Crossing Start Date: 10/10/2023	Crossing Completion Date: 12/08/2023
Milepost: 253.9	Pre-Con Assessment Date: 10/02/2023	Post-Con Assessment Date: 12/09/2023
Station: 13413+65	Stream Classification: Intermittent (Perennial, Intermittent, Ephemeral)	Bankfull Width (ft.): 2.5
County: Franklin	303(d) Impairment Listing: Not Impaired	Riffle:Pool Complexes Present? No

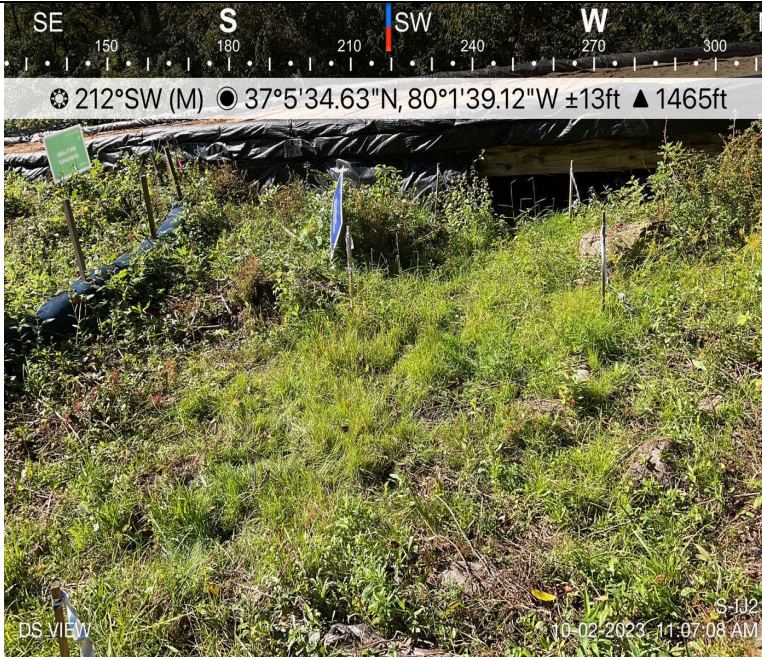
Photo Description: Downstream view of permitted impact area during pre-construction assessment.

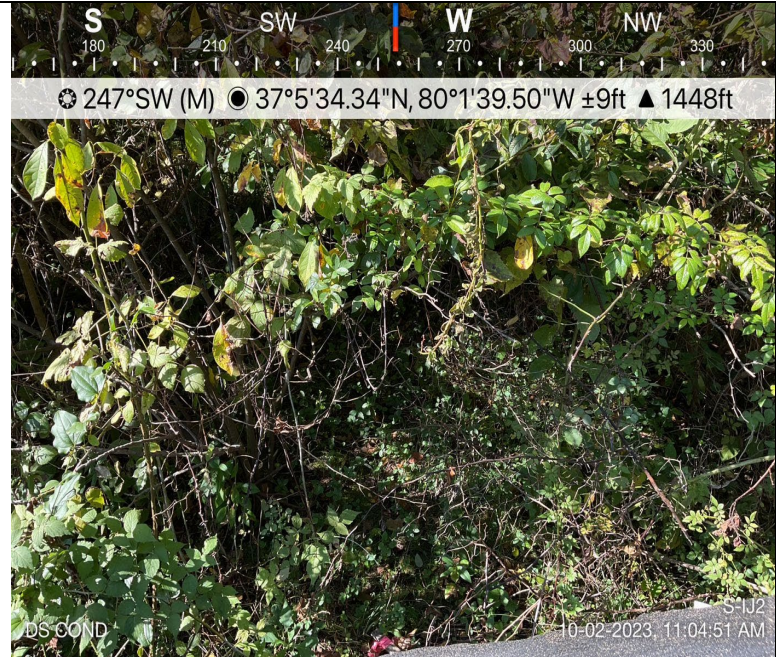
Photo Description: Conditions of the downstream area outside the ROW during pre-construction assessment.

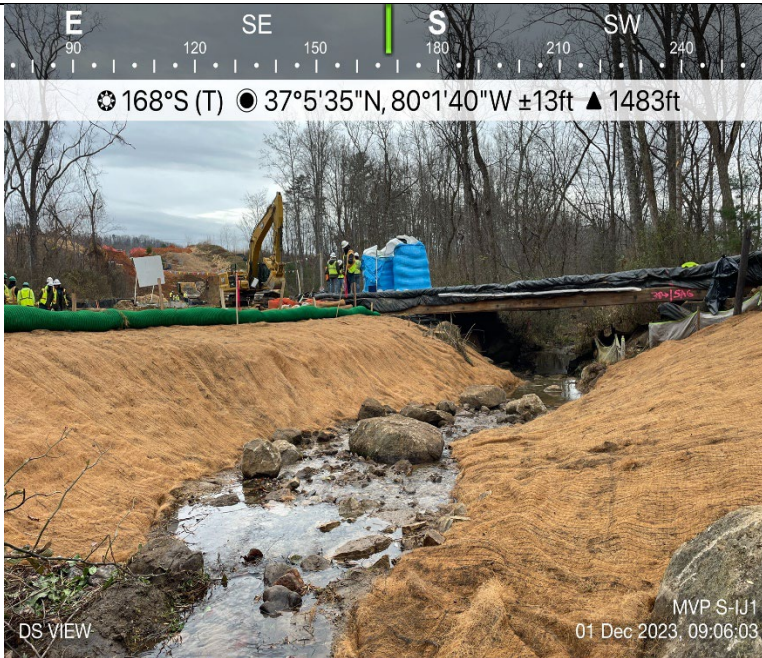
Photo Description: Downstream view of permitted impact area during post-construction assessment.

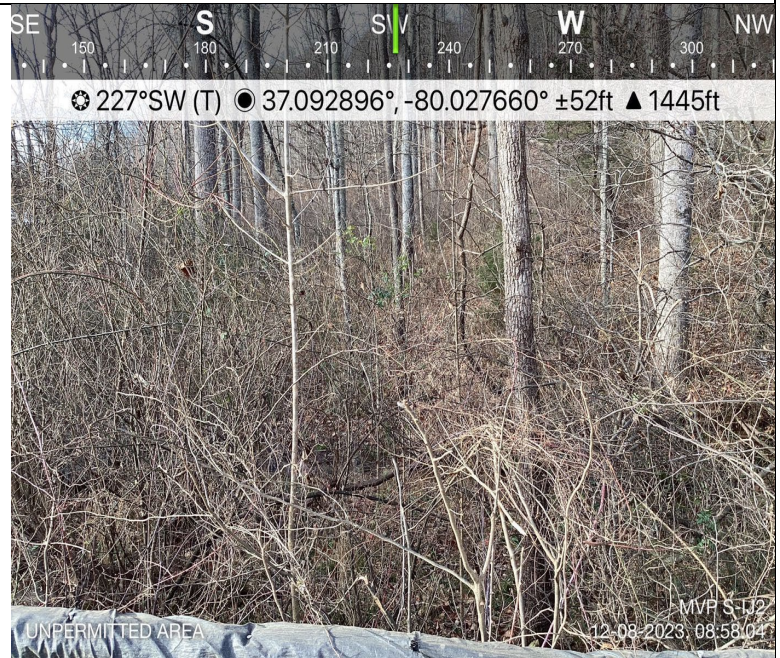
Photo Description: Conditions of the downstream area outside the ROW during post-construction assessment.

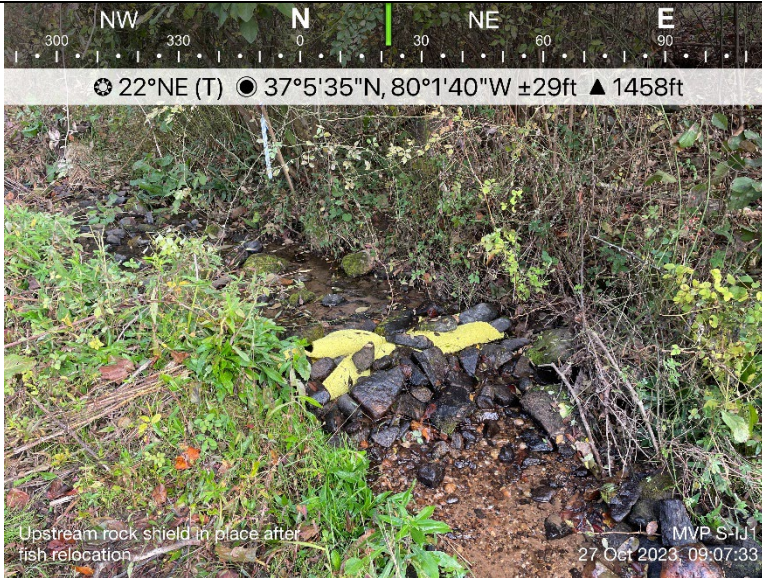
Upstream rock shield in place after fish relocation
MVP S-IJ1
27 Oct 2023 09:07:33

Photo Description: The upstream rock shield after installation.

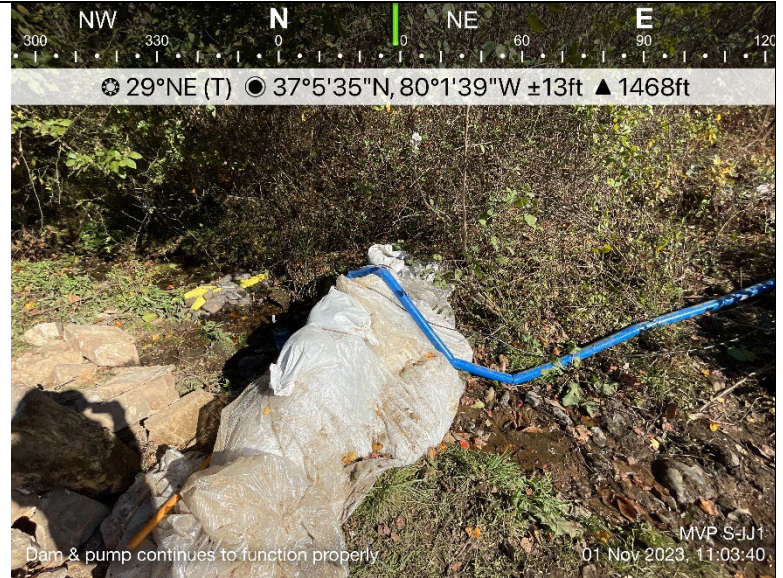
Dam & pump continues to function properly
MVP S-IJ1
01 Nov 2023 11:03:40

Photo Description: The dam and pump was installed and is functioning as designed.

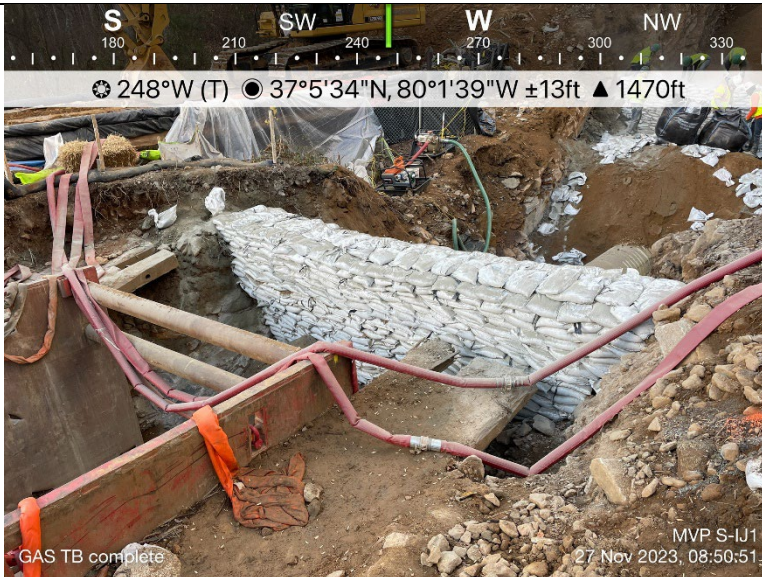
GAS TB complete
MVP S-IJ1
27 Nov 2023 08:50:51

Photo Description: The Going Away Side trench breaker after installation.

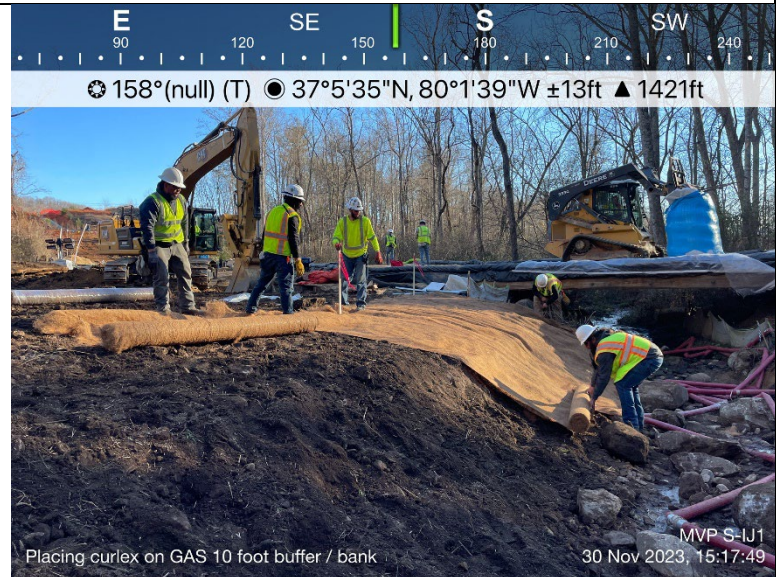
Placing curlex on GAS 10 foot buffer / bank
MVP S-IJ1
30 Nov 2023 15:17:49

Photo Description: The crew installed curlex matting along the Going Away Side 10-foot buffer and stream bank.
