STREAM BIOLOGICAL CONDITIONS ENVIRONMENTAL AUDITOR REPORT

Stream ID: S-IJ35-EPH	Crossing Start Date: 11/06/2023	Crossing Completion Date: 11/09/2023
Milepost: 296	Pre-Con Assessment Date: 11/01/2023	Post-Con Assessment Date: 11/09/2023
Station: 156336+54	Stream Classification: Ephemeral (Perennial, Intermittent, Ephemeral)	Bankfull Width (ft.): 4
County: Pittsylvania	303(d) Impairment Listing: Not Impaired	Riffle:Pool Complexes Present? No

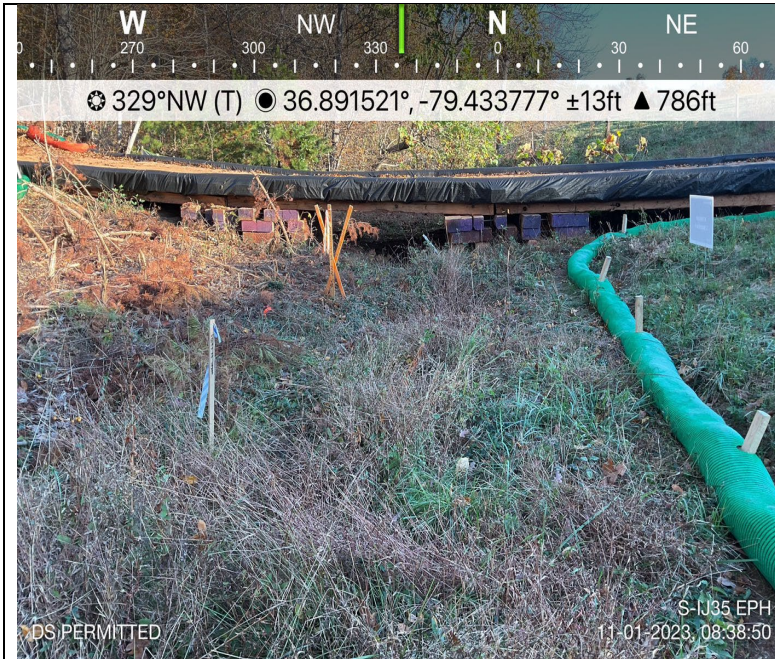
Photo Description: Downstream view of permitted impact area during pre-construction assessment.

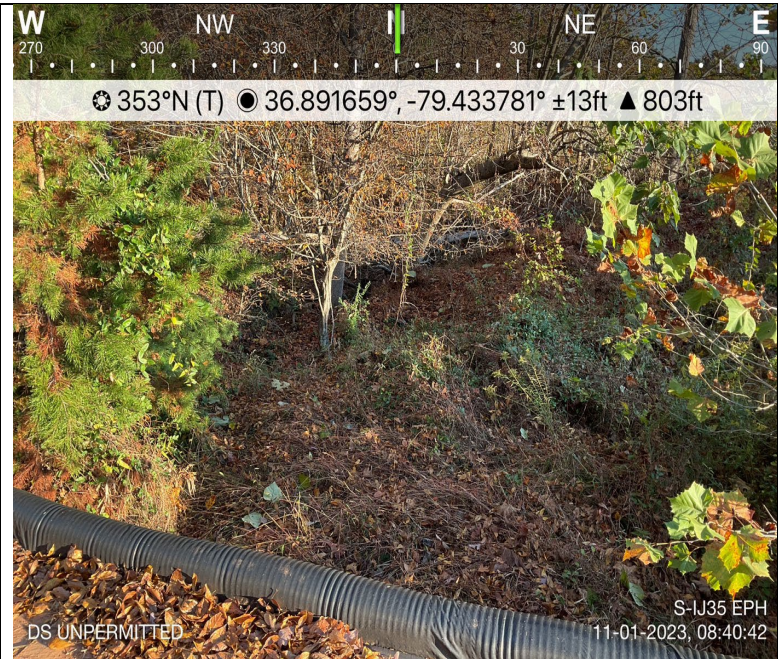
Photo Description: Conditions of the downstream area outside the ROW during pre-construction assessment.

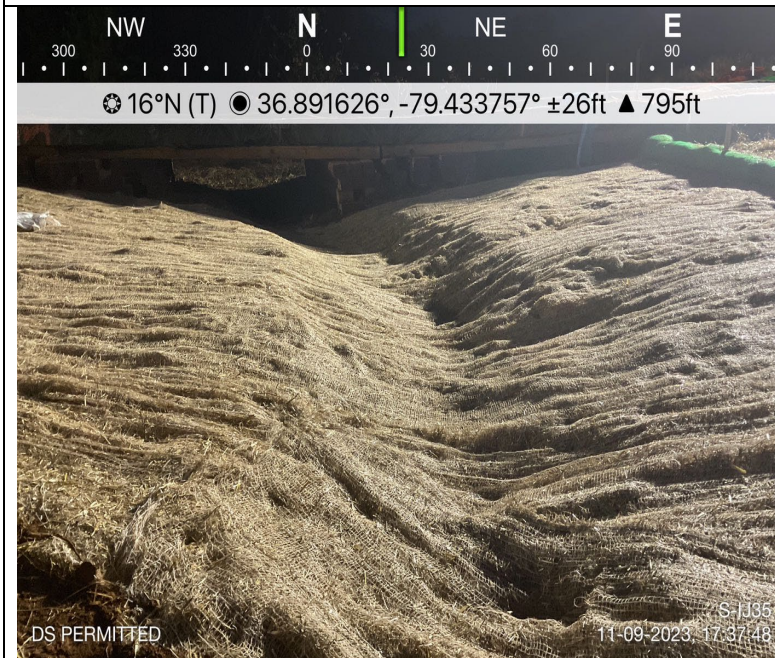
Photo Description: Downstream view of permitted impact area during post-construction assessment.

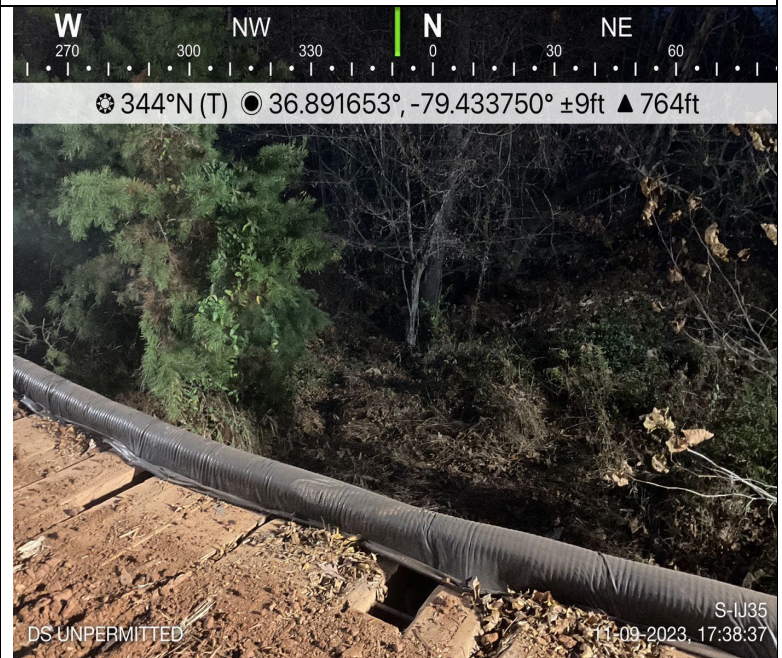
Photo Description: Conditions of the downstream area outside the ROW during post-construction assessment.

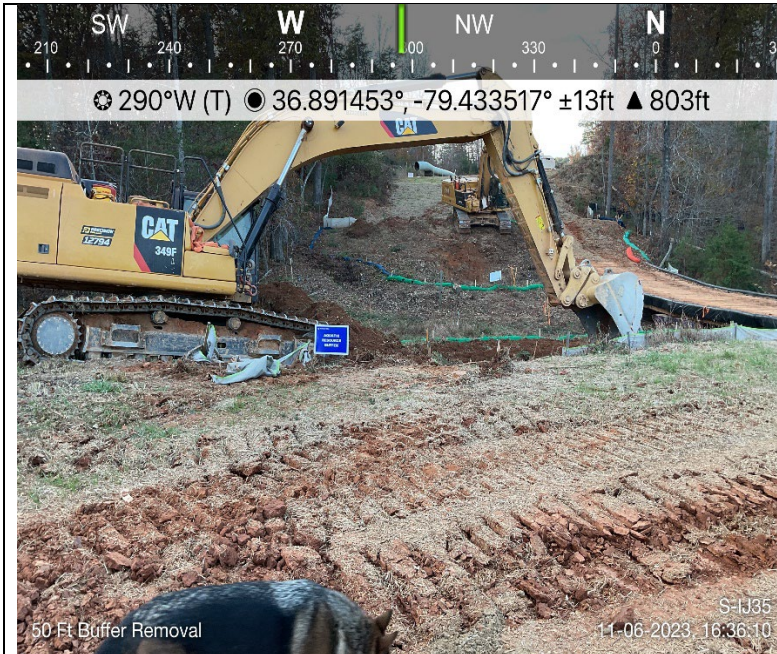
Photo Description: Excavation of the 50-foot buffer.

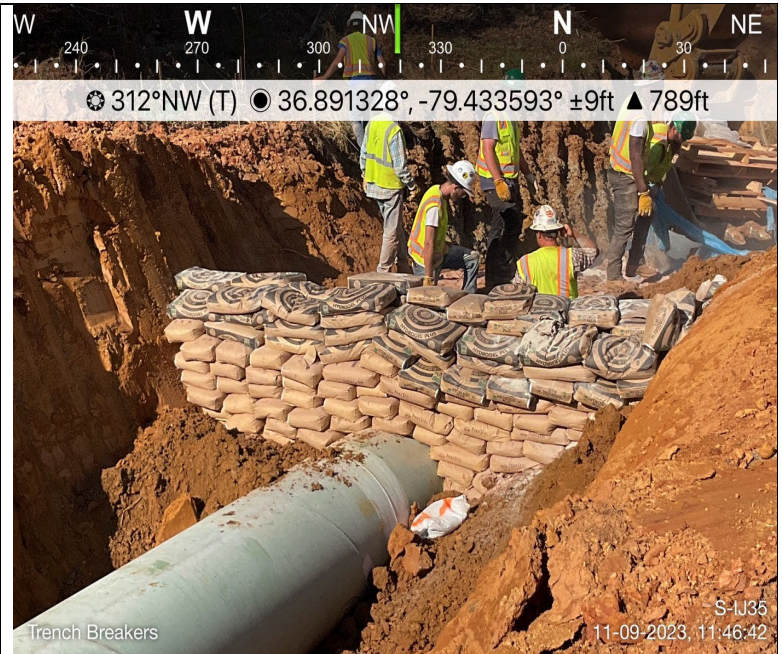
Photo Description: The crew installing trench breakers.

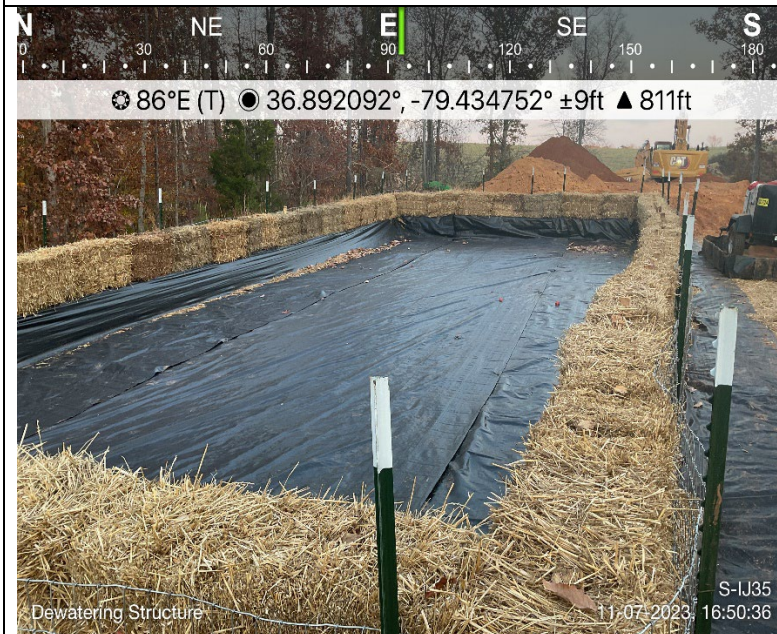
Photo Description: An overview of the dewatering structure.

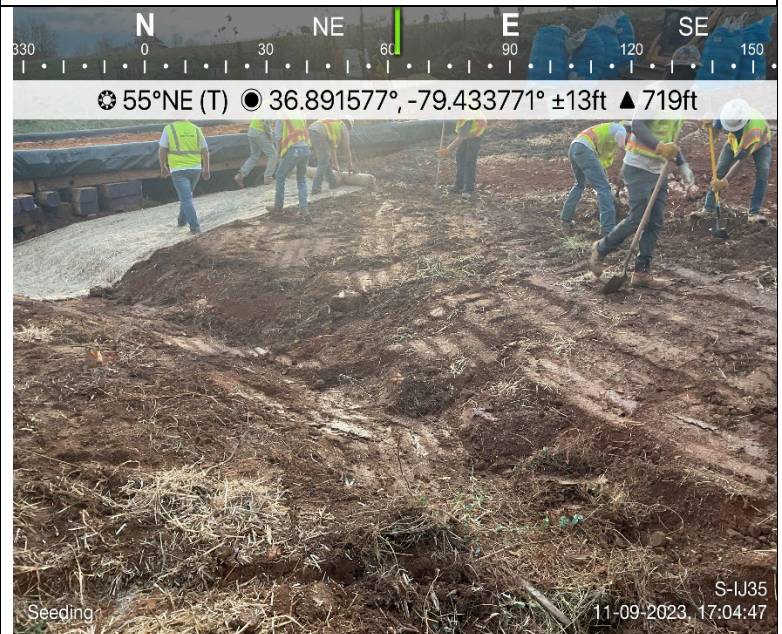
Photo Description: The crew seeding and installing straw matting.
