STREAM BIOLOGICAL CONDITIONS ENVIRONMENTAL AUDITOR REPORT

Stream ID: S-KL25	Crossing Start Date: 12/18/2023	Crossing Completion Date: 12/31/2023
Milepost: 243	Pre-Con Assessment Date: 12/07/2023	Post-Con Assessment Date: 12/31/2023
Station: 12838+07	Stream Classification: Intermittent (Perennial, Intermittent, Ephemeral)	Bankfull Width (ft.): 5
County: Roanoke	303(d) Impairment Listing: Not Impaired	Riffle:Pool Complexes Present? No

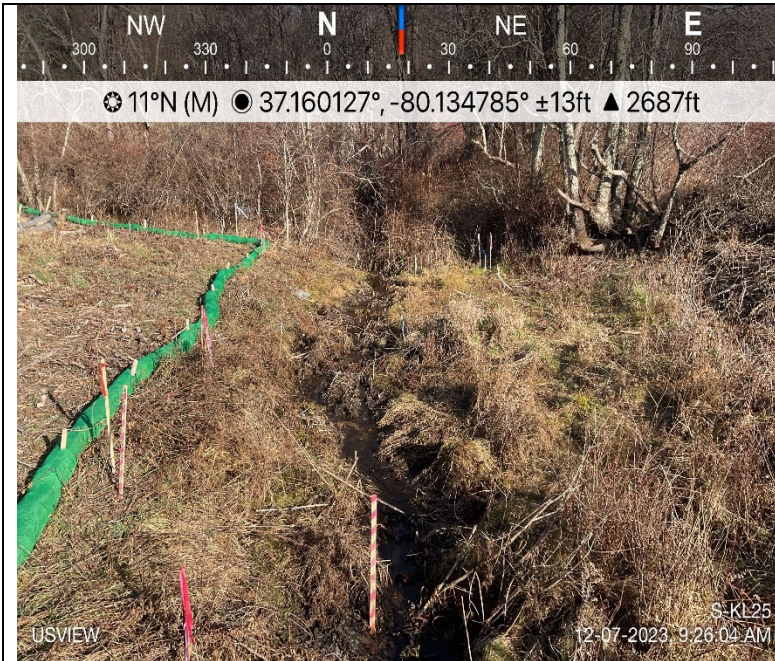
Photo Description: Upstream view of permitted impact area during pre-construction assessment.

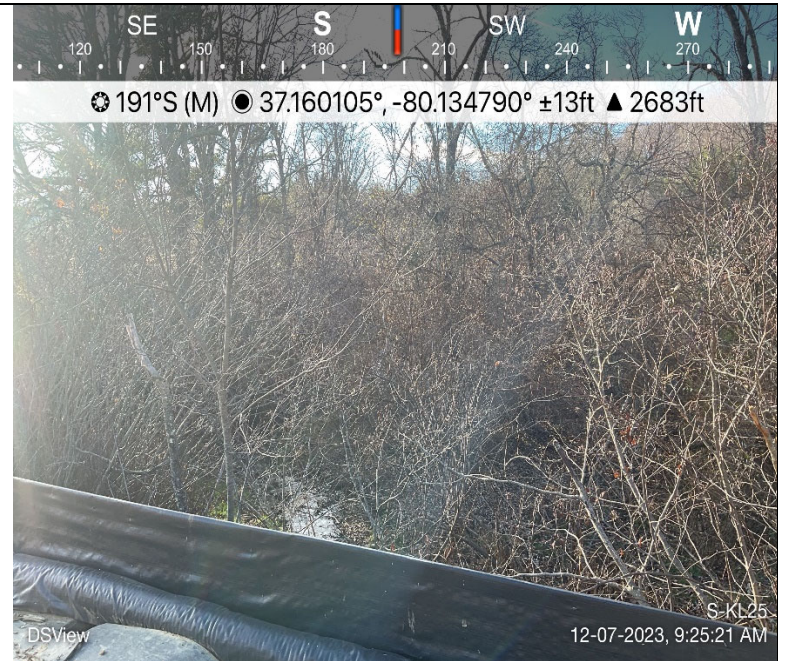
Photo Description: Conditions of the downstream area outside the ROW during pre-construction assessment.

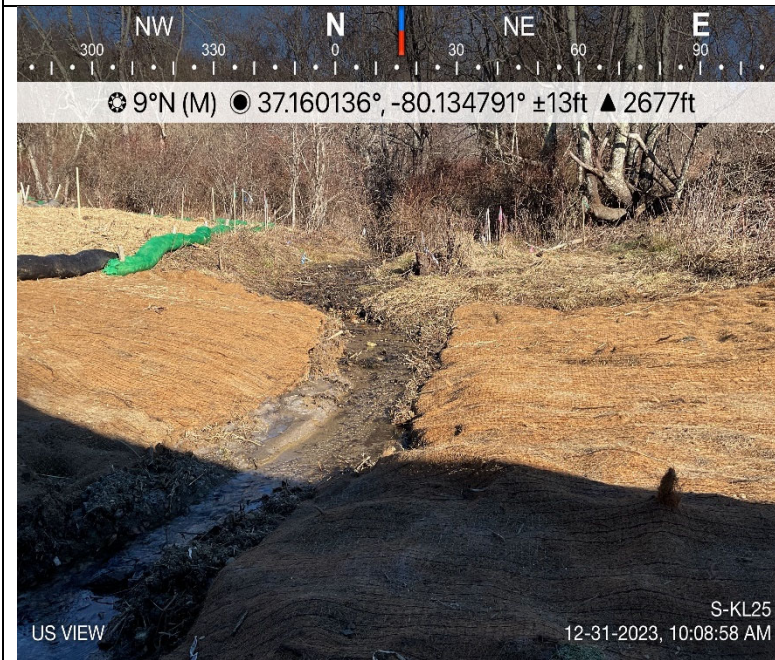
Photo Description: Upstream view of permitted impact area during post-construction assessment.

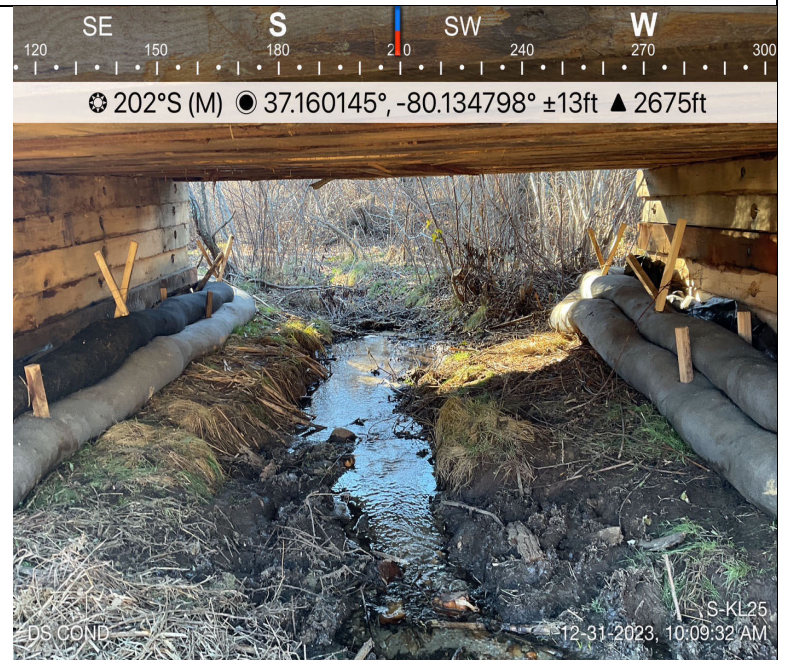
Photo Description: Conditions of the downstream area outside the ROW during post-construction assessment.

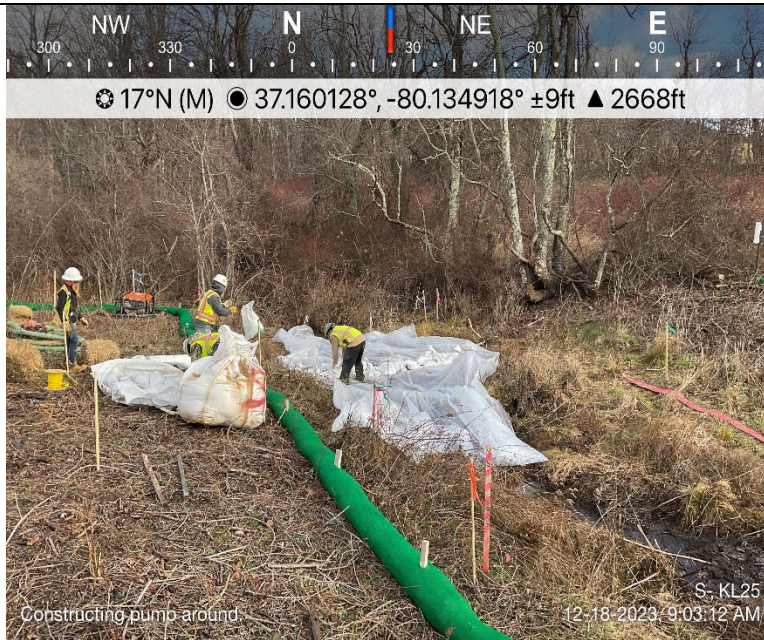
Photo Description: The construction of the pump around for the stream.

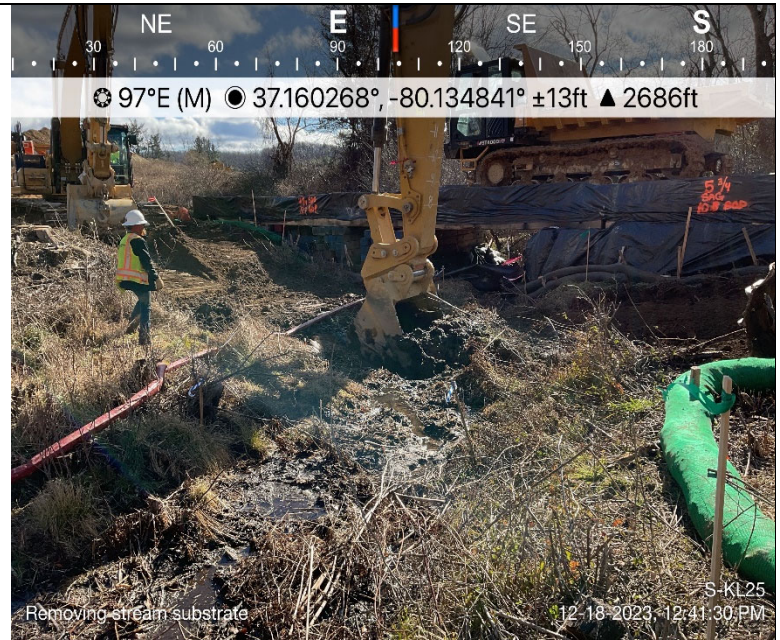
Photo Description: Excavation of the stream substrate.

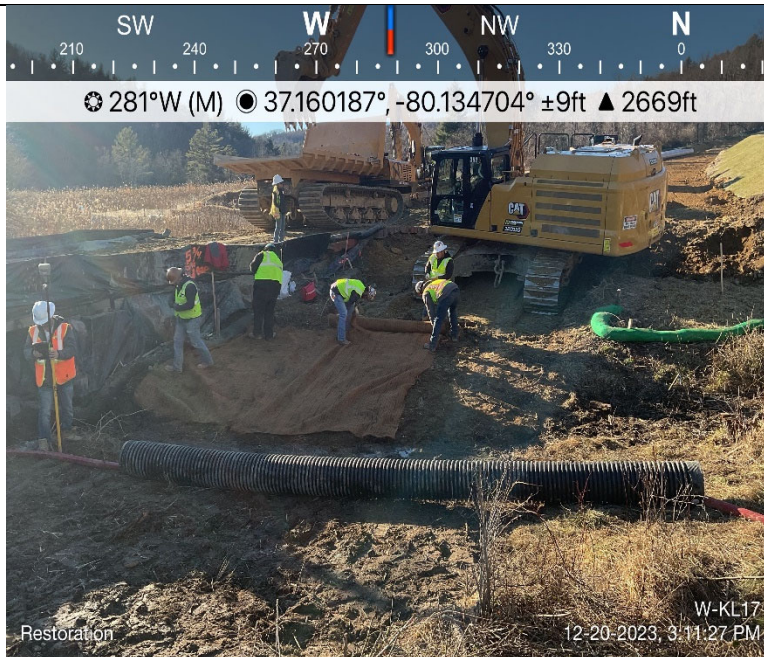
Photo Description: Restoration of the stream bank with matting.

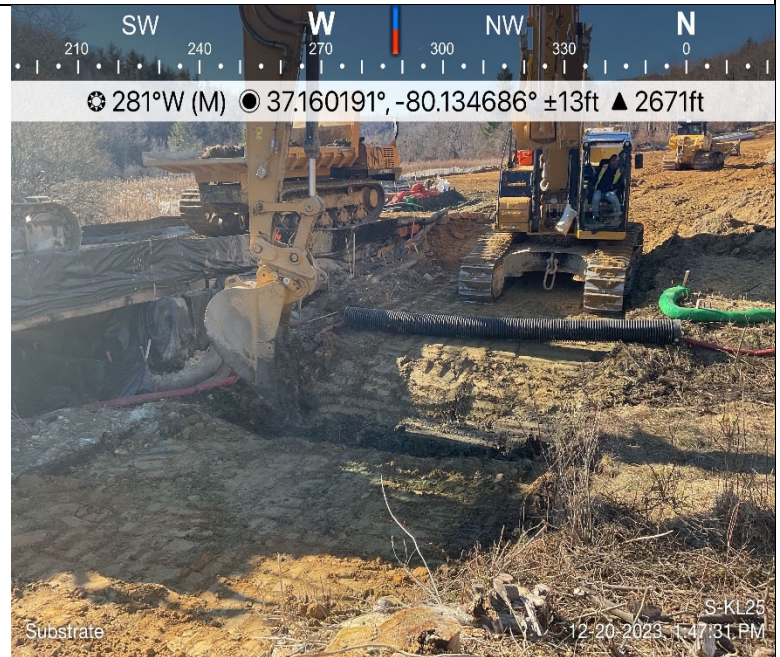
Photo Description: Restoration of the stream substrate.
