# Stream Biological Conditions EA Report

<b>Project Name</b>	H-600 Pipeline Spread F	<b>AFE</b>	124300135	<b>Spread</b>	H-600 Pipeline Spread F
<b>Contractor</b>	Price Gregory	<b>Report #</b>	437		
<b>Environmental Auditor</b>	Eric Schicker	<b>Date/Time</b>	12/12/2023 7:19 AM		
<b>Stream ID</b>	S-MN37	<b>Crossing Start Date</b>	12/12/2023	<b>Crossing Completion Date</b>	12/21/2023
<b>Milepost</b>	188.98	<b>Pre-Con Assessment Date</b>	12/11/2023	<b>Post-Con Assessment Date</b>	12/21/2023
<b>Station</b>	9978+02	<b>Bankfull Width (ft.)</b>	2.0	<b>Riffle:Pool Complexes Present?</b>	No
<b>State</b>	WV	<b>Stream Classification</b>	Intermittent		
<b>County</b>	Monroe	<b>303(d) Impairment Listing</b>	No

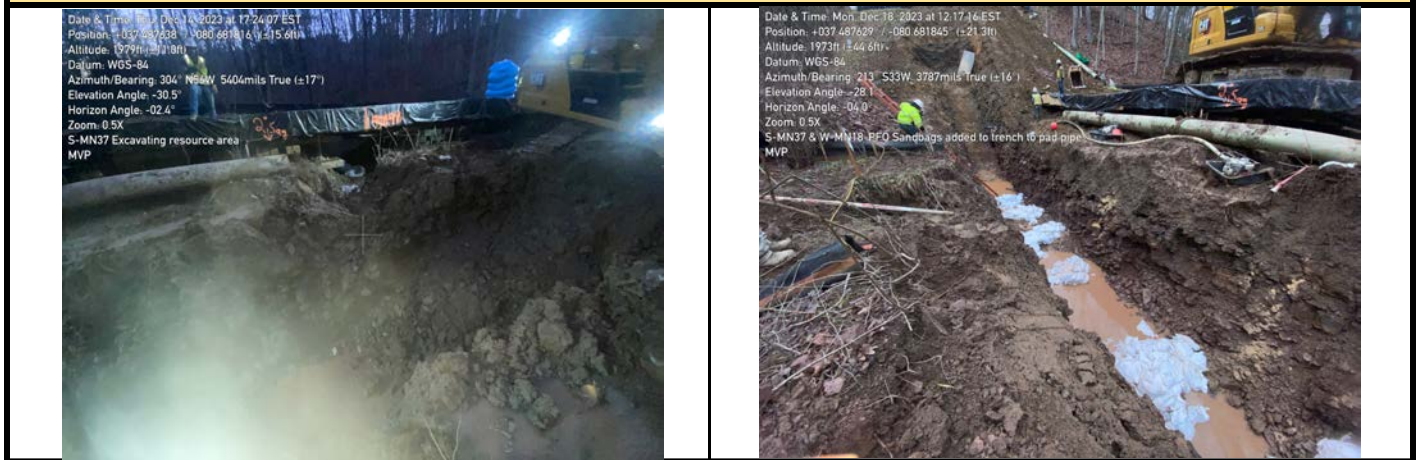
<b>GPS Location</b>	See Photo	<b>GPS Location</b>	See Photo
<b>Description</b>	Photo 3: Excavating through aquatic resource.	<b>Description</b>	Photo 4: Placing sandbags in trench for padding.

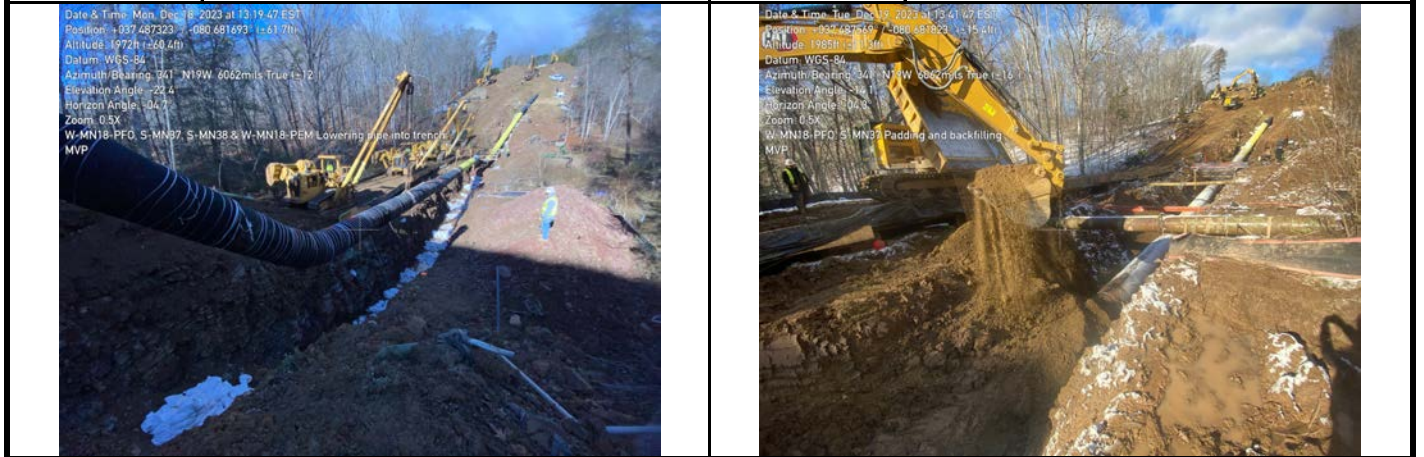
<b>GPS Location</b>	See Photo	<b>GPS Location</b>	See Photo
<b>Description</b>	Photo 5: Putting pipe in trench through aquatic resource area.	<b>Description</b>	Photo 6: Adding padding and backfilling.

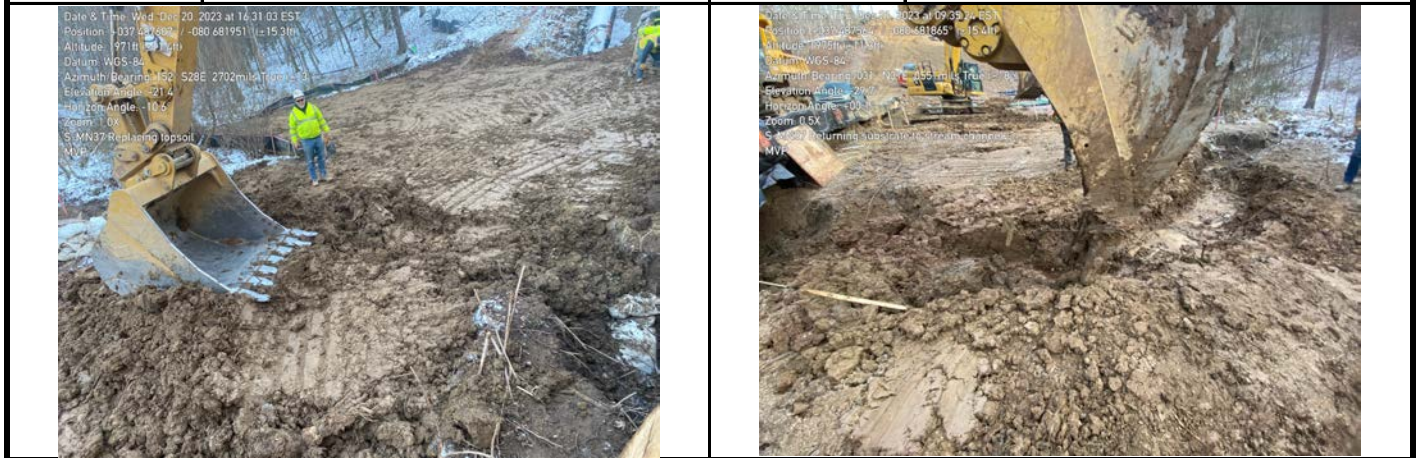
<b>GPS Location</b>	See Photo	<b>GPS Location</b>	See Photo
<b>Description</b>	Photo 7: Restoring topsoil.	<b>Description</b>	Photo 8: Restoring substrate.
