Stream Biological Conditions EA Report

Project Name	H-600 Pipeline Spread F	AFE	124300135	Spread	H-600 Pipeline Spread F
Contractor	Price Gregory	Report #	435		
Environmental Auditor	Eric Schicker	Date/Time	12/12/2023 7:17 AM		
Stream ID	S-MN38	Crossing Start Date	12/12/2023	Crossing Completion Date	12/21/2023
Milepost	188.96	Pre-Con Assessment Date	12/11/2023	Post-Con Assessment Date	12/21/2023
Station	9977+29	Bankfull Width (ft.)	4.0	Riffle:Pool Complexes Present?	No
State	WV	Stream Classification	Intermittent		
County	Monroe	303(d) Impairment Listing	No

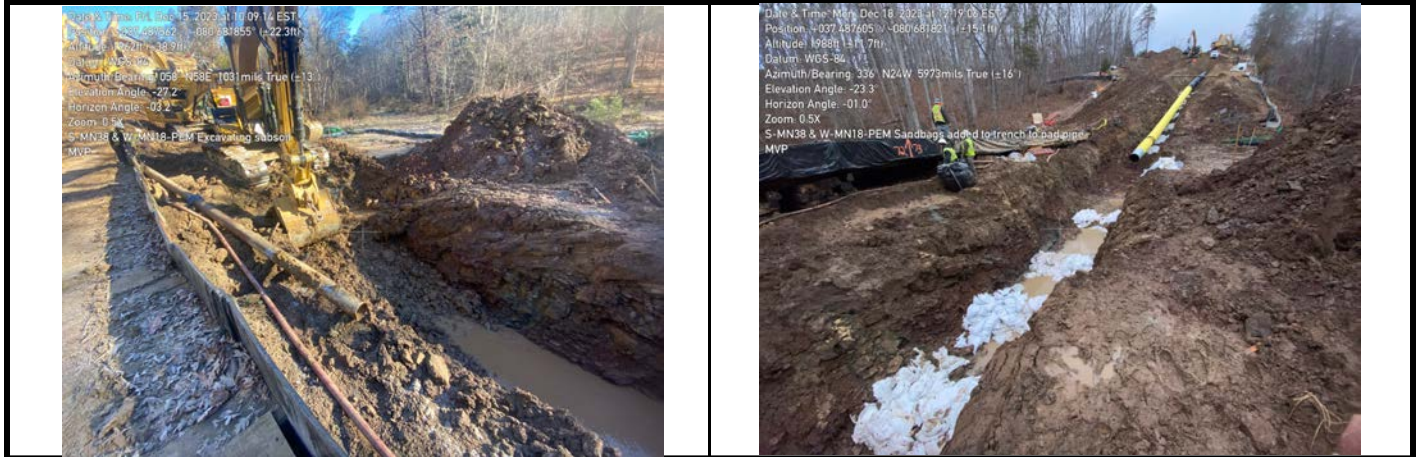
GPS Location	See Photo	GPS Location	See Photo
Description	Photo 3: Excavation of trench through aquatic resource.	Description	Photo 4: Sandbags in trench for padding.

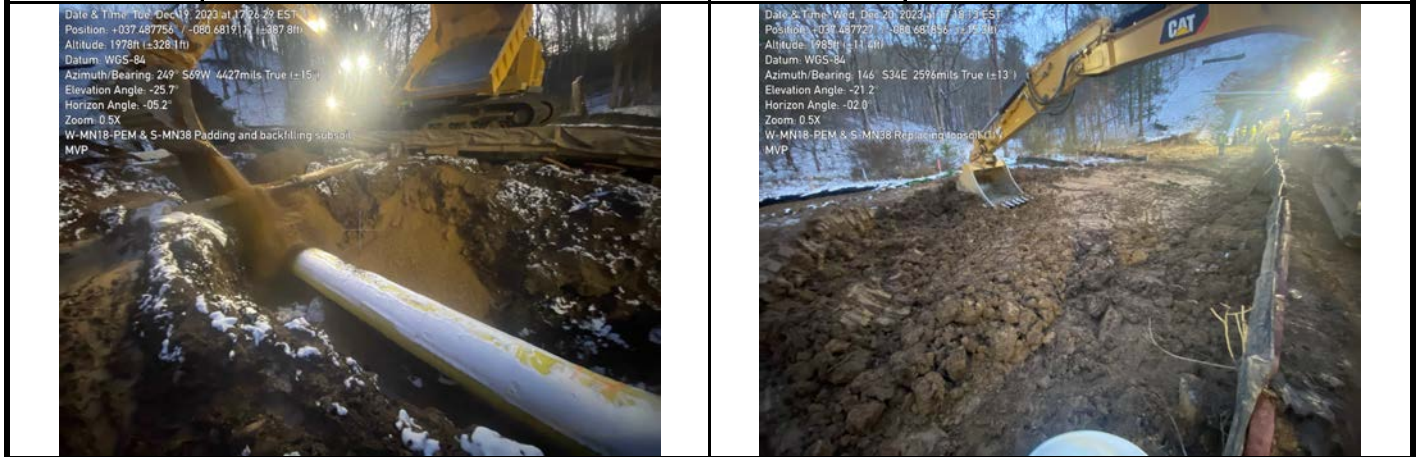
GPS Location	See Photo	GPS Location	See Photo
Description	Photo 5: Backfilling.	Description	Photo 6: Topsoil restoration.

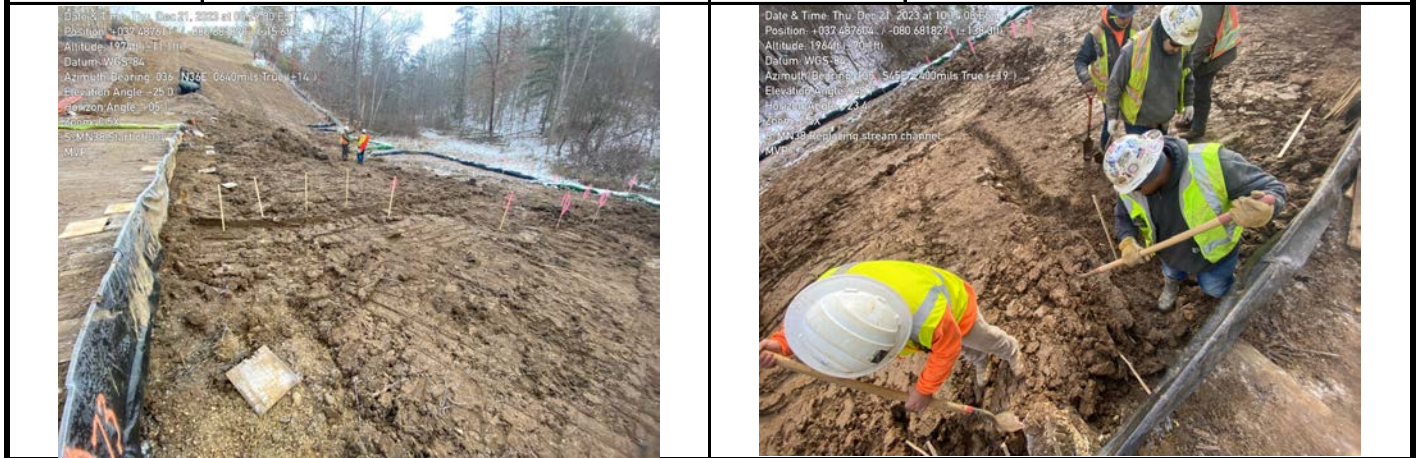
GPS Location	See Photo	GPS Location	See Photo
Description	Photo 7: Elevations staked by survey.	Description	Photo 8: Contouring channel by hand.
