WETLAND BIOLOGICAL CONDITIONS ENVIRONMENTAL AUDITOR REPORT

Wetland ID: W-AB6-PEM-2	Crossing Start Date: 12/01/2023	Crossing Completion Date: 12/15/2023
Milepost: 243.3	Pre-Con Assessment Date: 11/18/2023	Post-Con Assessment Date: 12/16/2023
Station: 12854+27	Cowardin Classification: PEM (PEM, PFO, PSS, POW)	Wetland Impact Area (sq ft.): 14248.48
County: Roanoke

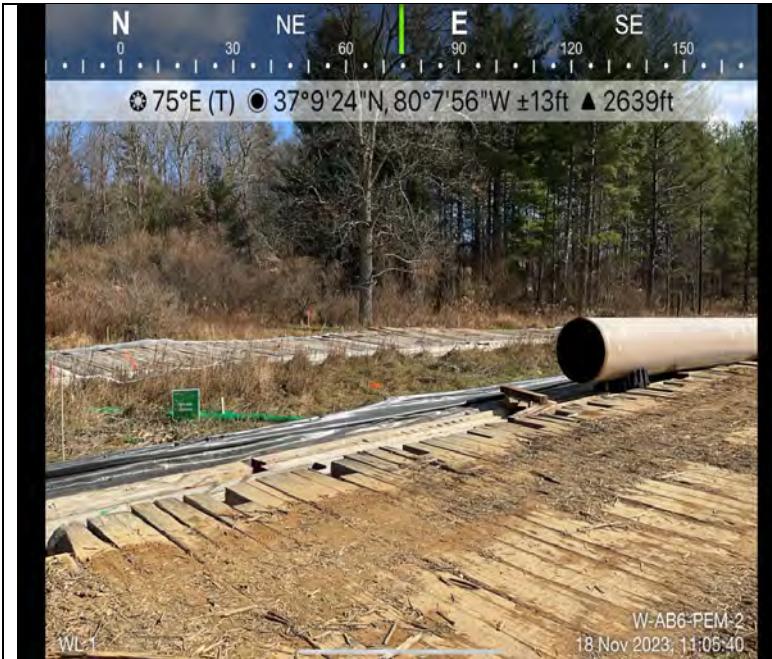
Photo Description: View of permitted resource impact area during pre-construction assessment.

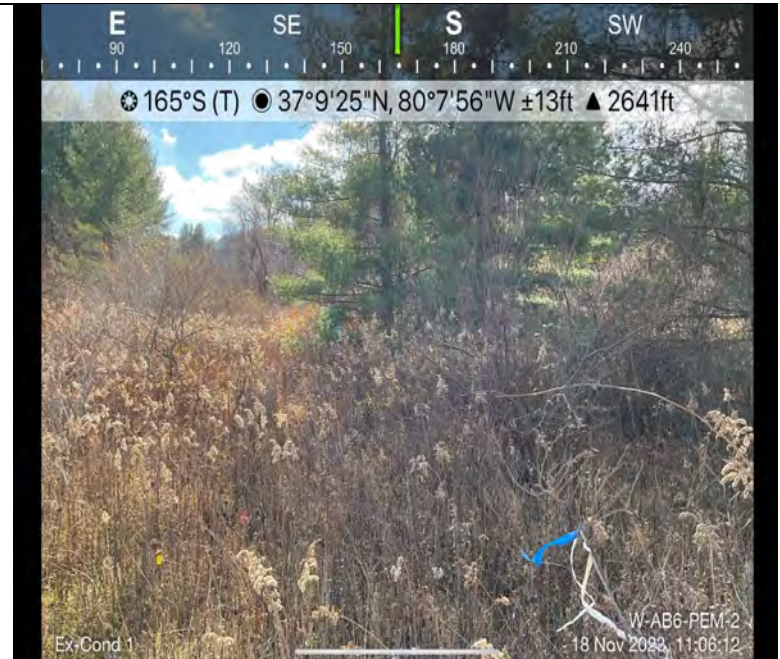
Photo Description: At edge of LOD, view of unpermitted resource area conditions during pre-construction assessment.

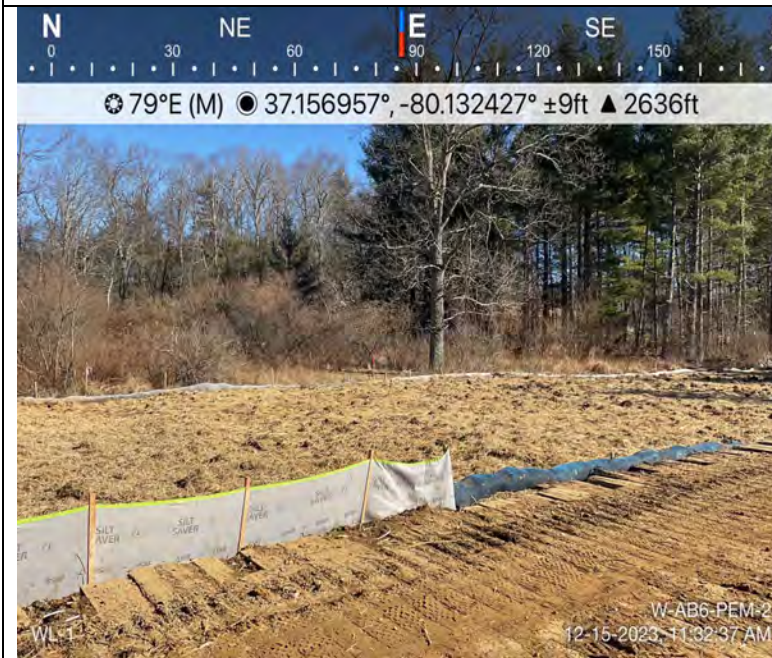
Photo Description: View of permitted resource impact area during post-construction assessment.

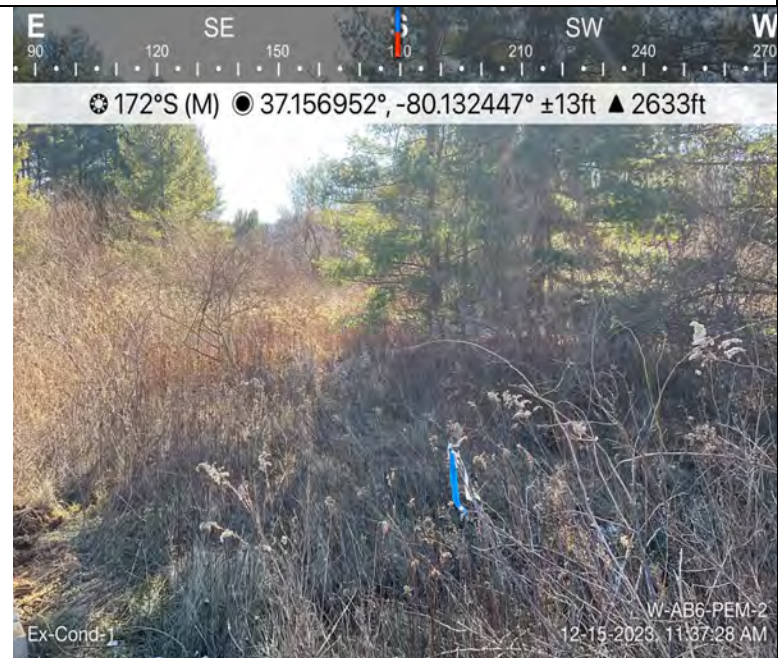
Photo Description: At edge of LOD, view of unpermitted resource area conditions during post-construction assessment.

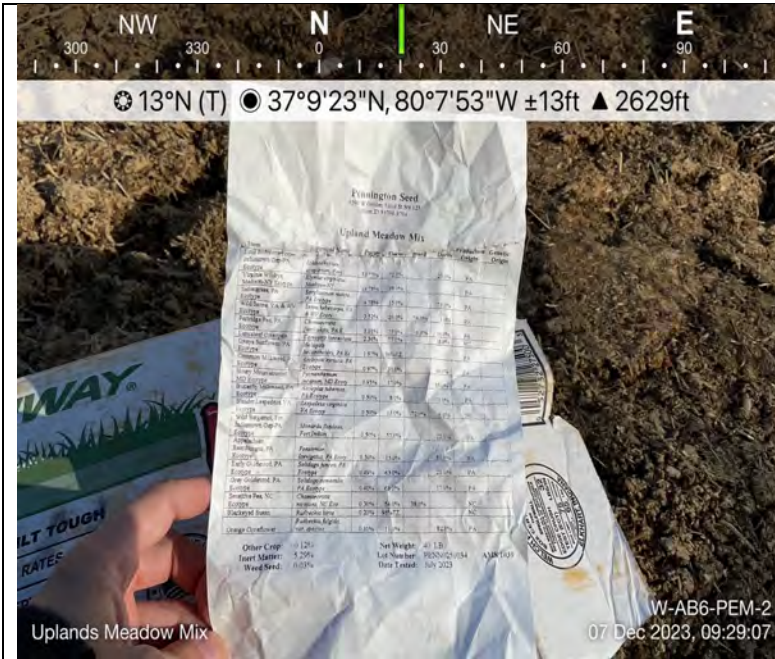
Photo Description: Upland Meadow Mix

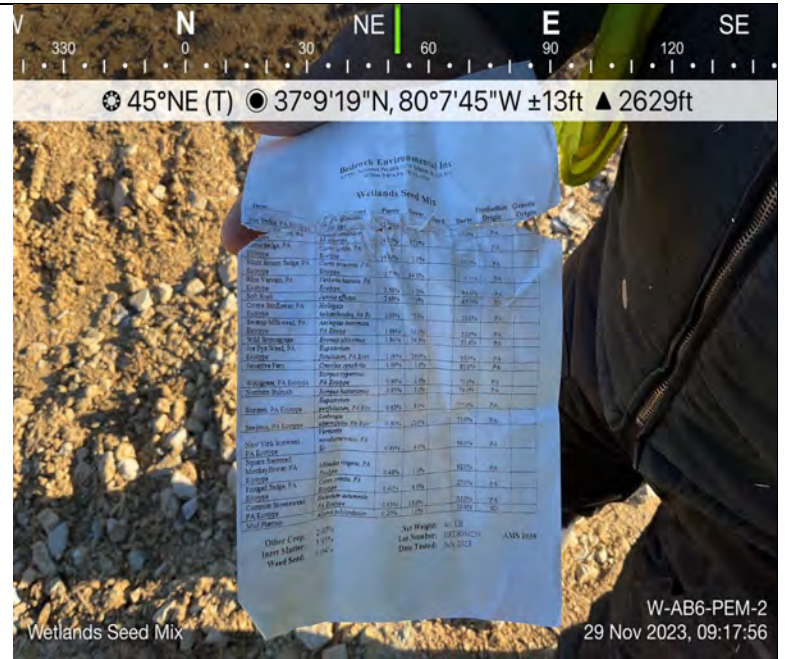
Photo Description: Wetlands Seed Mix

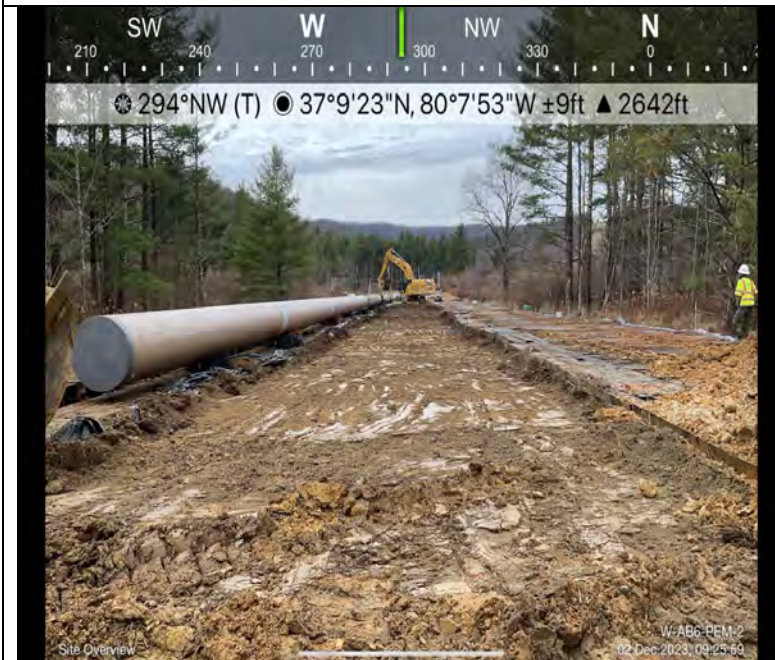
Photo Description: Wetland topsoil removal

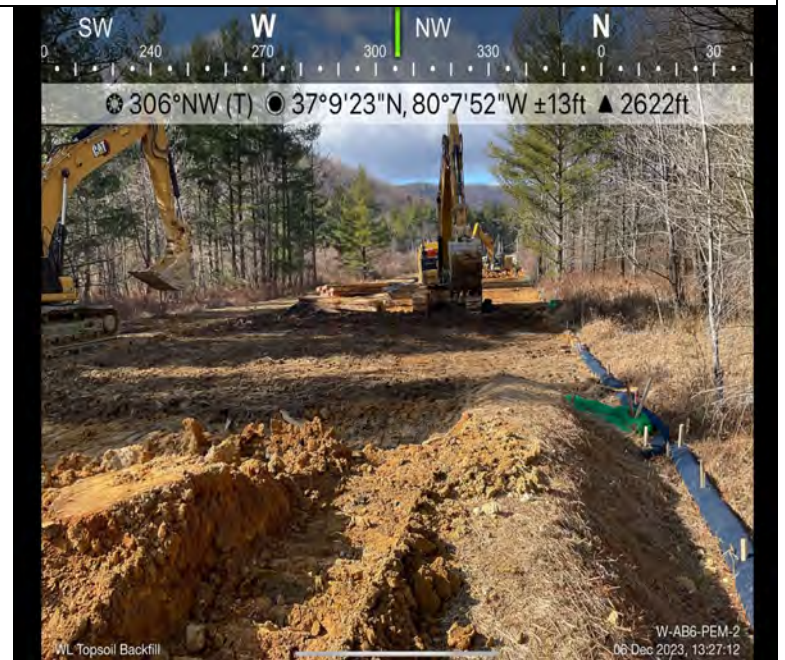
Photo Description: Wetland topsoil restoration
