# WETLAND BIOLOGICAL CONDITIONS ENVIRONMENTAL AUDITOR REPORT

<b>Wetland ID:</b> W-B24-PSS	<b>Crossing Start Date:</b> 11/25/2023	<b>Crossing Completion Date:</b> 01/02/2024
<b>Milepost:</b> 245.9	<b>Pre-Con Assessment Date:</b> 11/24/2023	<b>Post-Con Assessment Date:</b> 01/02/2024
<b>Station:</b> 12993+76	<b>Cowardin Classification:</b> PSS (PEM, PFO, PSS, POW)	<b>Wetland Impact Area (sq ft.):</b> 7130.77
<b>County:</b> Roanoke

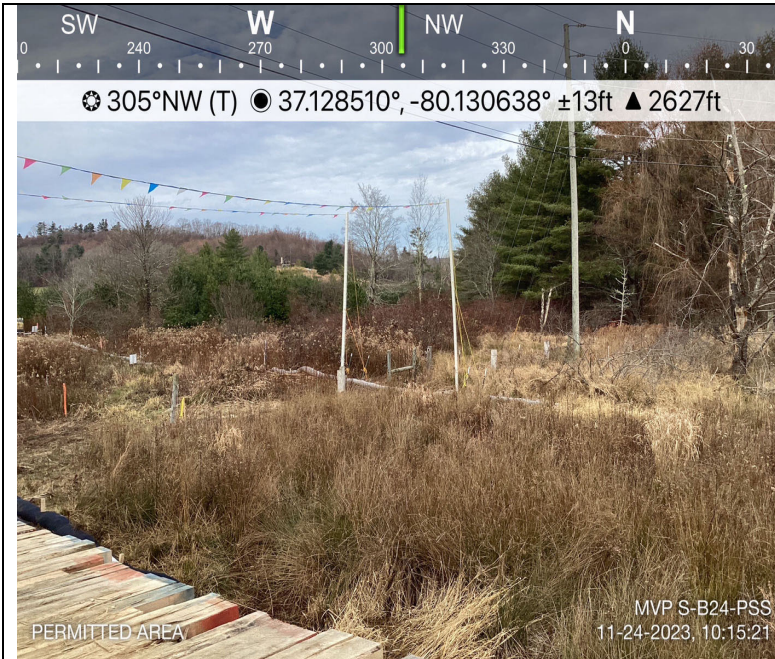
**Photo Description:** View of permitted resource impact area during pre-construction assessment.

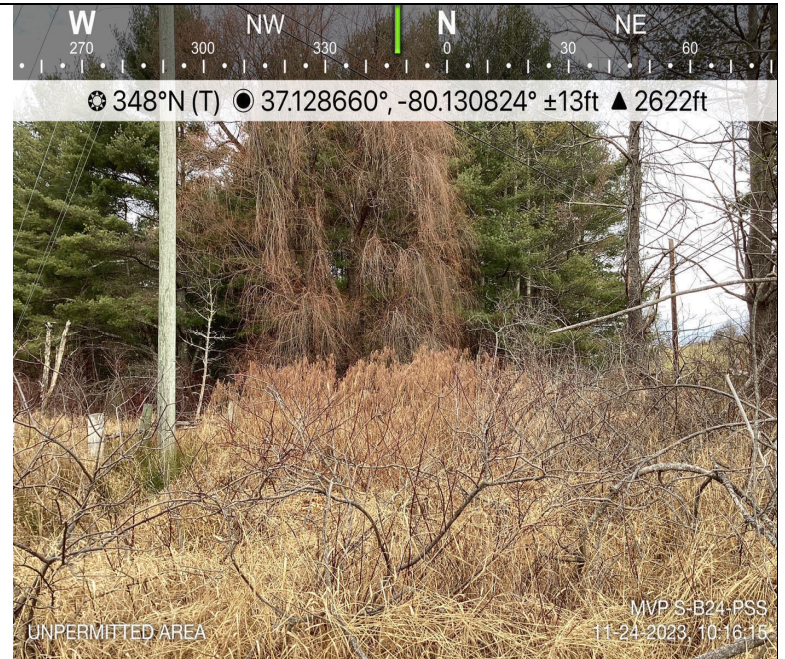
**Photo Description:** At edge of LOD, view of unpermitted resource area conditions during pre-construction assessment.

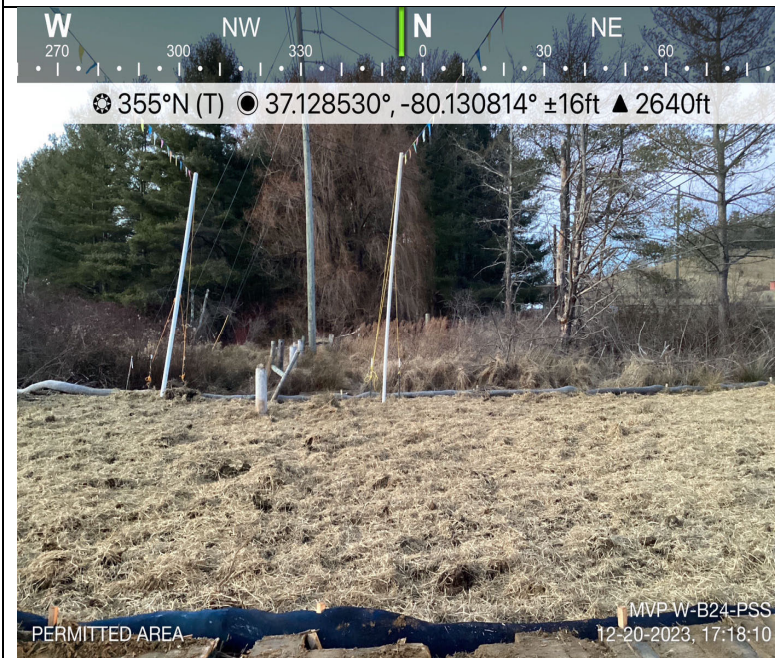
**Photo Description:** View of permitted resource impact area during post-construction assessment.

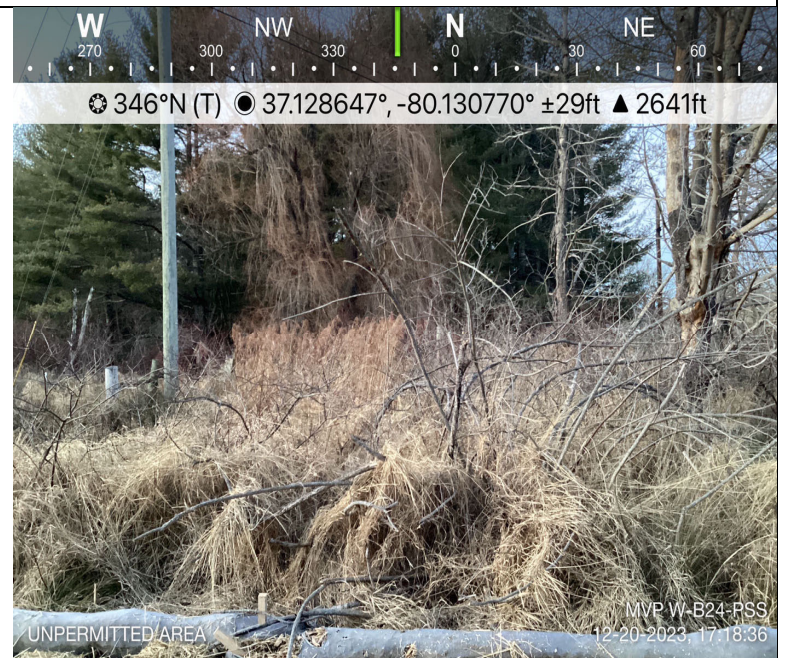
**Photo Description:** At edge of LOD, view of unpermitted resource area conditions during post-construction assessment.

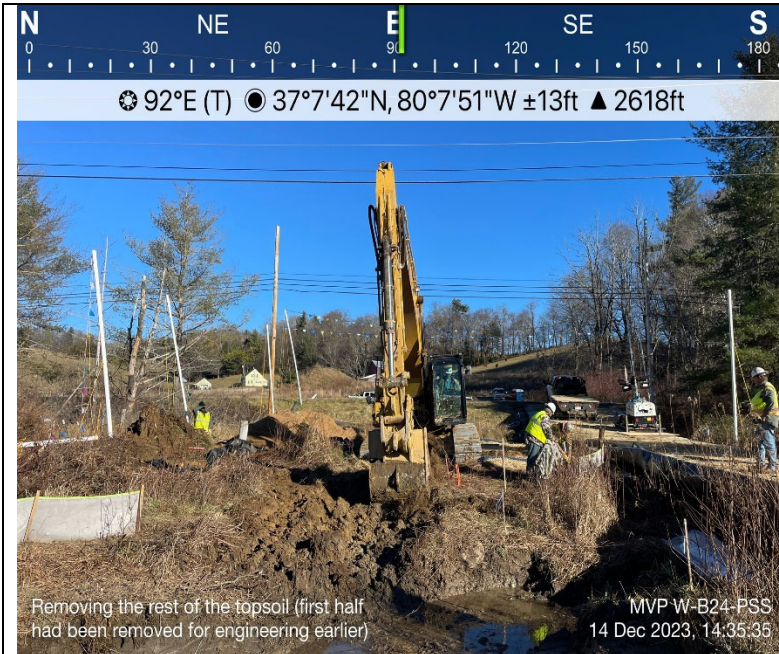
**Photo Description:** Removal of top 12 inches of wetland topsoil for separate storage and stabilization.

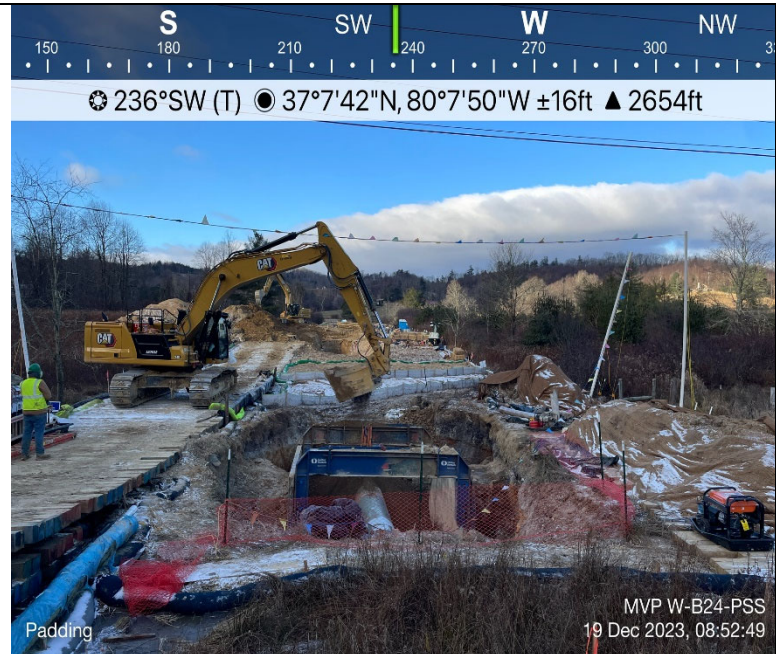
**Photo Description:** Subsoil padding backfill around pipe.

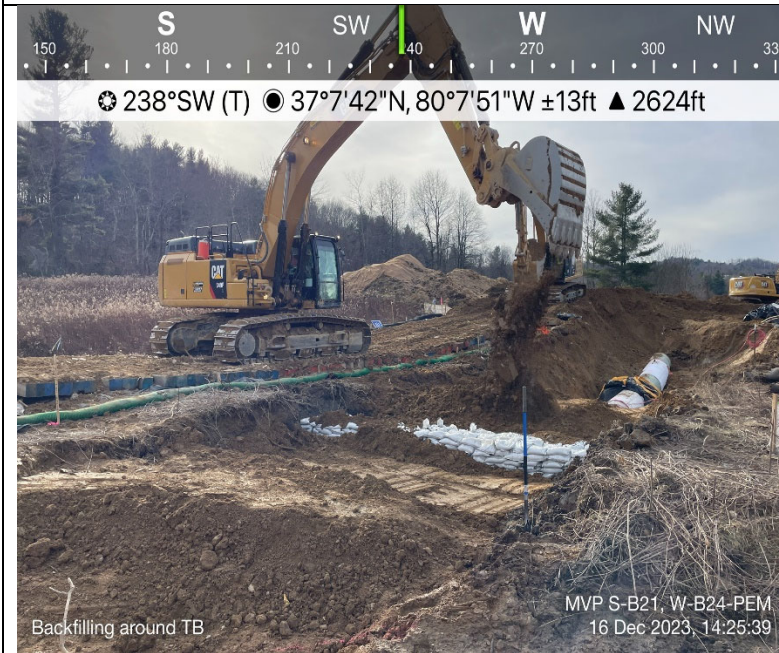
**Photo Description:** Trenchbreaker installed and subsoil backfill.

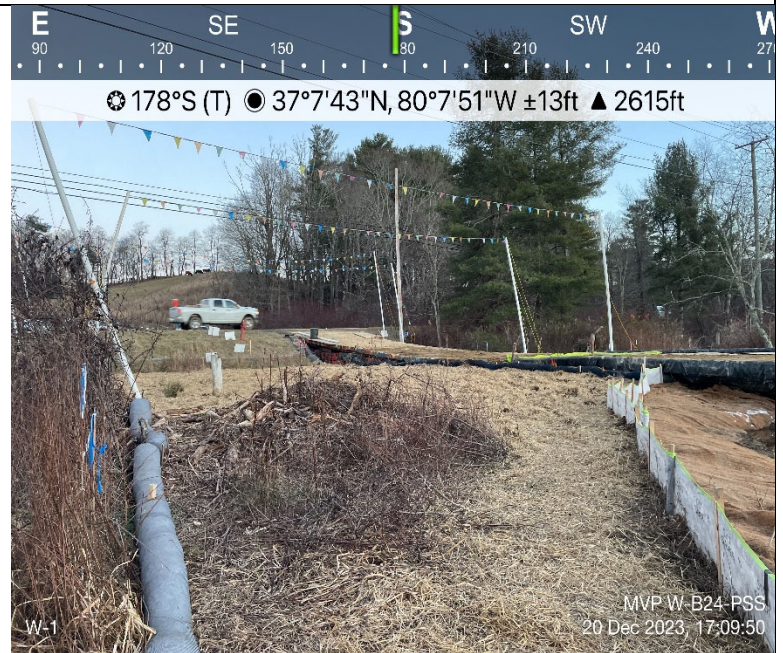
**Photo Description:** Full resource impact area restoration.
