# WETLAND BIOLOGICAL CONDITIONS ENVIRONMENTAL AUDITOR REPORT

<b>Wetland ID:</b> W-B25-PEM-1	<b>Crossing Start Date:</b> 11/29/2023	<b>Crossing Completion Date:</b> 12/14/2023
<b>Milepost:</b> 245.6	<b>Pre-Con Assessment Date:</b> 11/29/2023	<b>Post-Con Assessment Date:</b> 12/14/2023
<b>Station:</b> 12986+67	<b>Cowardin Classification:</b> PEM (PEM, PFO, PSS, POW)	<b>Wetland Impact Area (sq ft.):</b> 609.84
<b>County:</b> Roanoke

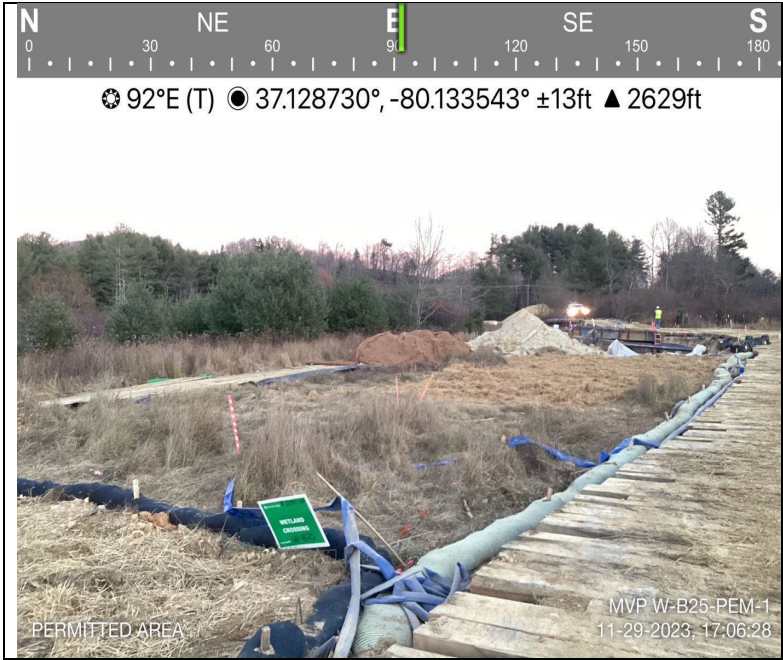
**Photo Description:** View of permitted resource impact area during pre-construction assessment.

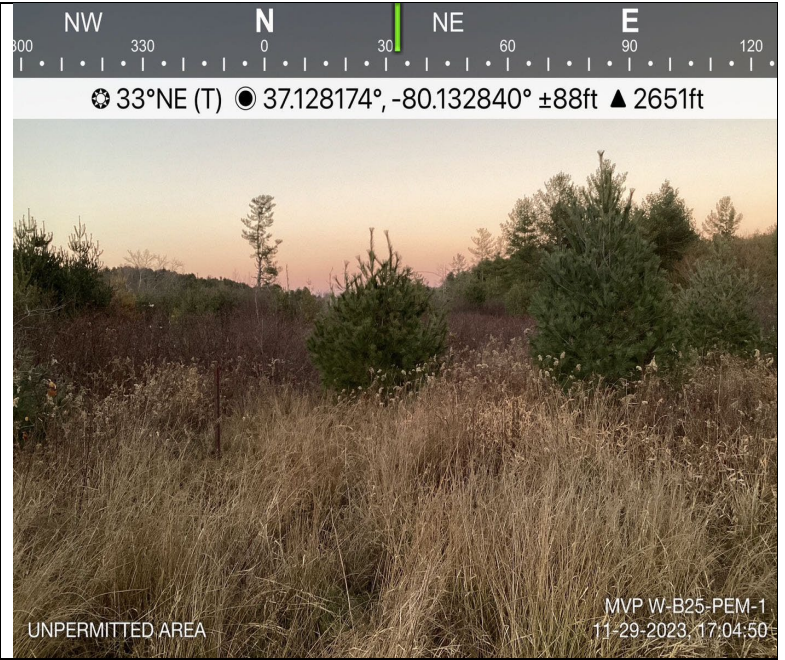
**Photo Description:** At edge of LOD, view of unpermitted resource area conditions during pre-construction assessment.

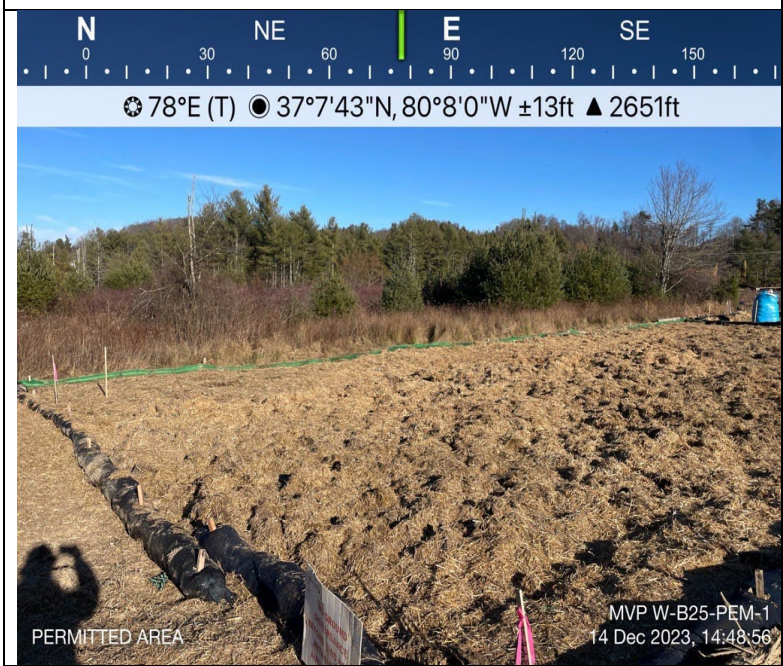
**Photo Description:** View of permitted resource impact area during post-construction assessment.

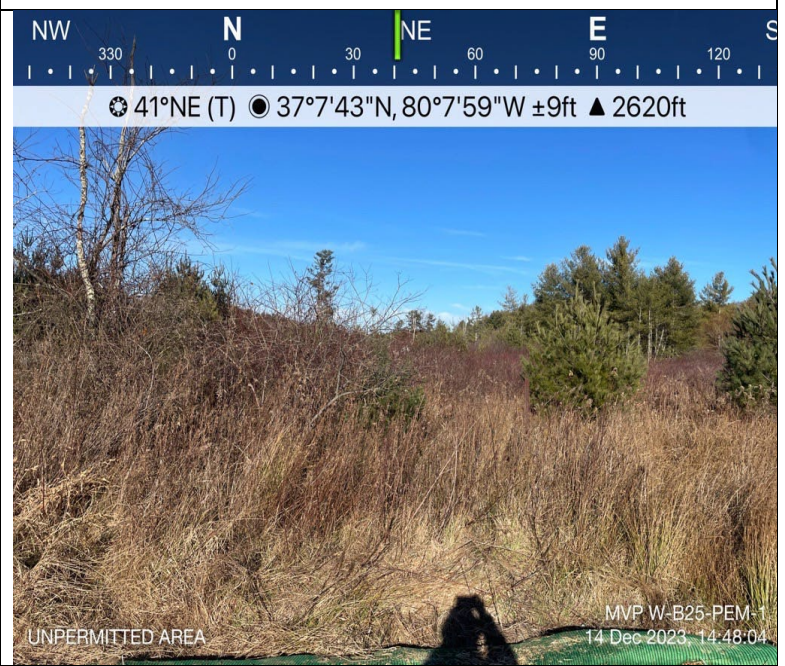
**Photo Description:** At edge of LOD, view of unpermitted resource area conditions during post-construction assessment.

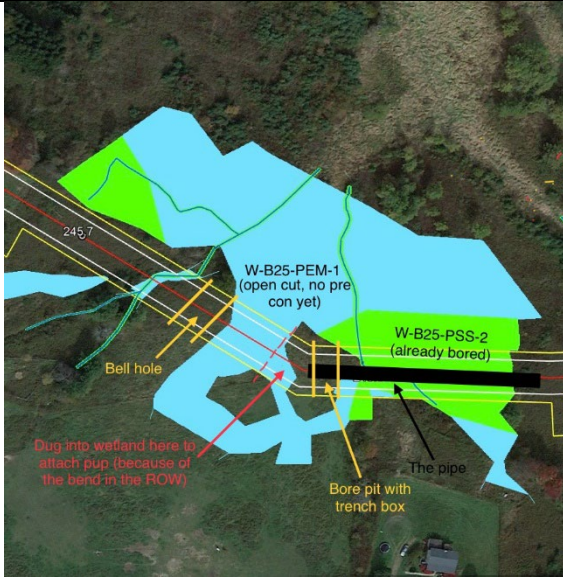
11/27/23: To have enough space to segregate and stockpile the topsoil for the S-B21, W-B24-PEM/PSS crossings, the large stockpile of subsoil from the excavation of the W-B25-PSS-2 entry and exit bore pits had to be relocated. Excess subsoil was used to backfill to the entry bore pit (which was dug in the upland patch between W-B25-PEM-1 and W-B25-PSS-2). Before this backfilling could take place, a 12-foot pup had to be added to the end of the pipe (going toward W-B25-PEM-1) within the bore pit. There was not enough space to add this pup within the current dimensions of the pit, so a tail ditch was dug about 10 feet into W-B25-PEM-1. The topsoil was removed, placed on timber mats, and covered with geotech fabric. The subsoil was stockpiled and segregated. However, due to a miscommunication during all the crew changes, there was no pre-construction meeting held for W-B25-PEM-1 before it was impacted, so this action was reported to the agencies as an Non-Compliance Report. The Pre-construction meeting for this crossing will be held on 11/29/23 at 10 AM. The open cut of this resource will not begin until next Tuesday, 12/5 after the projected rainfall has passed. -A. Thorpe

**Photo Description:** A diagram of the NCR that occurred on 11/27/23.

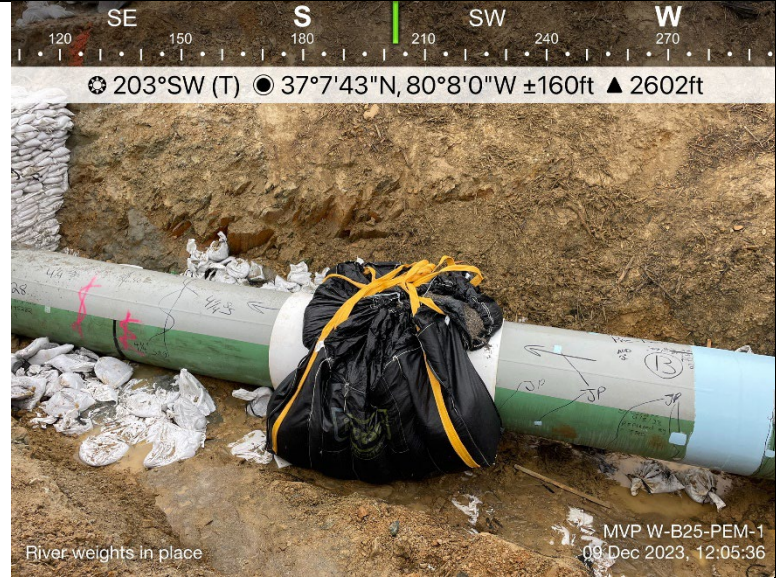
12/9/23: The CIS impervious trench breaker was constructed with bentonite bags and construction of the GAS impervious trench breaker began. River weights were installed and partial backfill also began. -A. Thorpe

**Photo Description:** River weights that were installed on the pipe.

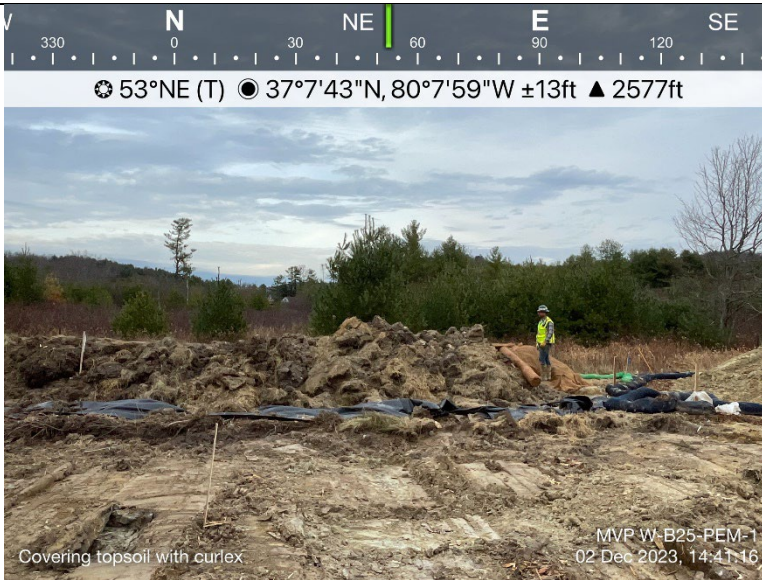
12/2/23: The top 12-inches of wetland topsoil was removed and segregated from trench spoils onto timber mats (with geotech underneath) and covered with curlex. Timber mats were used underneath the equipment during topsoil excavation. Survey staked the center line for the open cut and trench excavation began from the existing bell hole on the CIS. -A. Thorpe

**Photo Description:** The wetland topsoil in the process of being covered in curlex.

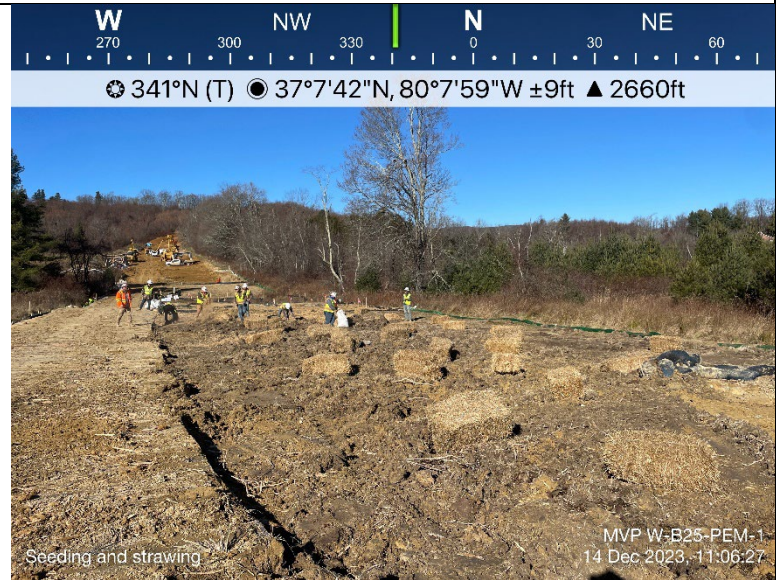
12/14/23: The topsoil was seeded with a wetland seed mix and straw mulch was applied. Fresh filter socks were placed along its boundaries and the post-construction assessment was completed. -A. Thorpe

**Photo Description:** The crew applying seed and straw mulch.
