Wetland Biological Conditions EA Report

Project Name	H-600 Pipeline Spread F	AFE	124300135	Spread	H-600 Pipeline Spread F
Contractor	Price Gregory	Report #	145		
Environmental Auditor	Mathew Huber			Date/Time	12/3/2023 8:30 PM
Wetland ID	W-C13	Crossing Start Date	12/11/2023	Crossing Completion Date	12/22/2023
Milepost	194.73	Pre-Con Assessment Date	12/4/2023	Post-Con Assessment Date	12/22/2023
Station	10281+97	Cowardin Classification	PEM	Wetland Impact Area(acres)	0.2172
State	WV				
County	Monroe

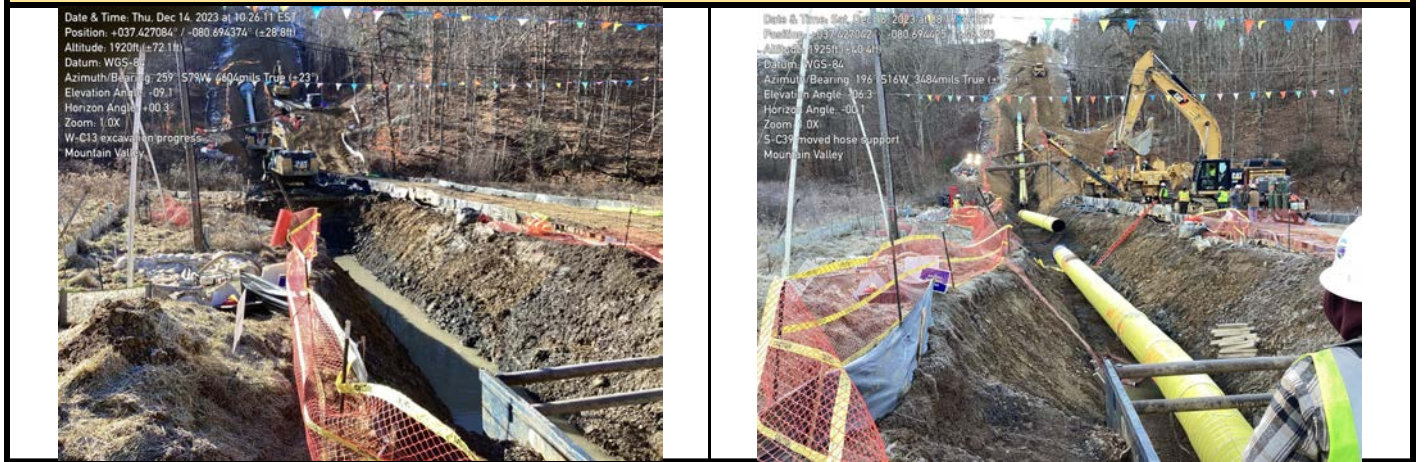
12/14/2023 - Excavated in aquatic resource and adjacent area. X-rayed. Pumped water from trench. Continued to excavate through aquatic resource and adjacent area (Photo 3). Excavation completed.

12/16/2023-12/18/2023 - Pumped water from trench. Welding, x-rayed, cutting, jeeeping outside of aquatic resource. Additional sections of pipe added to trench in aquatic resource area (Photo 4) (12/16/2023).

GPS Location See Photo	GPS Location See Photo
Description Photo 3: Excavating through aquatic resource.	Description Photo 4: Pipe lowered into trench into aquatic resource area.

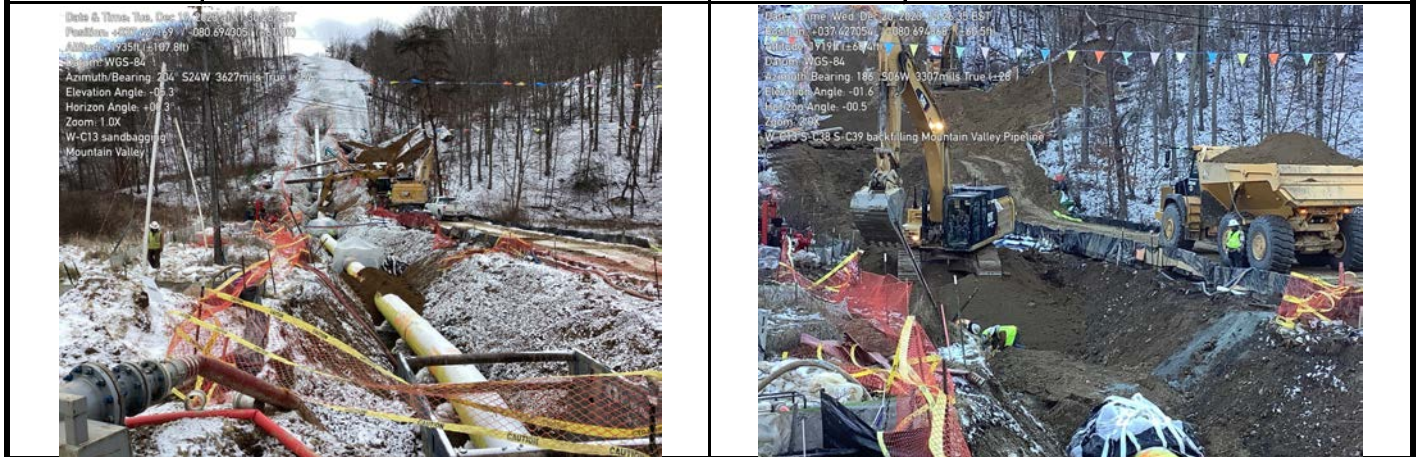
12/19/2023 - Pumped water from trench. Welding and X-ray ongoing. Bedding and sandbags (as bedding) added to trench (Photo 5). Began constructing trench breakers on the southern end of resource area (also northern trench break for S-C41). Trench backfilled. River weights added.

12/20/2023 - Continued to backfill (Photo 6). Trench breaker completed.

GPS Location See Photo	GPS Location See Photo
Description Photo 5: Padding and sandbags in trench.	Description Photo 6: Backfilling of trench.

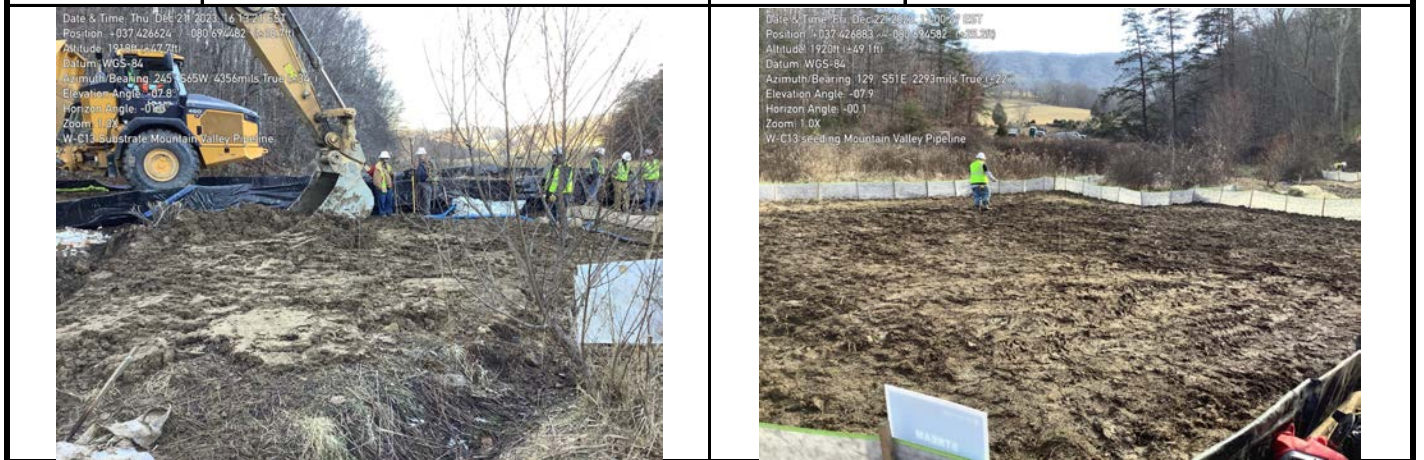
12/21/2023 - The crew replaced the top 12 inches of topsoil to the wetland area (Photo 7) and graded it to the correct contour. The upland topsoil was also replaced in adjacent upland areas and graded to the correct contour.

12/22/2023 - Aquatic resource seeded (Photo 8) and appropriate erosion control measures put in place.

GPS Location See Photo	GPS Location See Photo
Description Photo 7: Restoring topsoil.	Description Photo 8: Seeding aquatic resource.
