WETLAND BIOLOGICAL CONDITIONS ENVIRONMENTAL AUDITOR REPORT

Wetland ID: W-D7-PEM	Crossing Start Date: 12/12/2023	Crossing Completion Date: 12/16/2023
Milepost: 248.8	Pre-Con Assessment Date: 12/04/2023	Post-Con Assessment Date: 12/20/2023
Station: 13146+55	Cowardin Classification: PSS (PEM, PFO, PSS, POW)	Wetland Impact Area (sq ft.): 692.6
County: Franklin

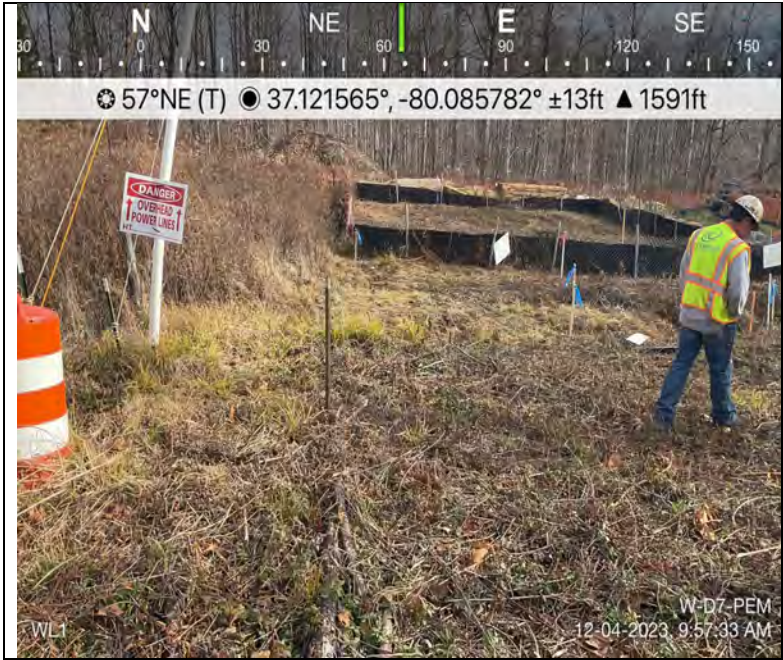
Photo Description: View of permitted resource impact area during pre-construction assessment.

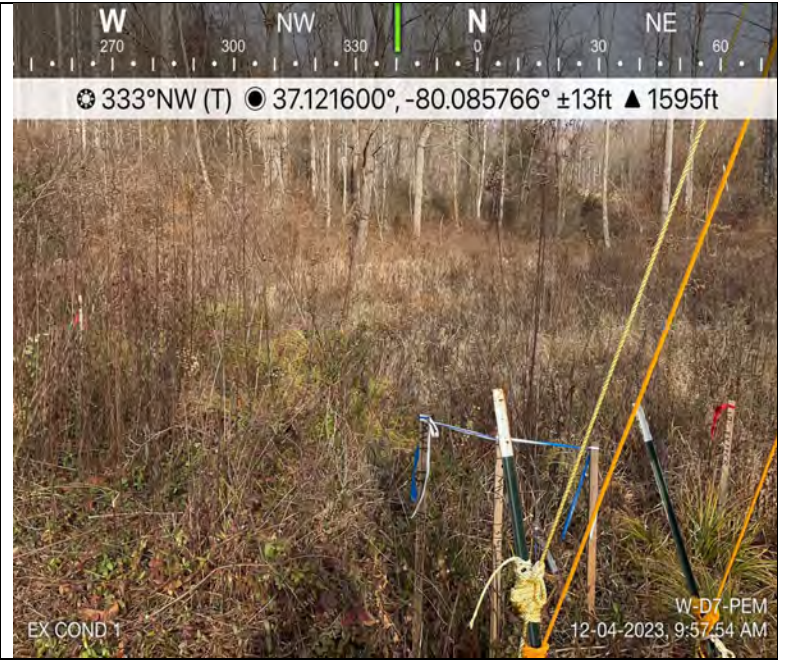
Photo Description: At edge of LOD, view of unpermitted resource area conditions during pre-construction assessment.

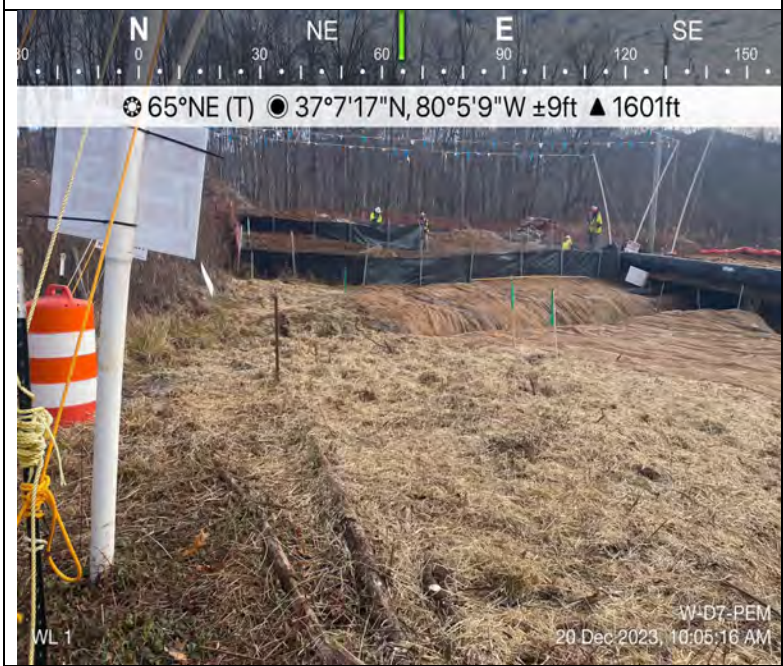
Photo Description: View of permitted resource impact area during post-construction assessment.

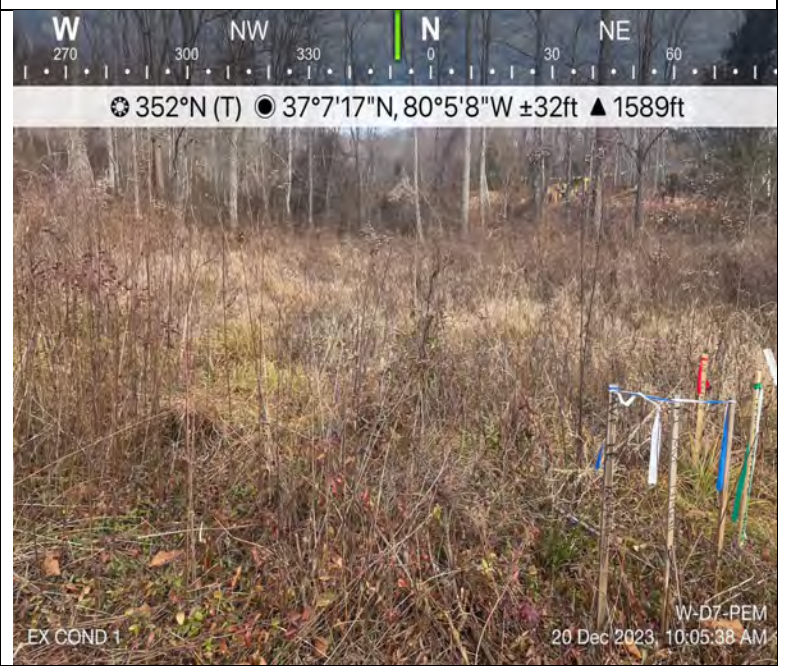
Photo Description: At edge of LOD, view of unpermitted resource area conditions during post-construction assessment.

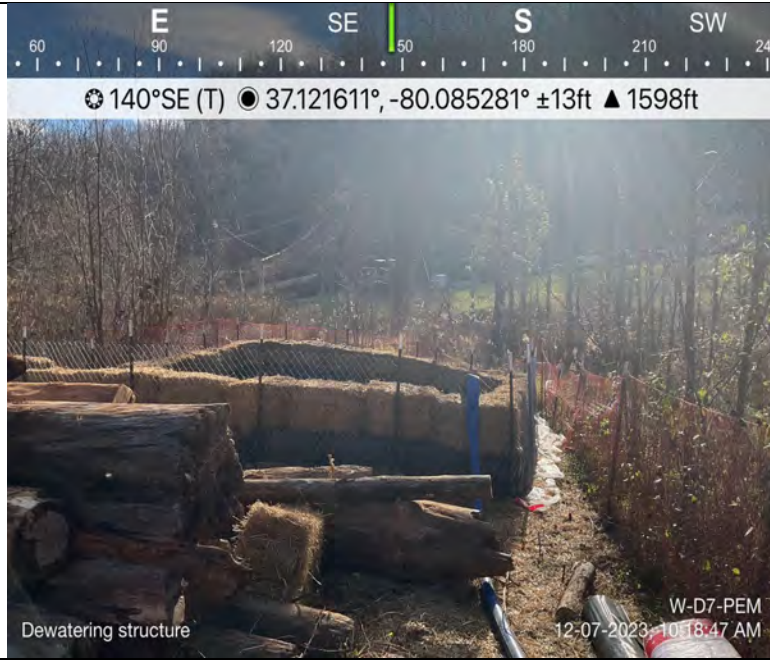
Photo Description: An overview of the dewatering structure.

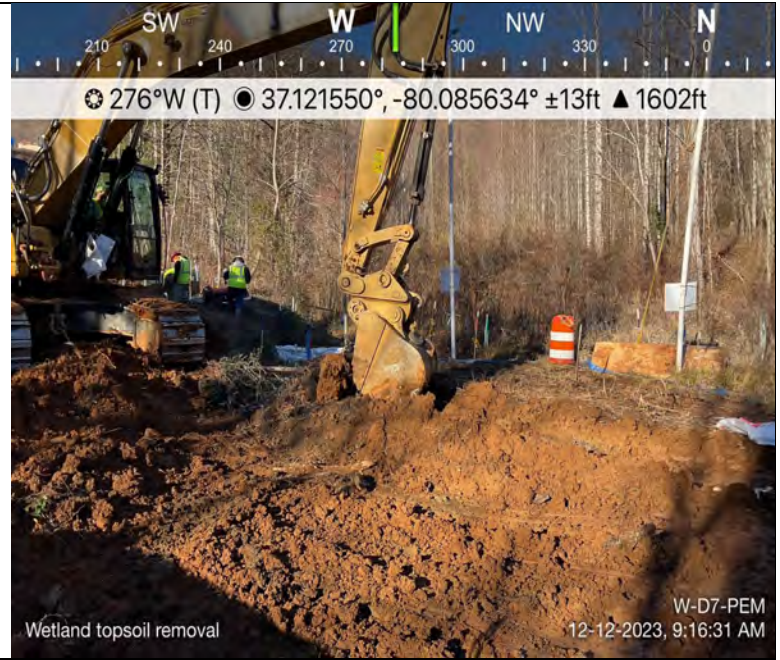
Photo Description: Removal of top 12-inches of wetland topsoil.

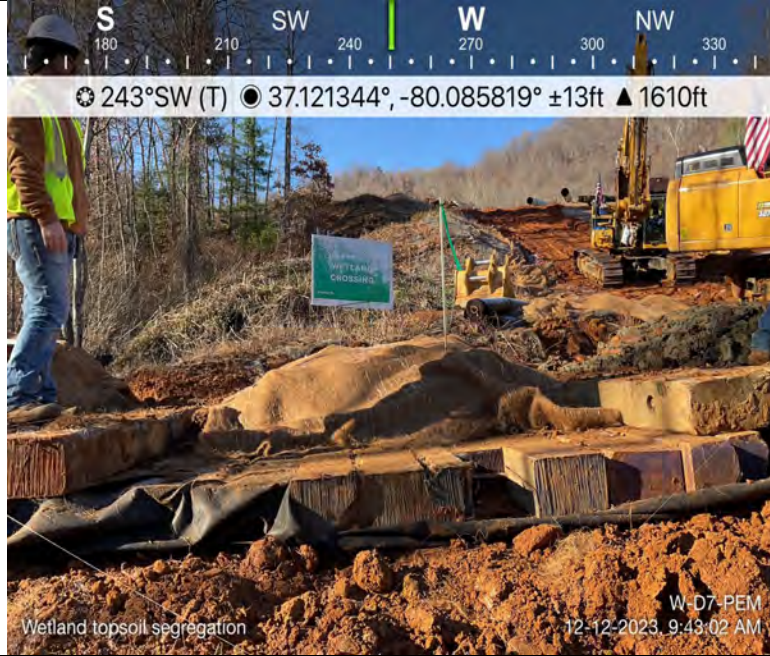
Photo Description: Segregated and stabilized wetland topsoil.

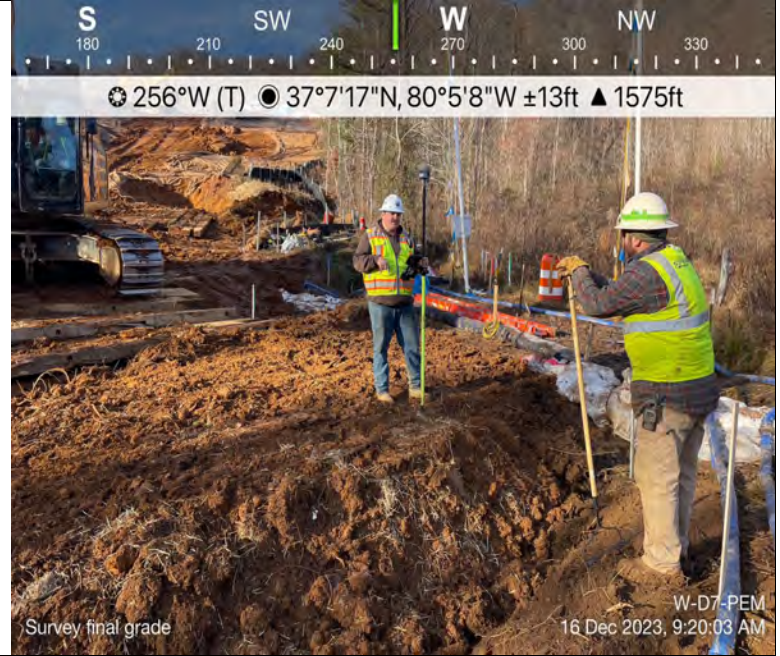
Photo Description: Survey shooting the final grade for wetland topsoil restoration.
