Wetland Biological Conditions EA Report

Project Name	H-600 Pipeline Spread F	A/E	124300135	Spread	H-600 Pipeline Spread F
Contractor	Price Gregory	Report #	148		
Environmental Auditor	Beth Burdette			Date/Time	12/4/2023 4:25 PM
Wetland ID	W-G6	Crossing Start Date	12/29/2023	Crossing Completion Date	1/14/2024
Milepost	190.23	Pre-Con Assessment Date	12/6/2023	Post-Con Assessment Date	1/14/2024
Station	10044+40	Cowardin Classification	PEM	Wetland Impact Area(acres)	0.0684
State	WV				
County	Monroe

Resource Post-Crossing Conditions

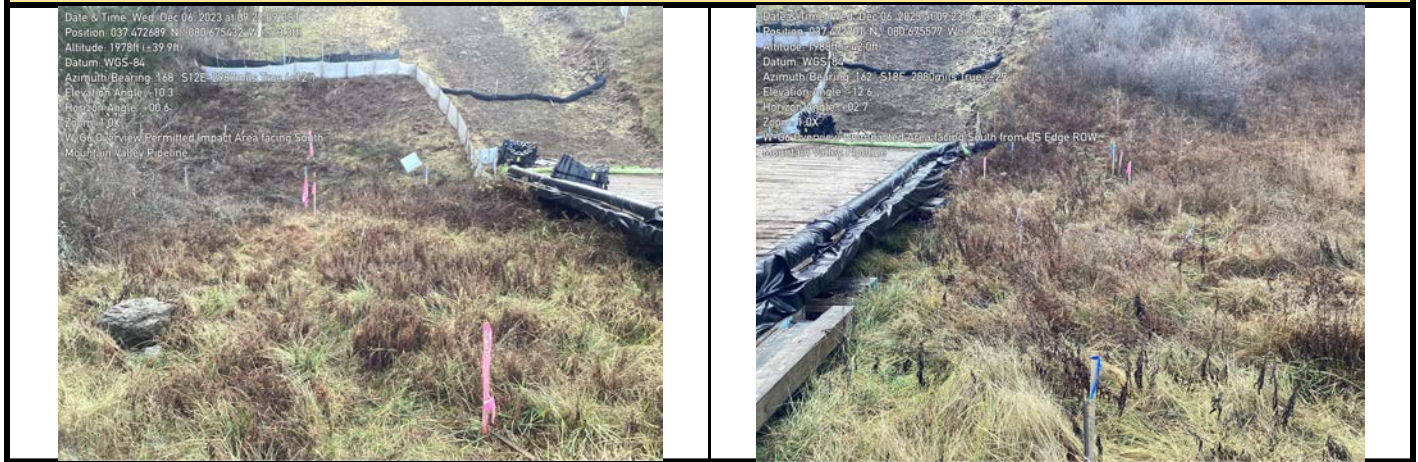
GPS Location See Photo	GPS Location See Photo
Description View of permitted resource impact area during pre-construction assessment.	Description At edge of LOD, view of unimpacted resource area conditions during pre-construction assessment.

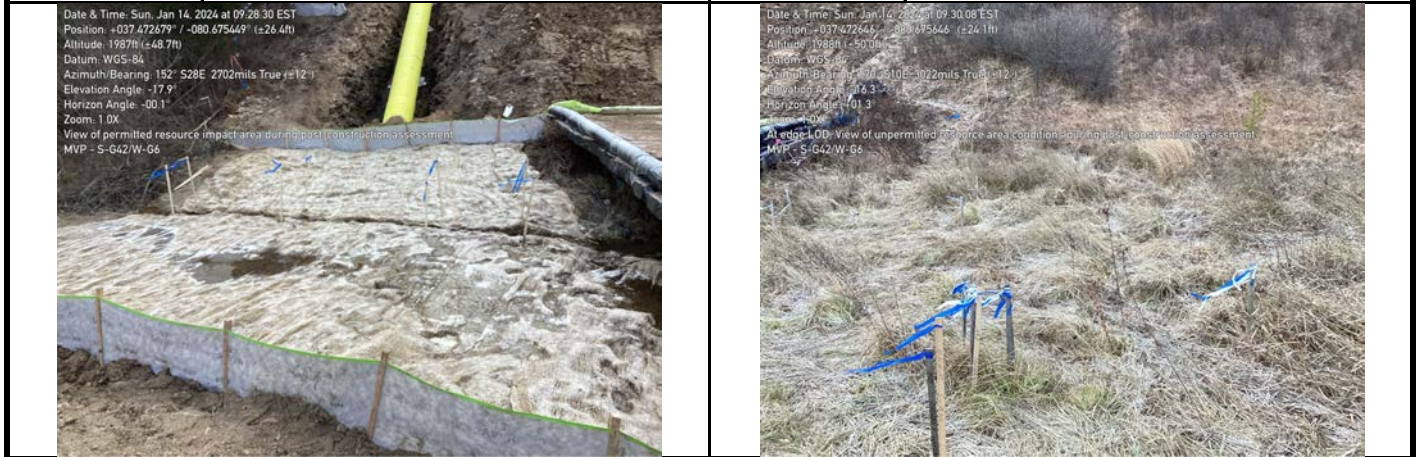
GPS Location See Photo	GPS Location See Photo
Description View of permitted resource impact area during post-construction assessment.	Description At edge of LOD, view of unimpacted resource area conditions during post-construction assessment.

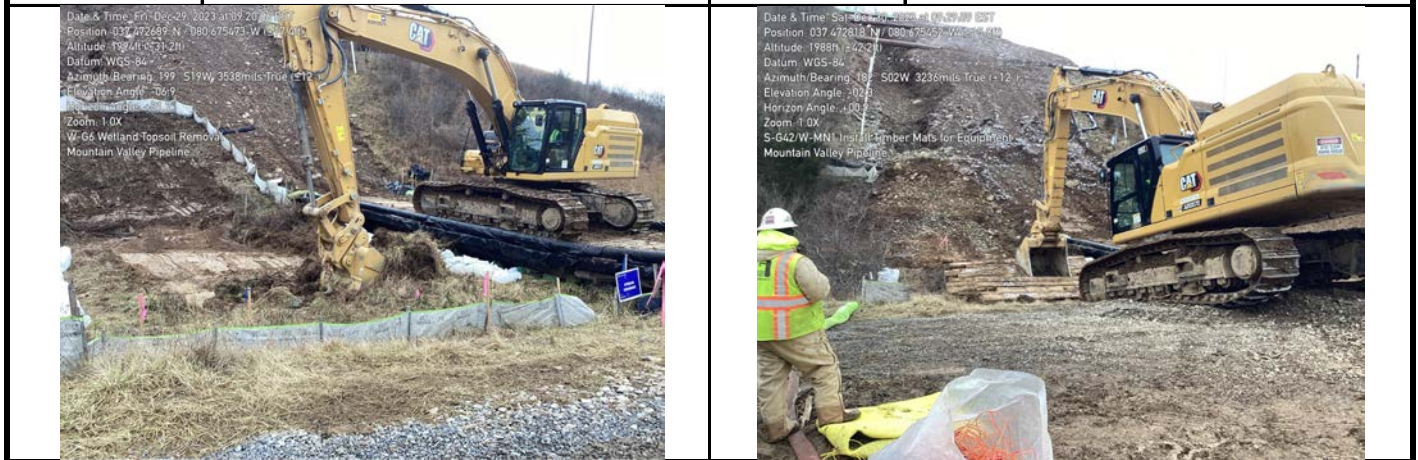
12/29/2023 - Excavated top 12 inches of topsoil from aquatic resource (Photo 1) and transport to north hill stockpile for segregated storage. Prepped for blast: drill charge holes, etc. Blasted. Removed blast mats in the vicinity of aquatic resource to install flume pipe.
 12/30/2023 - Removed remaining blast mats. Placed timber mats in aquatic resource area (Photo 2). Excavated trench upslope of resources and into topsoiled aquatic resource. Subsoil transported to coming-in sidehill. Welded pipe in upland area.
 12/31/2023 - Completed excavation of trench through aquatic resource (Photo 3) and relayed subsoil. Pumped water from trench to dewatering structure. Welded pipe in upland area. Timber mat bridge installed across trench for landowner to access property opposite ROW.
 1/2/2024 - Pumped water from trench. Walked pipe section to upland trench. Welded pipe in upland area. No activity in aquatic resource.

GPS Location See Photo	GPS Location See Photo
Description Photo 1: Excavation of top 12 inches of topsoil from aquatic resource.	Description Photo 2: Installing timber mats to minimize compaction during excavation.

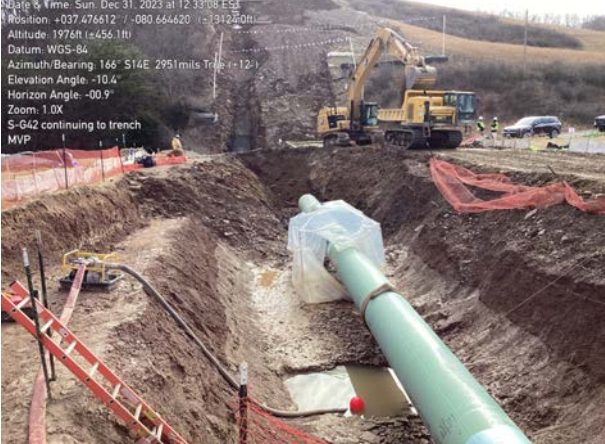
<p><small>Date & Time: Sun, Dec 31, 2023 at 12:33:08 EST Position: +037.476612 N / -080.644420 W (=1312.20ft) Altitude: 197.6ft (=60.1ft) Datum: WGS-84 Azimuth/Bearing: 166° S14E 2951mils True (=12°) Elevation Angle: -10.4 Horizon Angle: -00.9 Zoom: 1.0X S-G42 continuing to trench MVP</small></p>

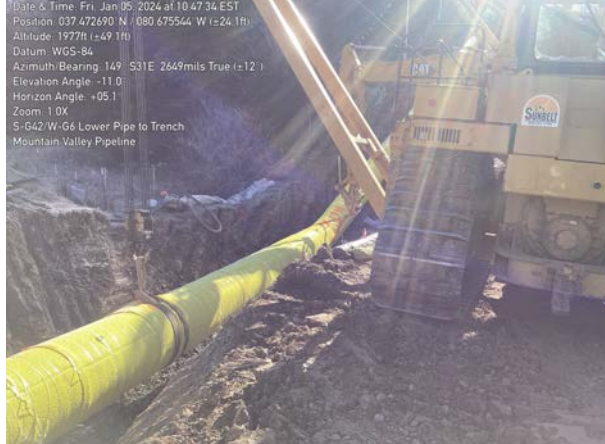
<p><small>Date & Time: Fri, Jan 05, 2024 at 10:47:34 EST Position: 037.472690 N / -080.675544 W (=24.1ft) Altitude: 197.7ft (=60.1ft) Datum: WGS-84 Azimuth/Bearing: 149° S31E 2649mils True (=12°) Elevation Angle: -11.0 Horizon Angle: +05.1 Zoom: 1.0X S-G42/W-G6 Lower Pipe to Trench Mountain Valley Pipeline</small></p>
GPS Location See Photo	GPS Location See Photo
Description Photo 3: Excavating last portion of trench through aquatic resource.	Description Photo 4: Lowering pipe into trench.

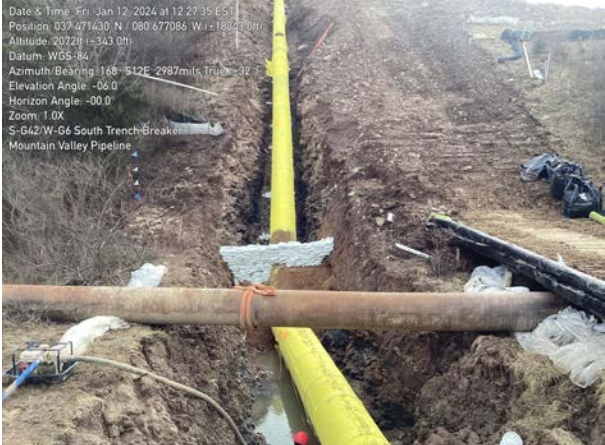
<p><small>Date & Time: Fri, Jan 12, 2024 at 12:27:35 EST Position: 037.471430 N / -080.677086 W (=188.23.0ft) Altitude: 202.2ft (=62.3.0ft) Datum: WGS-84 Azimuth/Bearing: 168° S12E 2987mils True (=32°) Elevation Angle: -06.0 Horizon Angle: -00.0 Zoom: 1.0X S-G42/W-G6 South Trench Breaker Mountain Valley Pipeline</small></p>

GPS Location See Photo	GPS Location See Photo
Description Photo 5: Constructing trench breaker adjacent to aquatic resource.	Description Photo 6: Backfilling trench.

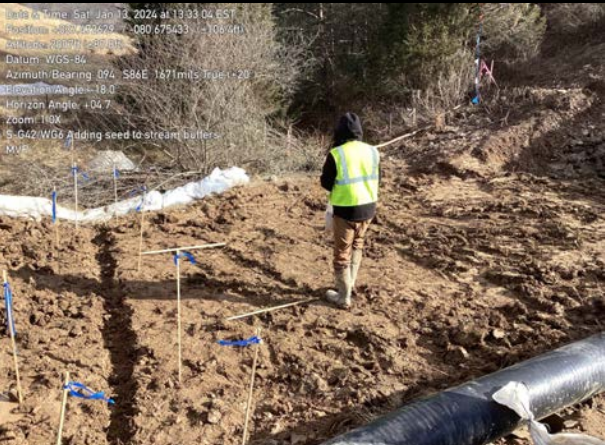
1/8/2024 - Site muddy due to weekend precipitation. Pumped water from trench. Dewatering structure discharge clear. Prepped pipe for weld. Welded pipe. X-rayed. No activity in aquatic resource.
 1/9/2024 - Rain out. Actively pumped water from trench. No activity in aquatic resource.
 1/10/2024 - Pumped water from trench. Sandblasted, jeeped, coated, and wrapped pipe with rock shield outside aquatic resource. Site cleanup. No activity in aquatic resource.
 1/11/2024 - Pumped water from trench to dewatering structure. Sandblasted, jeeped, coated, and wrapped pipe with rock shield outside aquatic resource. Site cleanup. Backfilled trench. No activity in aquatic resource.
 1/12/2024 - Pumped water from trench to dewatering structure. Site cleanup. Installed resource trench breakers (Photo 5). Backfilled trench (Photo 6). Rain in afternoon.
 1/13/2024 - Pumped water out of trench. Backfilled with padding dirt. Survey onsite, shot elevations. Contoured and restored topsoil in aquatic resource. Seeded aquatic resource (Photo 7). Survey shot final elevations.

<p><small>Date & Time: Sat, Jan 13, 2024 at 13:33:04 EST Position: 037.472657 N / -080.675433 W (=108.4ft) Altitude: 206.0ft (=62.8ft) Datum: WGS-84 Azimuth/Bearing: 092° S88E 1871mils True (=12°) Elevation Angle: +18.0 Horizon Angle: +04.7 Zoom: 1.0X S-G42/W-G6 Adding seed to stream buffers MVP</small></p>

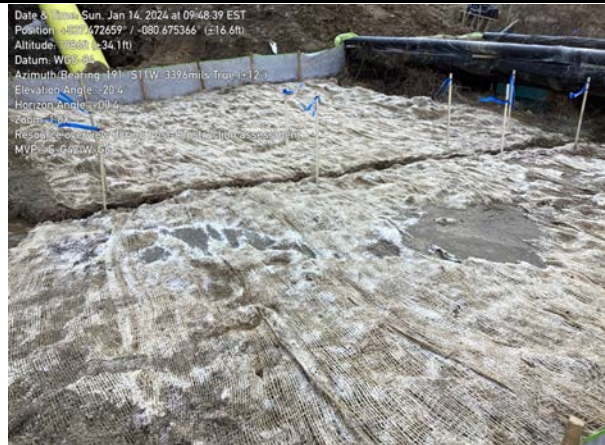
Post Construction Notes
 17. Surface water, high water table, and soil saturation observed (Photo 8).
 19. Aquatic resource has been recently restored. These areas will be monitored until 80% vegetative cover has been achieved and areas that do not have 80% vegetative cover within 30 days will be reseeded.
 Timber mats will remain in place for travel lane.

<p><small>Date & Time: Sun, Jan 14, 2024 at 09:48:39 EST Position: 037.472659 N / -080.675366 W (=16.6ft) Altitude: 188.0ft (=57.3ft) Datum: WGS-84 Azimuth/Bearing: 191° S11W 3395mils True (=12°) Elevation Angle: +23.0 Horizon Angle: +03.0 Zoom: 1.0X Residual surface water in aquatic resource post MVP S-G42/W-G6</small></p>
GPS Location See Photo	GPS Location See Photo
Description Photo 7: Seeding aquatic resource.	Description Photo 8: Surface water evident in aquatic resource post restoration.
