# WETLAND BIOLOGICAL CONDITIONS ENVIRONMENTAL AUDITOR REPORT

<b>Wetland ID:</b> W-IJ1	<b>Crossing Start Date:</b> 10/10/2023	<b>Crossing Completion Date:</b> 12/08/2023
<b>Milepost:</b> 253.9	<b>Pre-Con Assessment Date:</b> 10/02/2023	<b>Post-Con Assessment Date:</b> 12/08/2023
<b>Station:</b> 13414+11	<b>Cowardin Classification:</b> PEM (PEM, PFO, PSS, POW)	<b>Wetland Impact Area (sq ft.):</b> 1812.1
<b>County:</b> Franklin

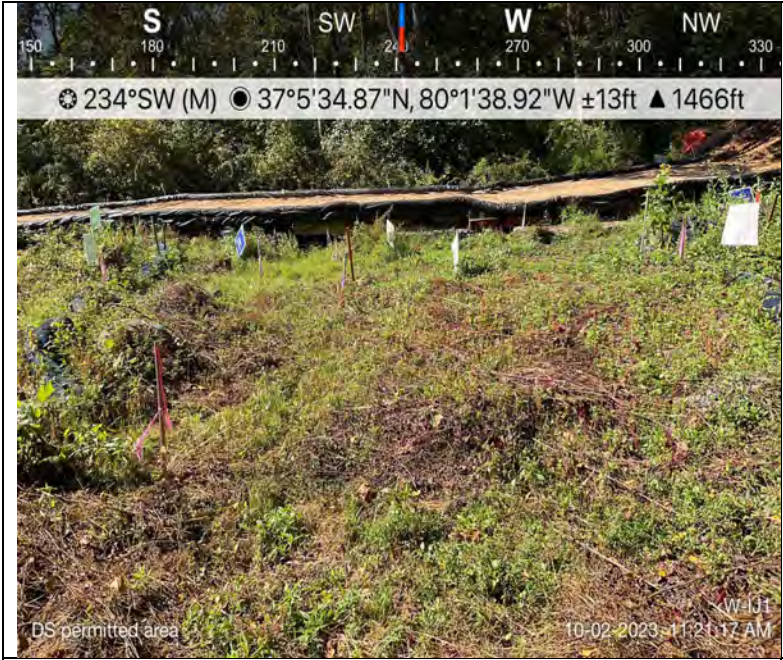
**Photo Description:** View of permitted resource impact area during pre-construction assessment.

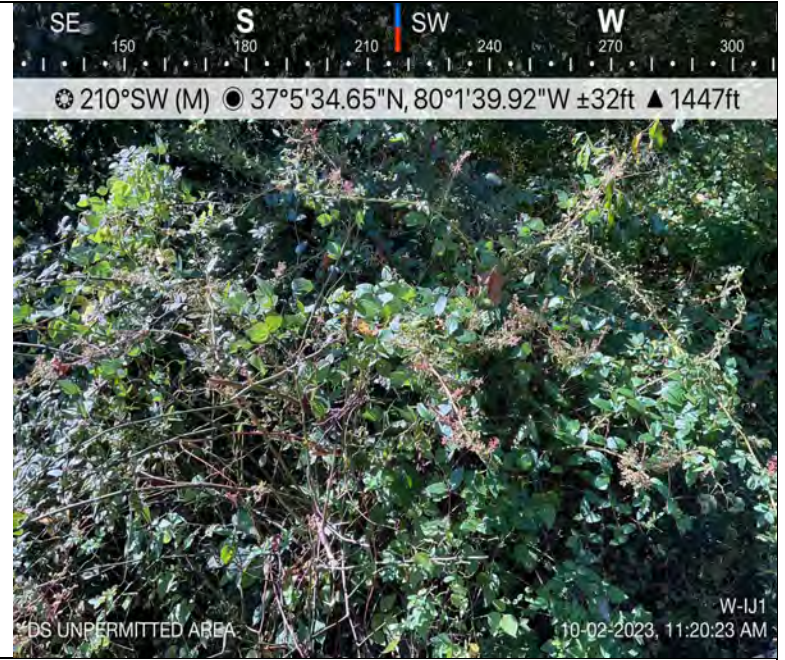
**Photo Description:** At edge of LOD, view of unpermitted resource area conditions during pre-construction assessment.

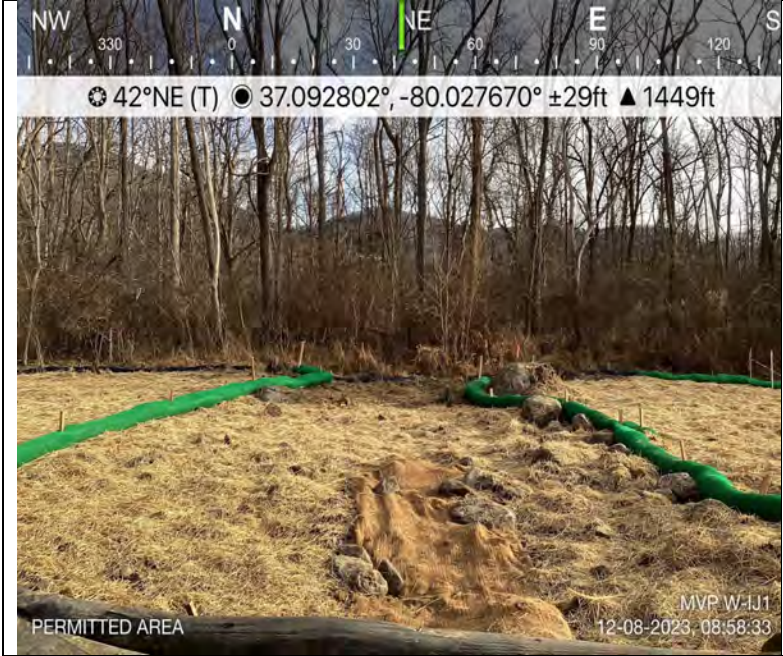
**Photo Description:** View of permitted resource impact area during post-construction assessment.

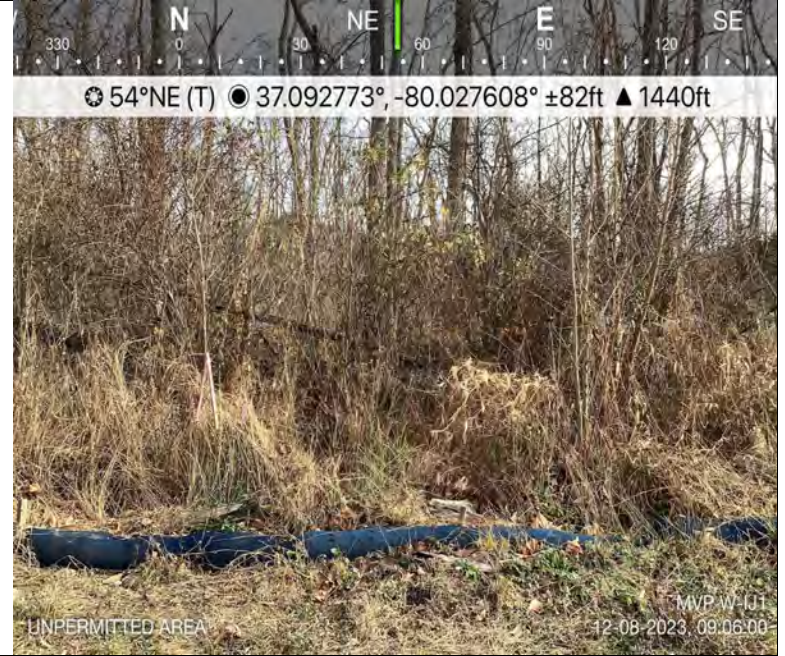
**Photo Description:** At edge of LOD, view of unpermitted resource area conditions during post-construction assessment.

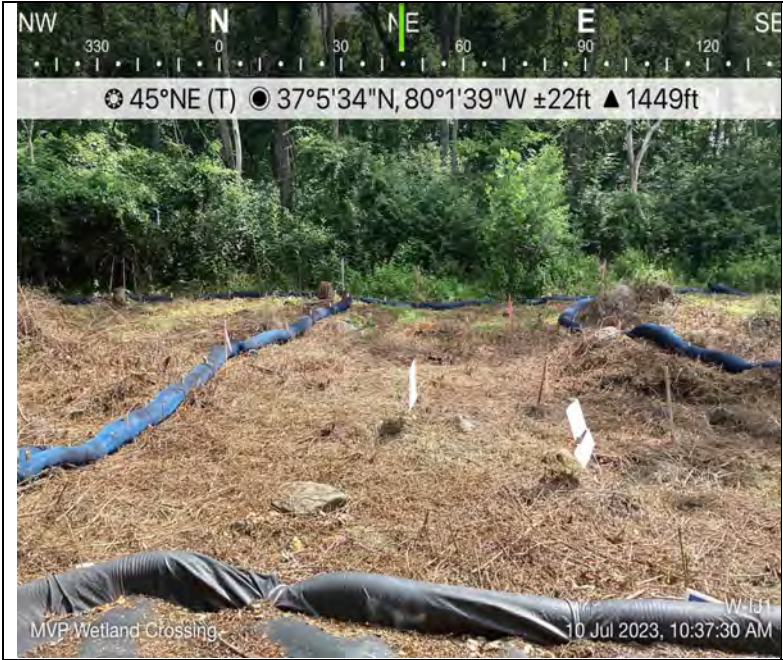
**Photo Description:** Upstream view of permitted area

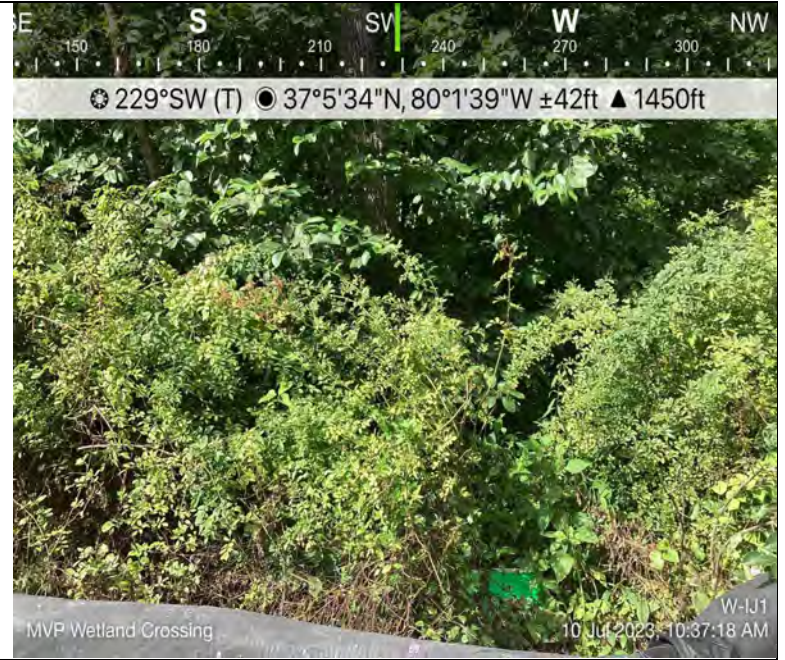
**Photo Description:** Additional downstream view of unpermitted area

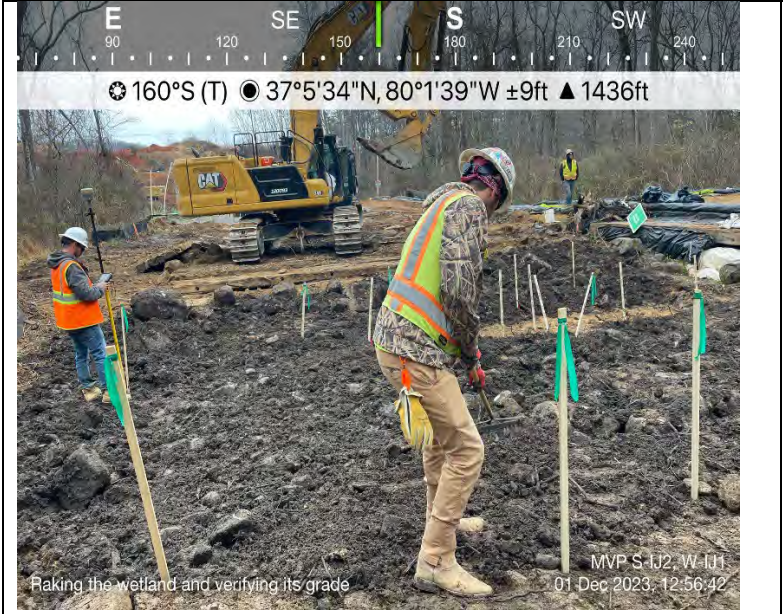
**Photo Description:** Raking and staking wetland elevations and topsoil.

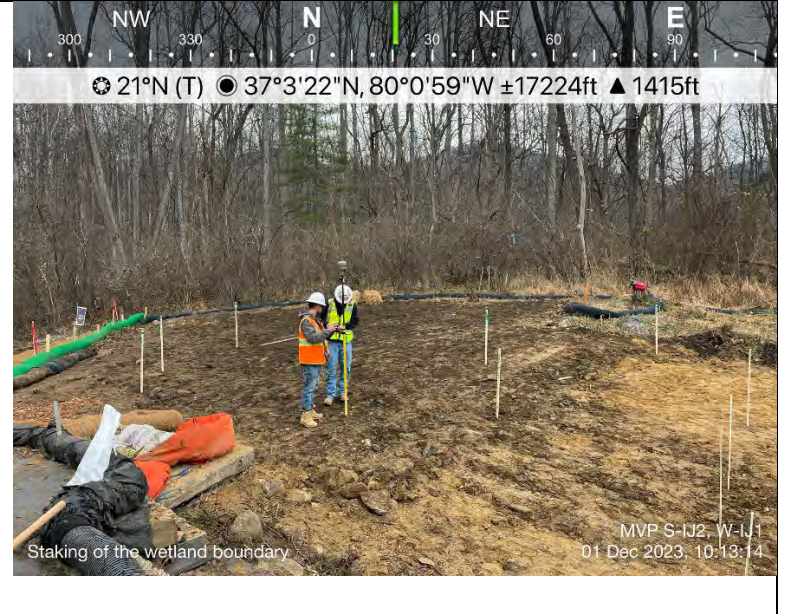
**Photo Description:** Staking W-IJ1 Boundary
