Wetland Biological Conditions EA Report

Project Name	H-600 Pipeline Spread D	AFE	124300132	Spread	H-600 Pipeline Spread D
Contractor	Precision	Report #	163		
Environmental Auditor	Gary Cruz			Date/Time	1/22/2024 10:32 AM
Wetland ID	W-IJ55	Crossing Start Date	1/11/2024	Crossing Completion Date	1/23/2024
Milepost	112.89	Pre-Con Assessment Date	1/11/2024	Post-Con Assessment Date	1/23/2024
Station	5960+43	Cowardin Classification	PEM	Wetland Impact Area(acs)	0.0218
State	WV				
County	Nicholas

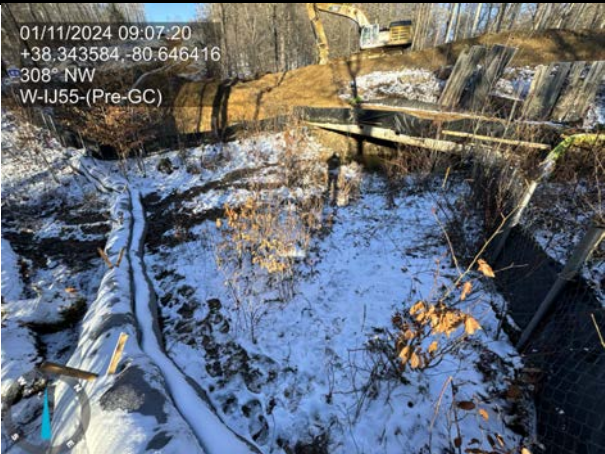
GPS Location	See photo above	GPS Location	See photo above
Description	View of permitted resource impact area during pre-construction assessment.	Description	At edge of LOD, view of unimpacted resource area conditions during pre-construction assessment.

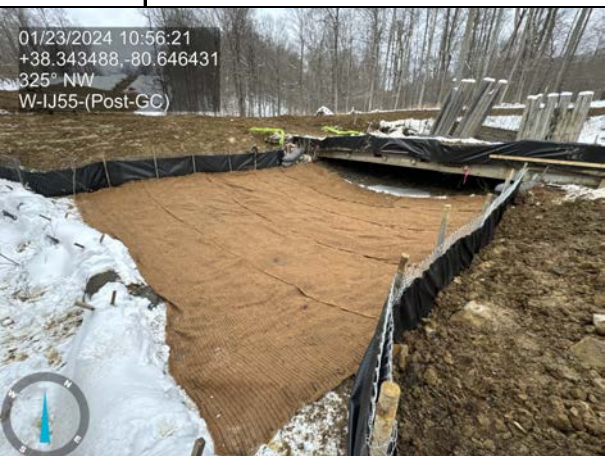
Conditions 18 & 19 were given a rating of 4 due to the lack of vegetation in the disturbed permitted impact area following completion of the crossing and restoration efforts. Wetland W-IJ55 topsoil was properly stabilized, and the disturbed areas were seeded with the appropriate permanent seed mix in accordance with Appendix B: Restoration Work Plan of the Mountain Valley Pipeline Comprehensive Stream and Wetland Monitoring, Restoration and Mitigation Framework.

GPS Location	See photo above	GPS Location	See photo above
Description	View of permitted resource impact area during post-construction assessment.	Description	At edge of LOD, view of unimpacted resource area conditions during post-construction assessment.

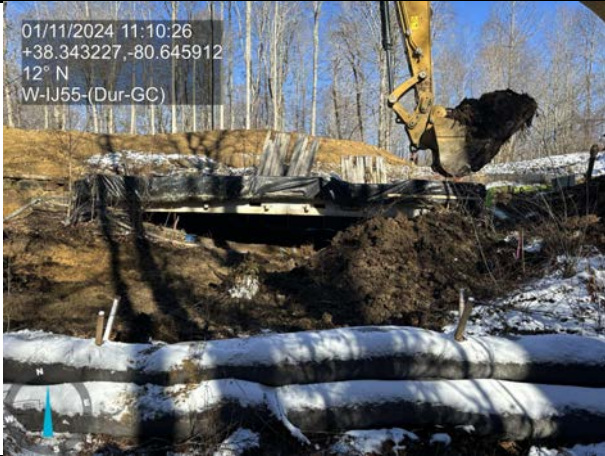
GPS Location	See photo above	GPS Location	See photo above
Description	Removing the top 12" of wetland topsoil.	Description	Wetland ditch line has been excavated.
