# WETLAND BIOLOGICAL CONDITIONS ENVIRONMENTAL AUDITOR REPORT

<b>Wetland ID:</b> W-KL17	<b>Crossing Start Date:</b> 12/18/2023	<b>Crossing Completion Date:</b> 12/31/2023
<b>Milepost:</b> 243	<b>Pre-Con Assessment Date:</b> 12/07/2023	<b>Post-Con Assessment Date:</b> 12/31/2023
<b>Station:</b> 12838+07	<b>Cowardin Classification:</b> PSS (PEM, PFO, PSS, POW)	<b>Wetland Impact Area (sq ft.):</b> 1894.86
<b>County:</b> Roanoke

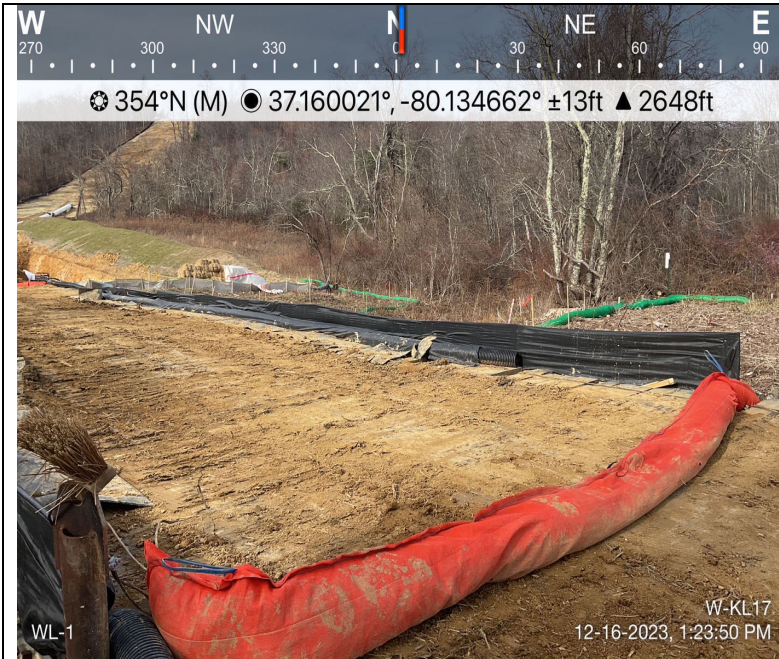
**Photo Description:** View of permitted resource impact area during pre-construction assessment.

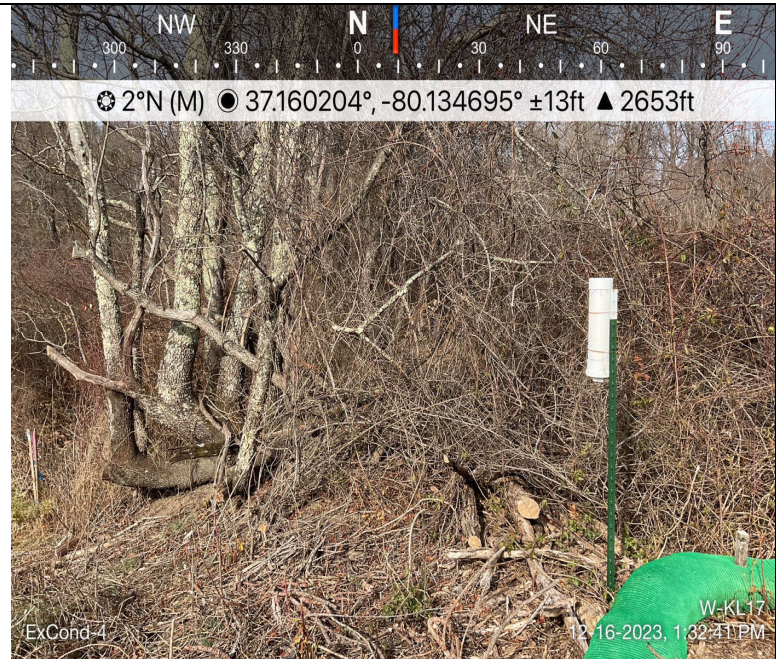
**Photo Description:** At edge of LOD, view of unpermitted resource area conditions during pre-construction assessment.

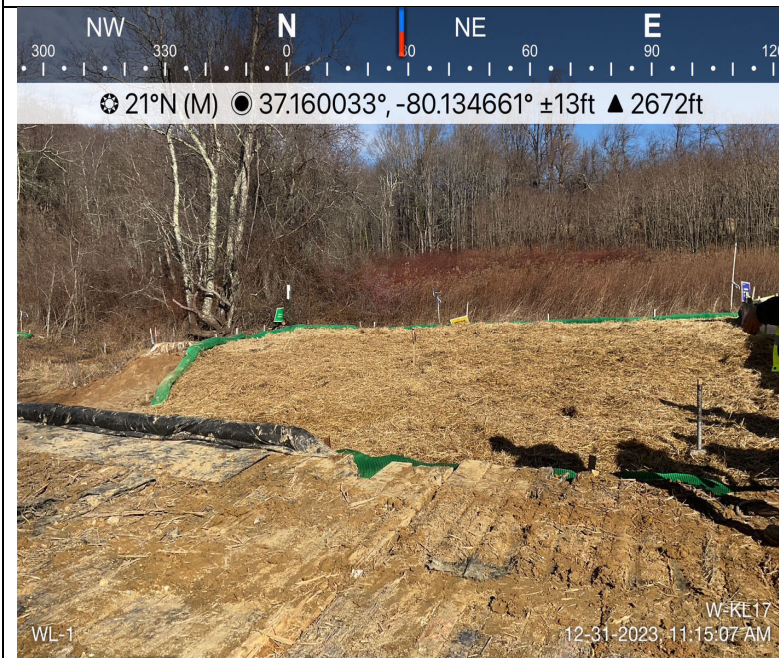
**Photo Description:** View of permitted resource impact area during post-construction assessment.

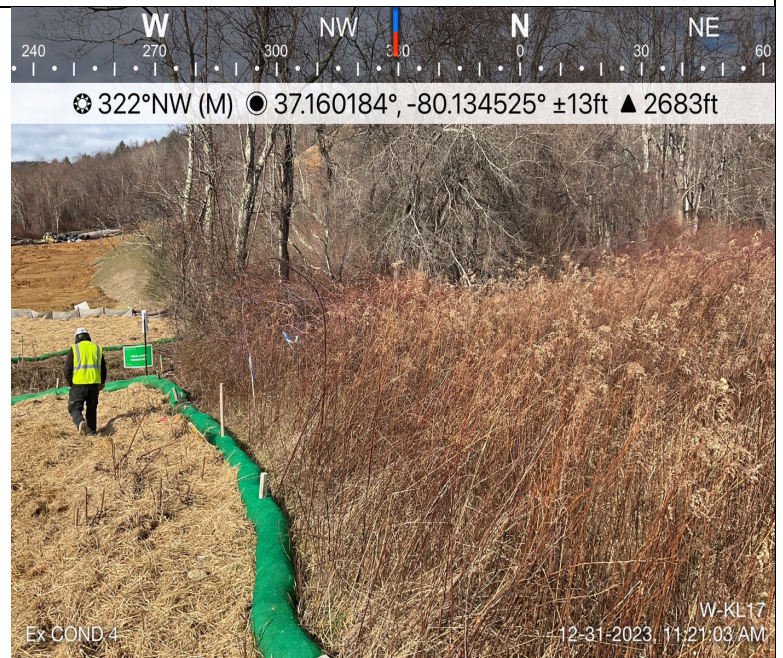
**Photo Description:** At edge of LOD, view of unpermitted resource area conditions during post-construction assessment.

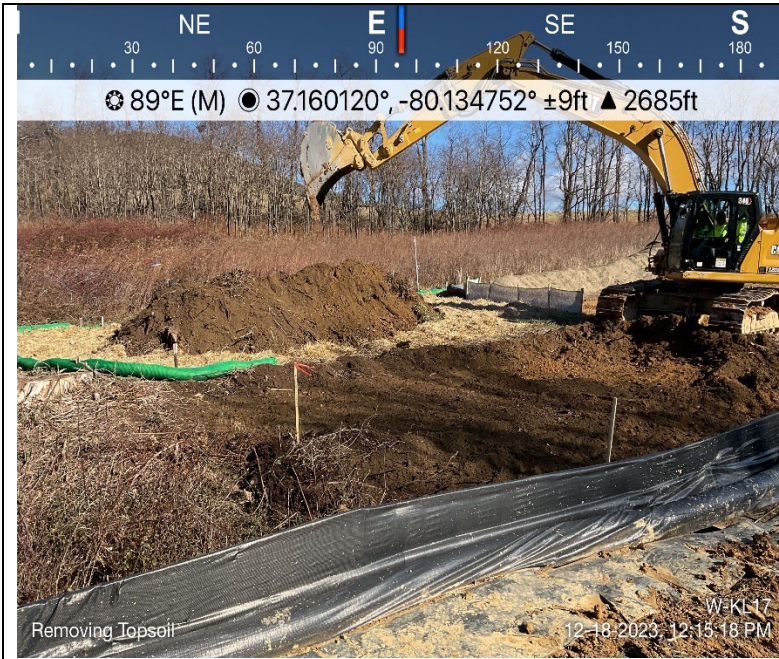
**Photo Description:** The topsoil was excavated and segregated.

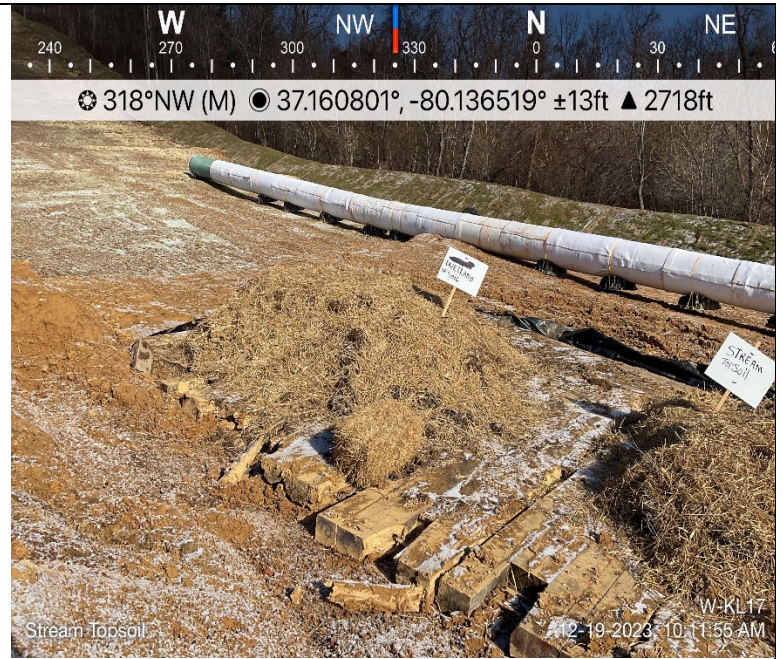
**Photo Description:** The segregated wetland and stream stockpiles.

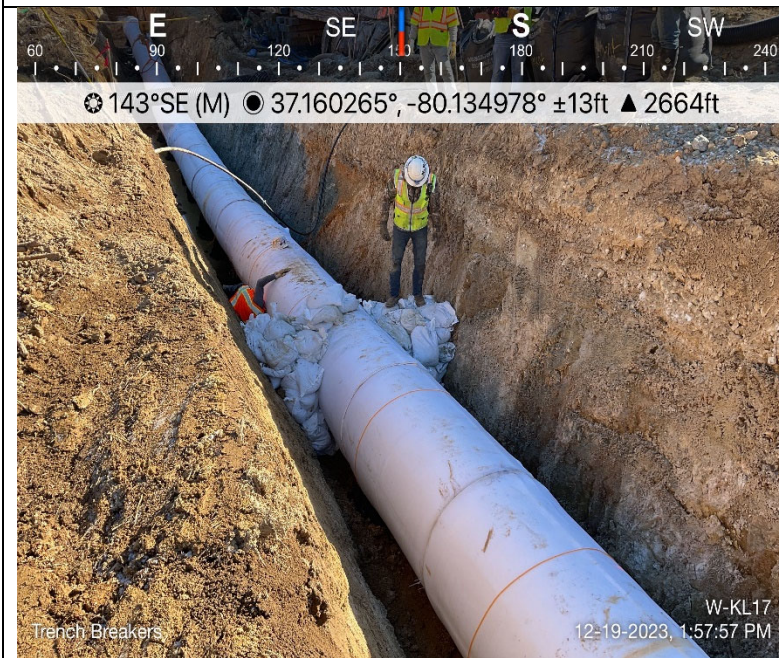
**Photo Description:** Trench breakers were installed along the pipe.

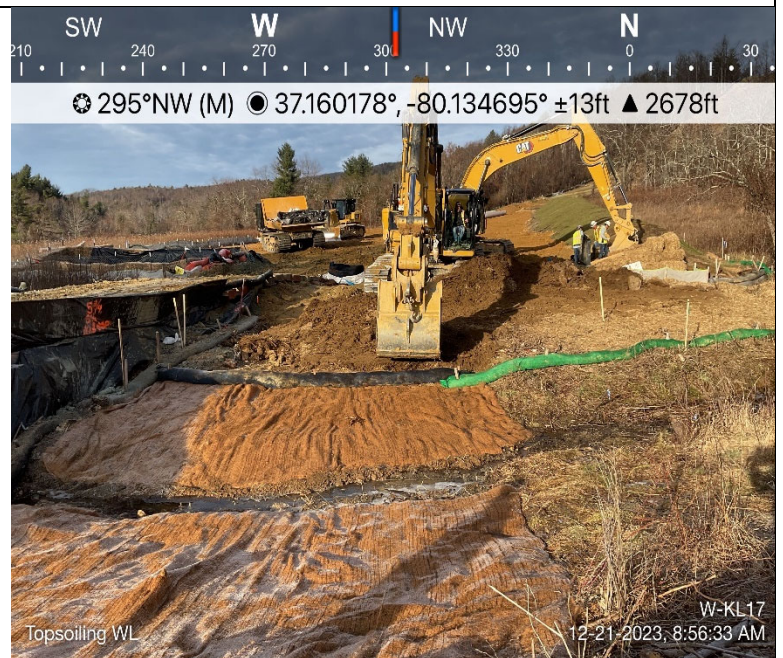
**Photo Description:** The wetland topsoil was restored.
