Wetland Biological Conditions EA Report

Project Name	H-600 Pipeline Spread F	AFE	124300135	Spread	H-600 Pipeline Spread F
Contractor	Price Gregory	Report #	146		
Environmental Auditor	Aaron Crank			Date/Time	12/4/2023 9:26 AM
Wetland ID	W-MN15	Crossing Start Date	12/4/2023	Crossing Completion Date	12/23/2023
Milepost	185.86	Pre-Con Assessment Date	12/4/2023	Post-Con Assessment Date	12/23/2023
Station	9813+36	Cowardin Classification	PEM	Wetland Impact Area(acres)	0.0070
State	WV				
County	Monroe

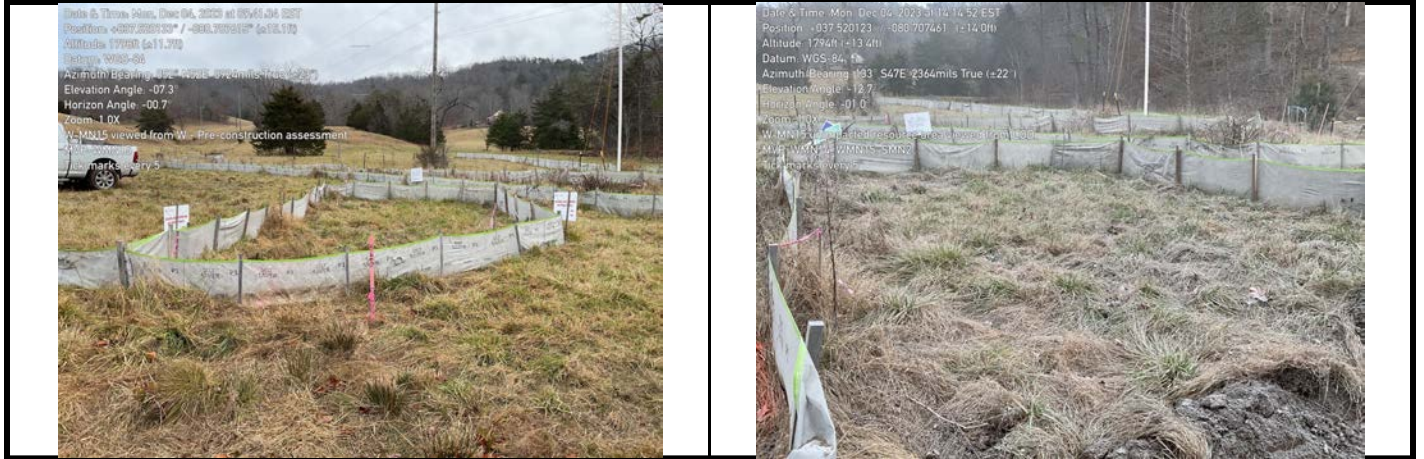
GPS Location	See Photo	GPS Location	See Photo
Description	View of permitted resource impact area during pre-construction assessment.	Description	At edge of LOD, view of unimpacted resource area conditions during pre-construction assessment.

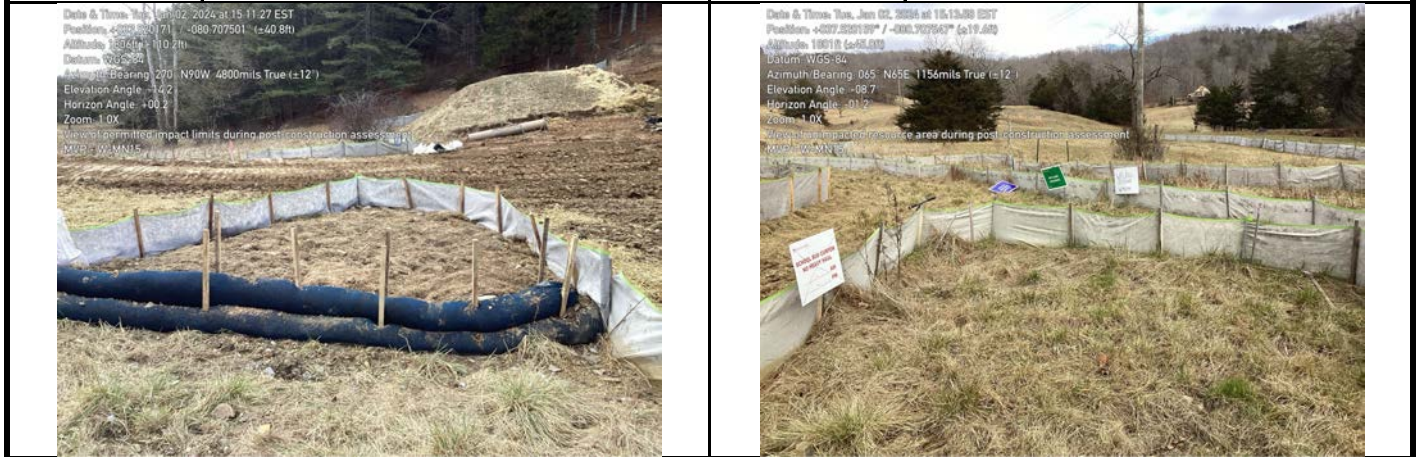
Post Construction Notes
 17. Test pit did not recharge, soils were not saturated.
 19. Crossing has recently been restored. These areas will be monitored until 80% vegetative cover is achieved. Areas that do not have 80% vegetative cover within 30 days will be reseeded.
 Timber mat bridge remains in place for travel lane.

GPS Location	See Photo	GPS Location	See Photo
Description	View of permitted resource impact area during post-construction assessment.	Description	At edge of LOD, view of unimpacted resource area conditions during post-construction assessment.

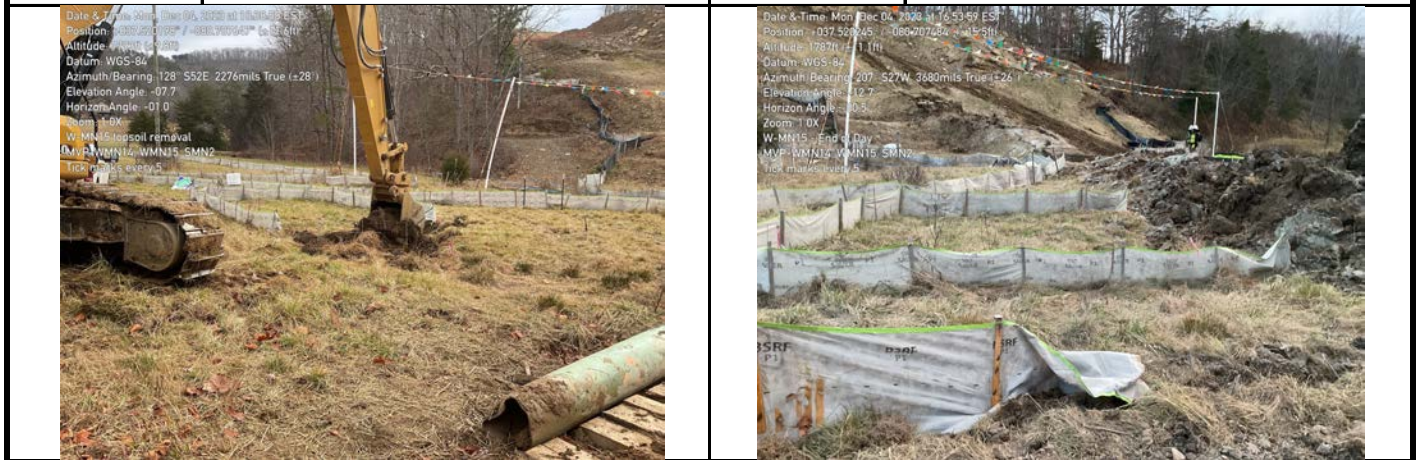
12/04/2023 - Excavated top 12 inches of topsoil (Photo 1). Holes drilled into resource with John Henry, explosive placed for blasting. Blasted (Photo 2). Trenching and welding occurred outside resource area on coming-in side throughout the day.
 12/05/2023 - Excavators removed soil displaced by blasting in aquatic resource. No additional work occurred within aquatic resource. Trenching, hammering and welding occurred outside aquatic resource area throughout the day.
 12/06/2023 - Environmental crew installed silt sock along edge of non-impacted aquatic resource area. No additional work occurred within aquatic resource. Trenching, hammering and welding occurred outside aquatic resource throughout the day.
 12/07/2023 - No work occurred in resource area. Trenching, hammering and welding occurred outside resource throughout the day.
 12/08/2023 - Section of pipe placed on skids over aquatic resource. No additional work occurred within aquatic resource. Welding and coating occurred outside of aquatic resource throughout the day.

GPS Location	See Photo	GPS Location	See Photo
Description	Photo 1: Excavation of top 12 inches of topsoil from aquatic resource.	Description	Photo 2: Aquatic resource post blast.

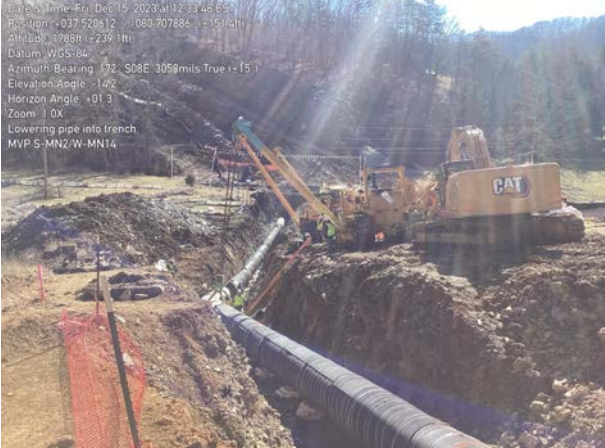
12/09/2023 - No work occurred in aquatic resource area. Welding and backfilling occurred outside aquatic resource area throughout the day.
 12/11/2023 - Rain from previous day resulted in standing water throughout aquatic resource. No work occurred in aquatic resource area. Welding occurred outside aquatic resource area in buffer zone throughout the day.
 12/12/2023-12/13/2023 - No work occurred in aquatic resource area. Welding, sandblasting and coating occurred outside aquatic resource area in buffer zone throughout the day.
 12/14/2023 - Crew marked route of pipe centerline through aquatic resource. Trenching began in resource area. Water pumping intermittently from excavated trench throughout the day and continued overnight. No additional work occurred in resource.
 12/15/23 - No flow in stream. Excavated trench. No pumping. Hammering in trench completed. Lowered pipe into trench (Photo 3). Began welding.

<p><small>Date & Time: Fri, Dec 15, 2023 at 12:33:48 EST Position: +037.520612, -080.707884 (-235.11ft) Altitude: 1788ft (-239.1ft) Datum: WGS-84 Azimuth Bearing: 172.508E 3059mils True (-15.1) Elevation Angle: -14.2 Horizon Angle: +01.3 Zoom: 1.0X Lowering pipe into trench MVP-S-MN2-W-MN14 Tick marks every 5'</small></p>

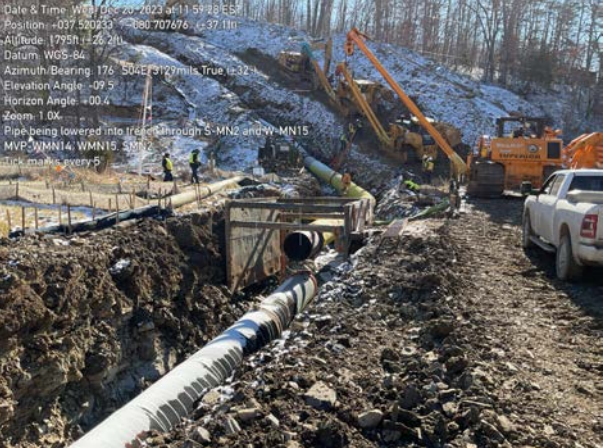
<p><small>Date & Time: Wed, Dec 20, 2023 at 11:59:38 EST Position: +037.520023, -080.707676 (-237.11ft) Altitude: 1795ft (-226.2ft) Datum: WGS-84 Azimuth Bearing: 176.504E 3127mils True (-32.1) Elevation Angle: -09.5 Horizon Angle: +00.4 Zoom: 1.0X Placing lowered pipe into trench through S-MN2 and W-MN15 MVP-S-MN14, W-MN15, SMN2 Tick marks every 5'</small></p>
GPS Location See Photo	GPS Location See Photo
Description Photo 3: Pipe placed in trench through aquatic resource.	Description Photo 4: Lowered additional section of pipe into trench through aquatic resource.

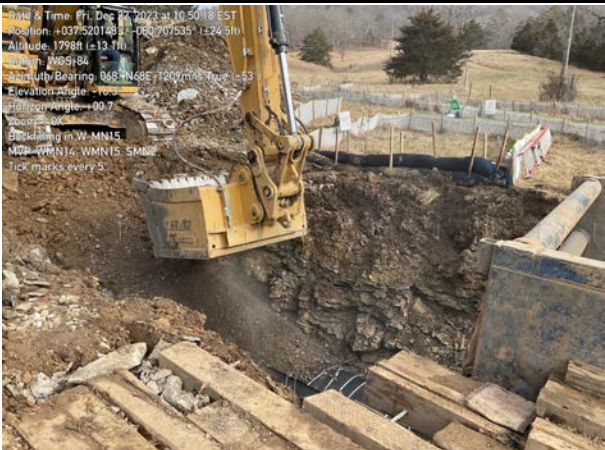
<p><small>Date & Time: Fri, Dec 22, 2023 at 10:50:18 EST Position: +037.52014831, -080.707535 (-224.5ft) Altitude: 1798ft (-13.7ft) Datum: WGS-84 Azimuth Bearing: 068.7148E 1207mils True (-43.1) Elevation Angle: -16.5 Horizon Angle: +00.7 Zoom: 1.0X Backfilling in W-MN15 MVP-W-MN14, W-MN15, SMN2 Tick marks every 5'</small></p>

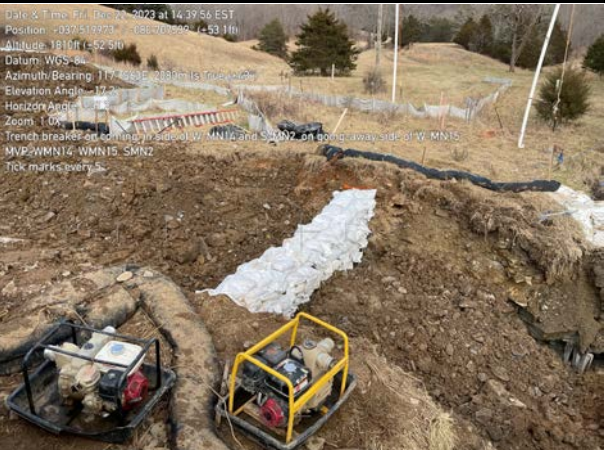
<p><small>Date & Time: Fri, Dec 22, 2023 at 14:39:56 EST Position: +037.519923, -080.706992 (-43.1ft) Altitude: 1810ft (-52.2ft) Datum: WGS-84 Azimuth Bearing: 117.448E 2089mils True (-16.1) Elevation Angle: -17.5 Horizon Angle: +00.3 Zoom: 1.0X Trench breaker and backfilling in S-MN2 on back side of W-MN15 MVP-W-MN14, W-MN15, SMN2 Tick marks every 5'</small></p>
GPS Location See Photo	GPS Location See Photo
Description Photo 5: Backfilling of trench.	Description Photo 6: Trench breaker and backfilling.

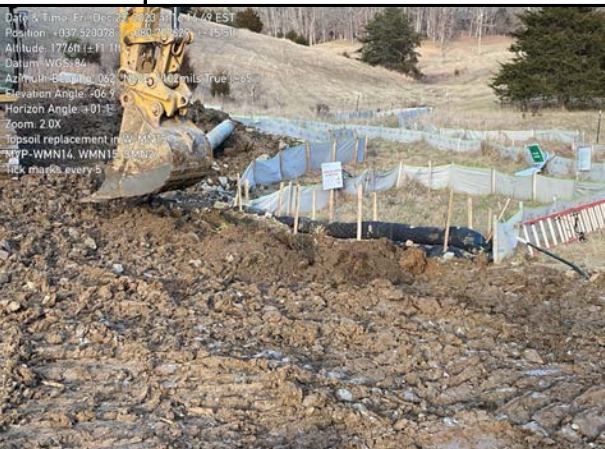
<p><small>Date & Time: Fri, Dec 22, 2023 at 14:27:07 EST Position: +037.520076, -080.707515 (-224.5ft) Altitude: 1776ft (-17.1ft) Datum: WGS-84 Azimuth Bearing: 308.308E 3333mils True (-33.1) Elevation Angle: +06.5 Horizon Angle: +01.5 Zoom: 2.0X Topsoil replacement in W-MN15 MVP-W-MN14, W-MN15, SMN2 Tick marks every 5'</small></p>

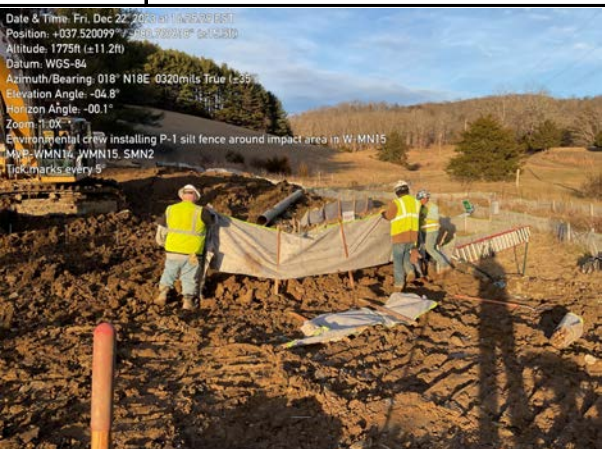
<p><small>Date & Time: Fri, Dec 22, 2023 at 10:27:55 EST Position: +037.520099, -080.708016 (-224.5ft) Altitude: 1779ft (-11.2ft) Datum: WGS-84 Azimuth Bearing: 018.118E 0320mils True (-33.1) Elevation Angle: -04.9 Horizon Angle: -00.1 Zoom: 1.0X Environmental crew installing P-1 silt fence around impact area in W-MN15 MVP-W-MN14, W-MN15, SMN2 Tick marks every 5'</small></p>
