# Wetland Biological Conditions EA Report

<b>Project Name</b>	H-600 Pipeline Spread F	<b>A/E</b>	124300135	<b>Spread</b>	H-600 Pipeline Spread F
<b>Contractor</b>	Price Gregory	<b>Report #</b>	151		
<b>Environmental Auditor</b>	Eric Schicker	<b>Date/Time</b>	12/12/2023 7:21 AM		
<b>Wetland ID</b>	W-MN18-PEM	<b>Crossing Start Date</b>	12/12/2023	<b>Crossing Completion Date</b>	12/21/2023
<b>Milepost</b>	188.80	<b>Pre-Con Assessment Date</b>	12/11/2023	<b>Post-Con Assessment Date</b>	12/21/2023
<b>Station</b>	9968+64	<b>Cowardin Classification</b>	PEM	<b>Wetland Impact Area(acres)</b>	0.0510
<b>State</b>	WV				
<b>County</b>	Monroe

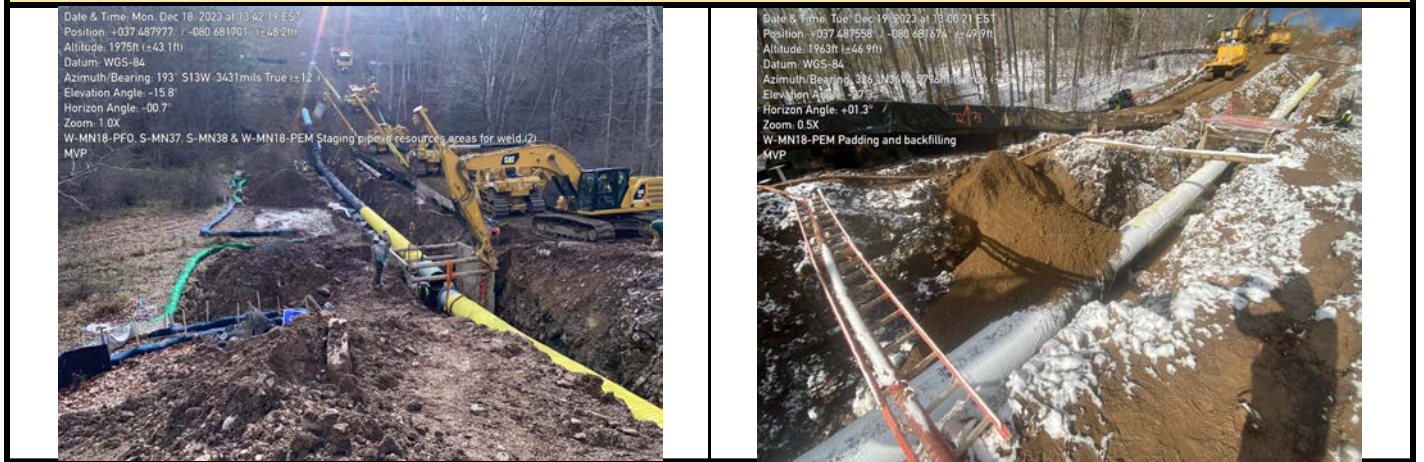
12/18/2023 - Pumped water from aquatic resource areas. Minor excavating. Placed trench box into trench adjacent to aquatic resource. Sandbags added to trench for padding. Lowered pipe into trench. Staged pipe and began welding (Photo 3).

12/19/2023 - Restaged pipe through aquatic resource area for welding. Welding completed. Pumped from trench in aquatic resource area. Padded and backfilled subsoil in aquatic resource area (Photo 4). X-rayed. Continued to pad and backfill. Began constructing trench breaker.

<b>GPS Location</b>	See Photo	<b>GPS Location</b>	See Photo
<b>Description</b>	Photo 3: Staging pipe in resource area for welding.	<b>Description</b>	Photo 4: Padding and backfilling.

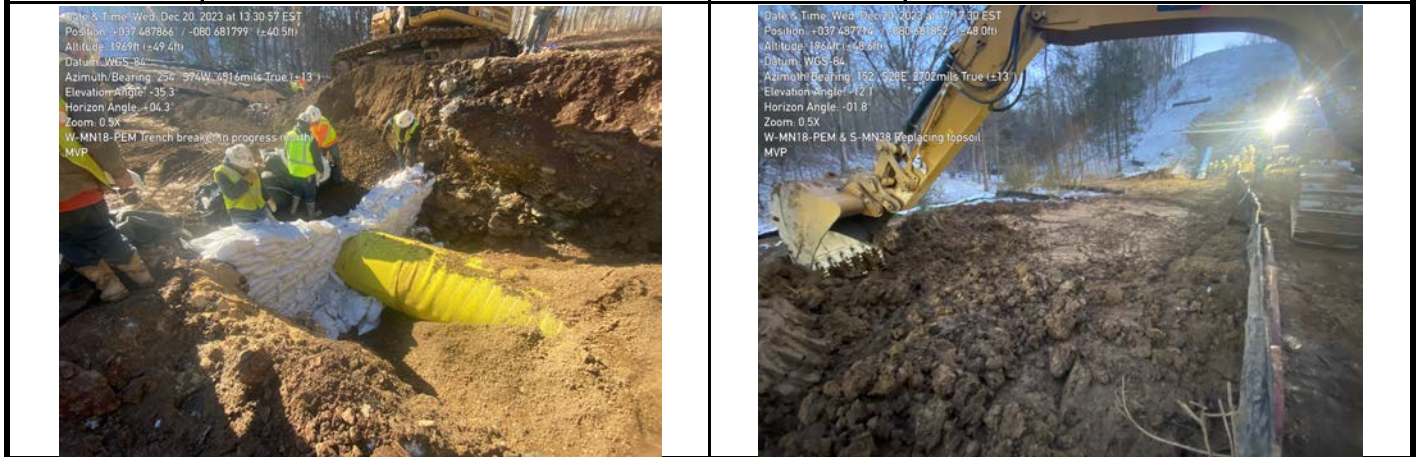
12/20/2023 - Continued to construct trench breaker (Photo 5). Backfilled subsoil in aquatic resource area. Removed trench box. Timber mat placed in aquatic resource area for backfilling. Continued to backfill. Restored topsoil in aquatic resource (Photo 6).

<b>GPS Location</b>	See Photo	<b>GPS Location</b>	See Photo
<b>Description</b>	Photo 5: Constructing trench breaker.	<b>Description</b>	Photo 6: Restoring topsoil.

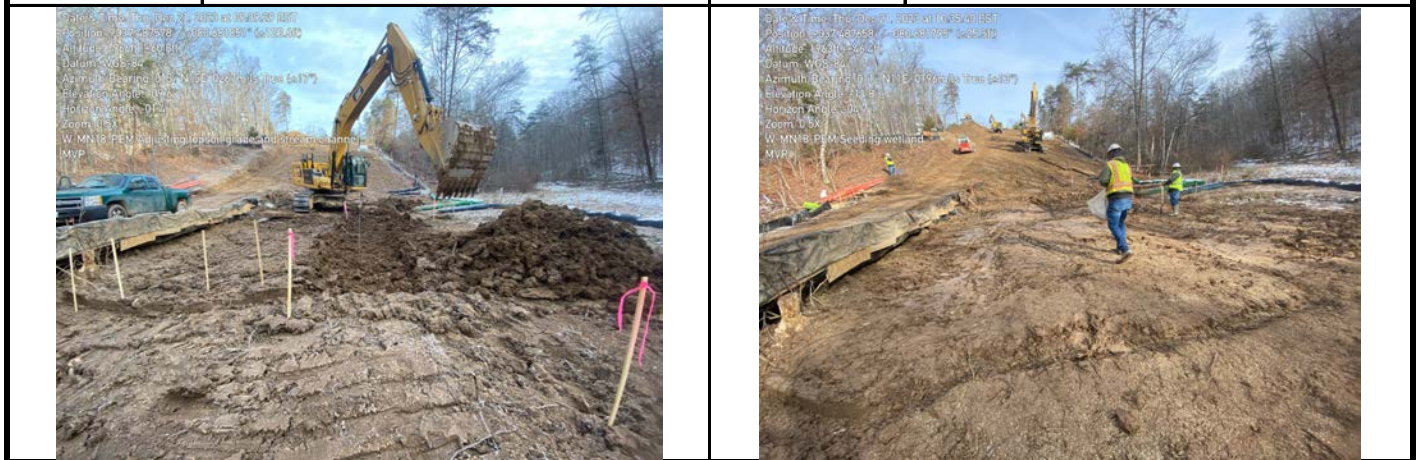
12/21/2023 - Survey onsite. Survey evaluated elevations. Adjusted grade (Photo 7). Seeded (Photo 8). Applied jute. Installed P1 fencing.

<b>GPS Location</b>	See Photo	<b>GPS Location</b>	See Photo
<b>Description</b>	Photo 7: Adjusted grade of wetland.	<b>Description</b>	Photo 8: Seeding wetland.
