Wetland Biological Conditions EA Report

Project Name	H-600 Pipeline Spread F	A/E	124300135	Spread	H-600 Pipeline Spread F
Contractor	Price Gregory	Report #	153		
Environmental Auditor	Eric Schicker			Date/Time	12/13/2023 2:57 PM
Wetland ID	W-MN24	Crossing Start Date	12/14/2023	Crossing Completion Date	12/22/2023
Milepost	191.05	Pre-Con Assessment Date	11/28/2023	Post-Con Assessment Date	12/22/2023
Station	10087+62	Cowardin Classification	PEM	Wetland Impact Area(acres)	0.0100
State	WV				
County	Monroe

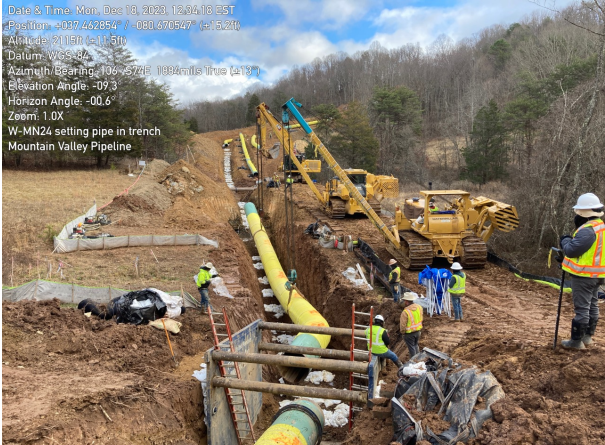
<p><small>Date & Time: Thu, Dec 21, 2023 10:24:06 EST Position: +037.462772 N, -080.670026 W (-17.6) Altitude: 2086ft (-58.3ft) Datum: WGS-84 Azimuth/Bearing: 208.586W 4729mils True (-14) Elevation Angle: -07.9 Horizon Angle: -02.4 Zoom: 1.0X W-MN24 completed trench breakers Mountain Valley Pipeline</small></p>
