Stream Biological Conditions EA Report

Project Name	H-600 Pipeline Spread D	AFE	124300129	Spread	H-600 Pipeline Spread D
Contractor	Precision	Report #	503		
Environmental Auditor	Scott Wessel	Date/Time	2/8/2024 11:09 AM		
Stream ID	S-A69	Crossing Start Date	2/8/2024	Crossing Completion Date	2/17/2024
Milepost	115.65	Pre-Con Assessment Date	2/2/2024	Post-Con Assessment Date	2/18/2024
Station	6106+37	Bankfull Width (ft.)	6.0	Riffle:Pool Complexes Present?	No
State	WV	Stream Classification	Intermittent		
County	Nicholas	303(d) Impairment Listing	No

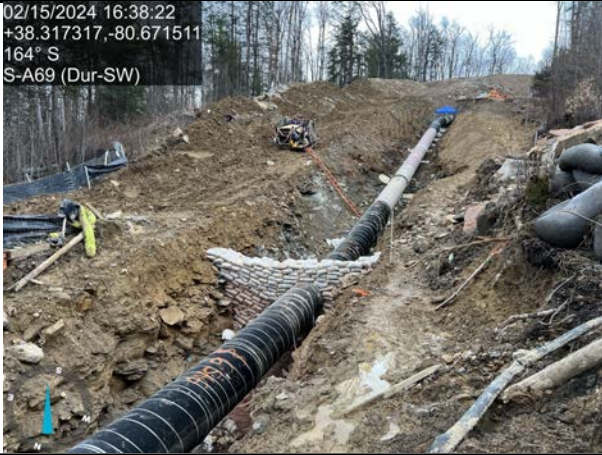
<p>GPS Location See coordinates in above photo.</p>		<p>GPS Location See coordinates in above photo.</p>			
<p>Description Contractor lowering in pipe section for resource crossing.</p>		<p>Description Trench breaker being constructed on the GAS of resource.</p>			
<p>02/17/2024 14:56:56 +38.317163,-80.671484 190° S S-A69 (Dur-SW)</p>

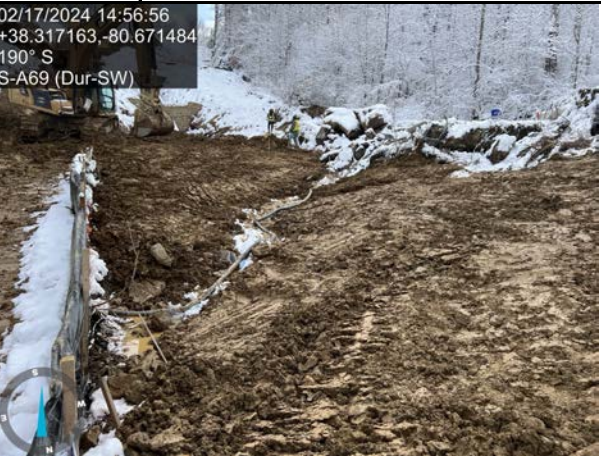
<p>02/17/2024 15:30:33 +38.317560,-80.671567 159° S S-A69 (Dur-SW)</p>  			
<p>GPS Location See coordinates in above photo.</p>		<p>GPS Location See coordinates in above photo.</p>			
<p>Description Contractor working on re-contouring stream and buffer zone in preparation for topsoil.</p>		<p>Description Stream substrate material being put back once elevations were verified by survey.</p>
