STREAM BIOLOGICAL CONDITIONS ENVIRONMENTAL AUDITOR REPORT

Stream ID: S-P6	Crossing Start Date: 02/06/2024	Crossing Completion Date: 02/09/2024
Milepost: 200.2	Pre-Con Assessment Date: 02/02/2024	Post-Con Assessment Date: 02/09/2024
Station: 10578+11	Stream Classification: Ephemeral (Perennial, Intermittent, Ephemeral)	Bankfull Width (ft.): 3
County: Giles	303(d) Impairment Listing: Not Impaired	Riffle:Pool Complexes Present? No

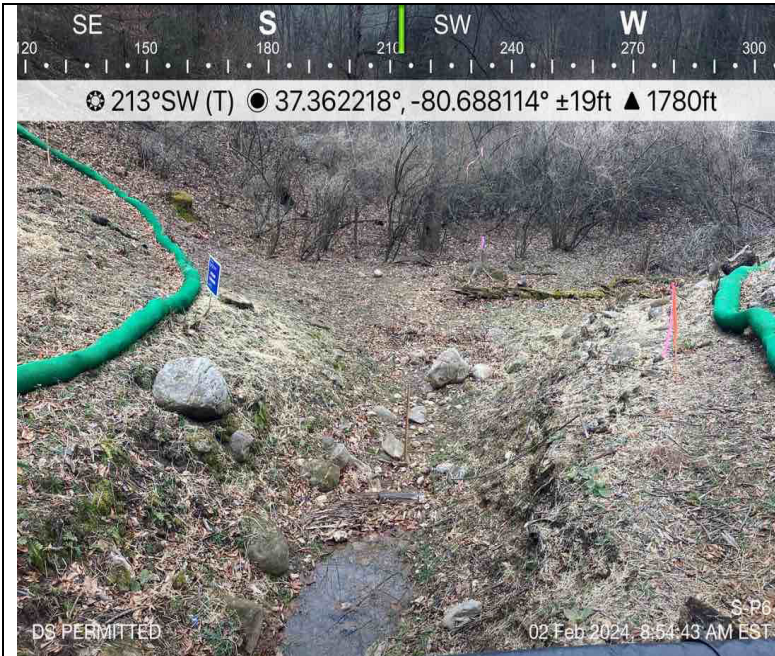
02/02/2024- Pre-construction meeting held and pre-construction assessment completed. The banks of the stream show signs of erosion near the TMB. MVP EI is Adam Taylor. -A. Breeding

Photo Description: Downstream view of permitted impact area during pre-construction assessment.

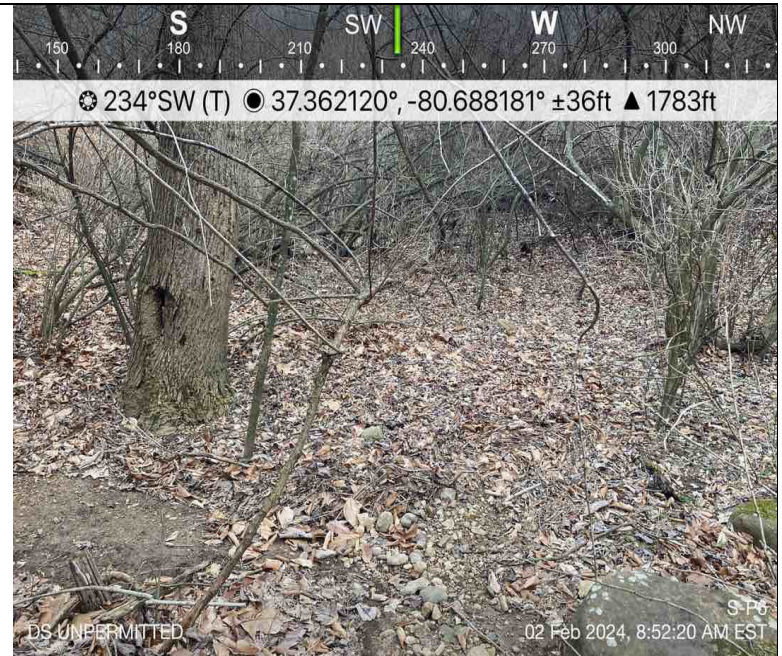
Photo Description: Conditions of the downstream area outside the ROW during pre-construction assessment.

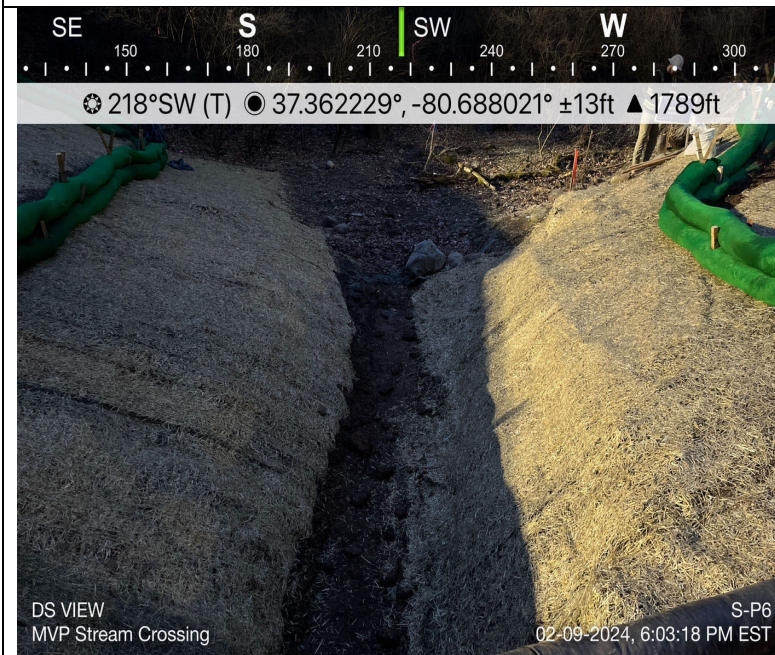
Item #16- Channel conditions rated as marginal due to banks being restored to pre-construction conditions, as per, permit requirements.

Photo Description: Downstream view of permitted impact area during post-construction assessment.

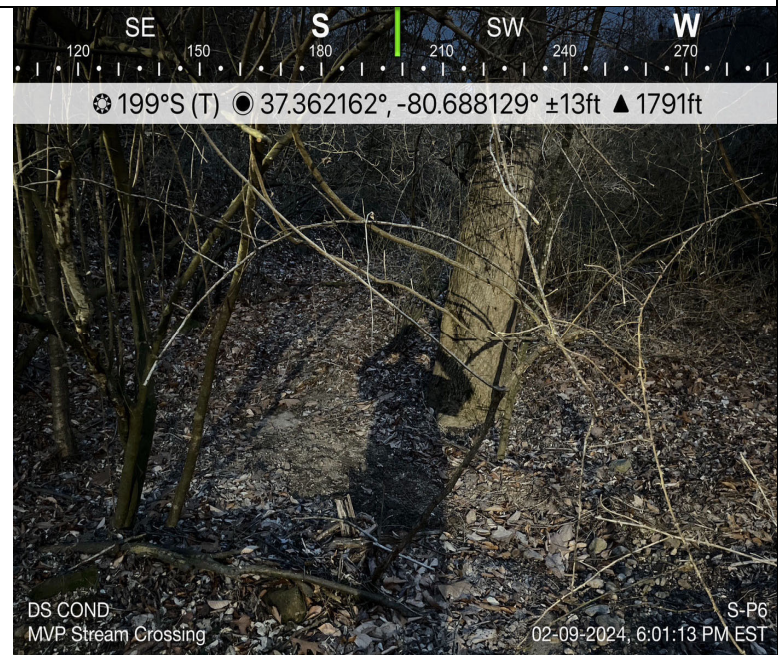
Photo Description: Conditions of the downstream area outside the ROW during post-construction assessment.

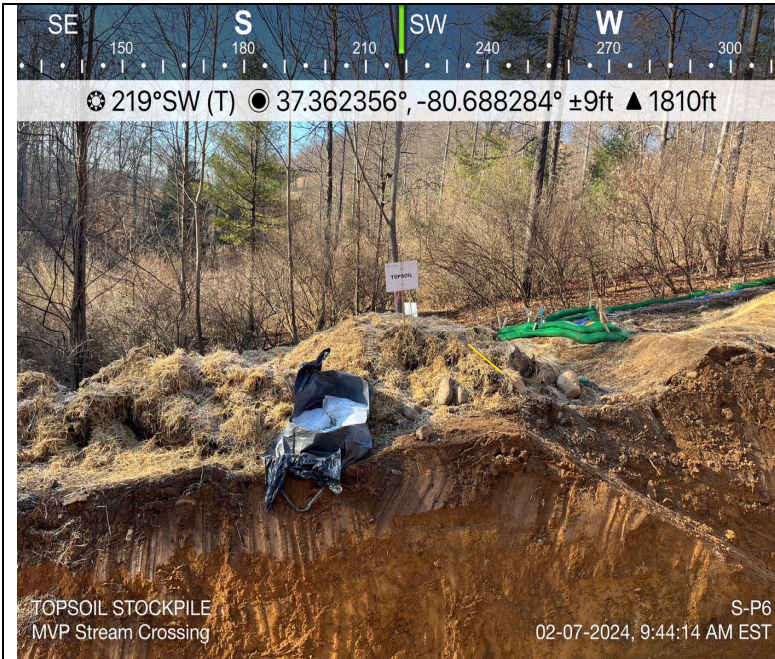
Photo Description: Topsoil stockpile stabilized with straw during resource crossing.

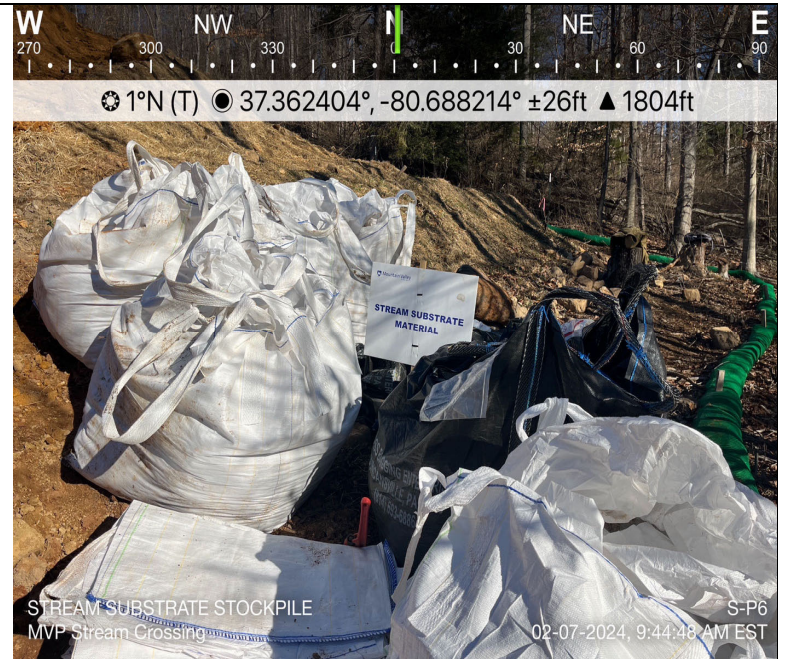
Photo Description: Stream substrate stored inside Super Saks.

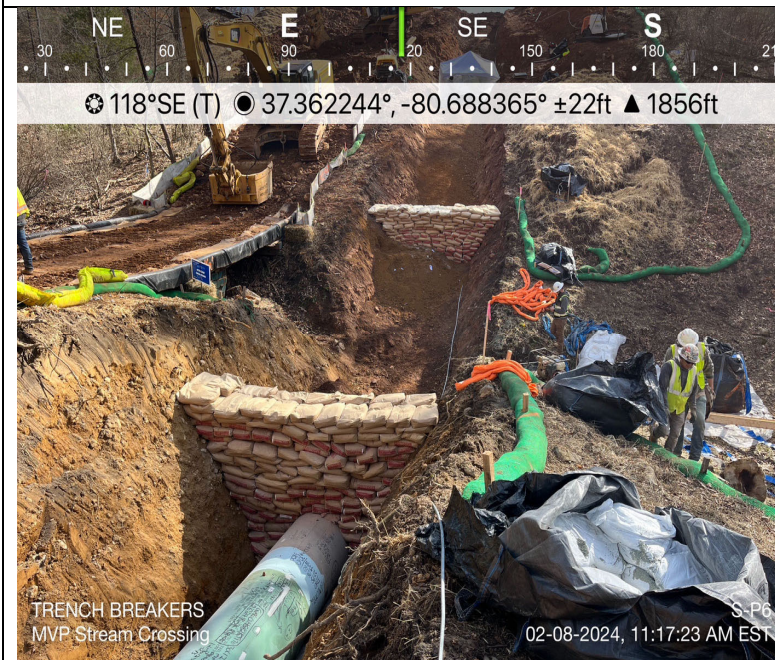
Photo Description: Trench breakers installed in upland areas adjacent to resource.

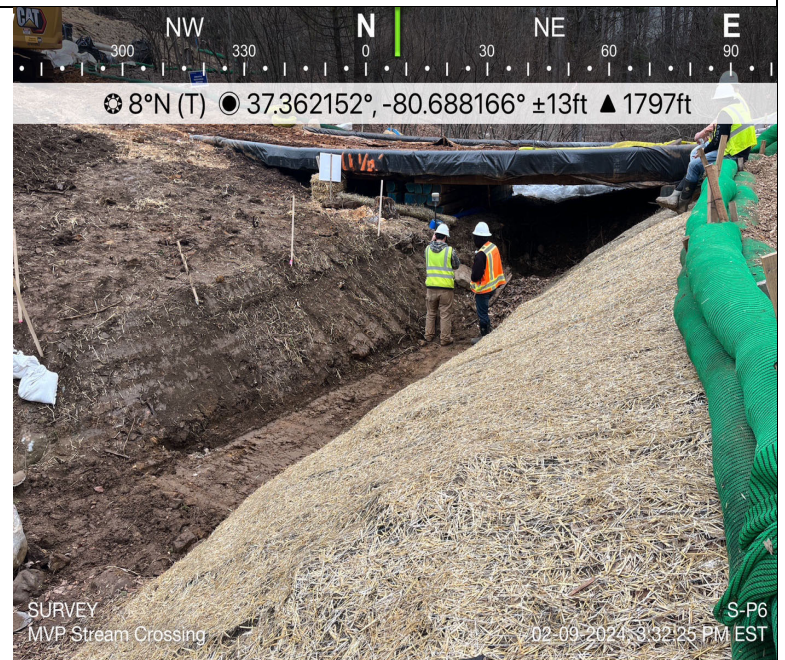
Photo Description: Survey on site assisting with restoration to pre-construction conditions.
