STREAM BIOLOGICAL CONDITIONS ENVIRONMENTAL AUDITOR REPORT

Stream ID: S-Q2	Crossing Start Date: 10/30/2023	Crossing Completion Date: 02/02/2024
Milepost: 296.6	Pre-Con Assessment Date: 10/30/2023	Post-Con Assessment Date: 02/02/2024
Station: 15669+44	Stream Classification: Perennial (Perennial, Intermittent, Ephemeral)	Bankfull Width (ft.): 7
County: Pittsylvania	303(d) Impairment Listing: Not Impaired	Riffle:Pool Complexes Present? No

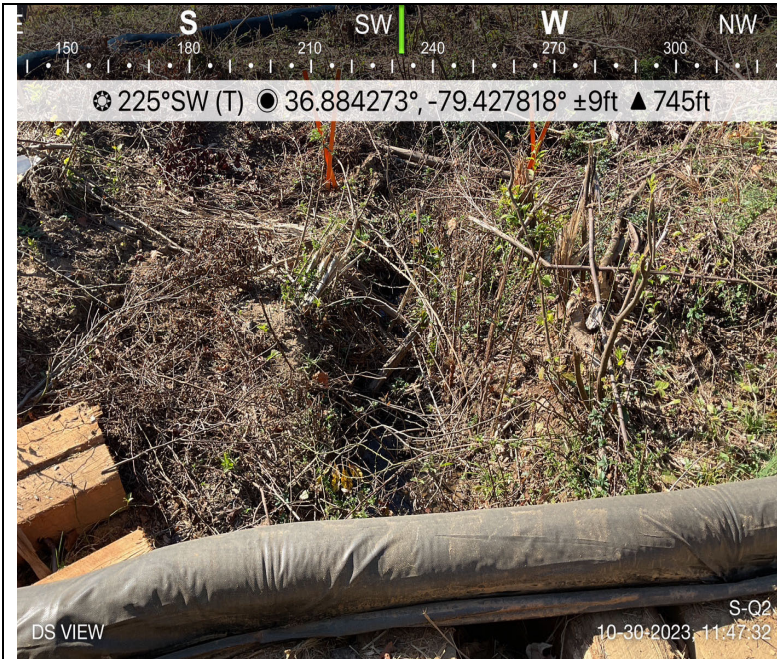
Photo Description: Downstream view of permitted impact area during pre-construction assessment.

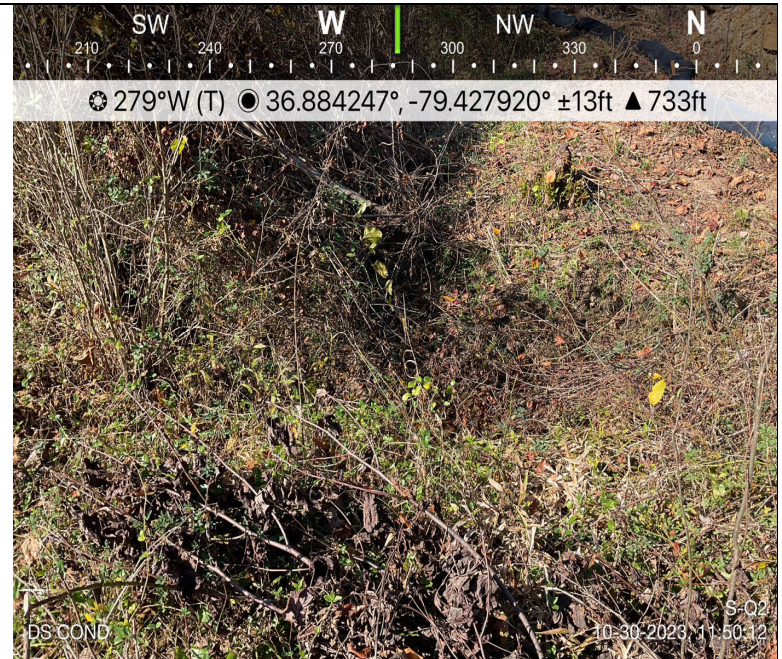
Photo Description: Conditions of the downstream area outside the ROW during pre-construction assessment.

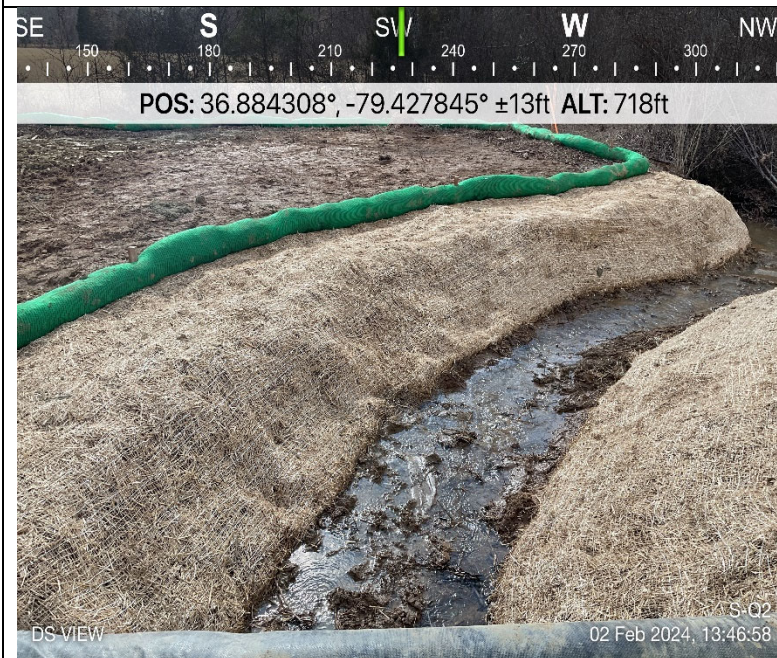
Photo Description: Downstream view of permitted impact area during post-construction assessment.

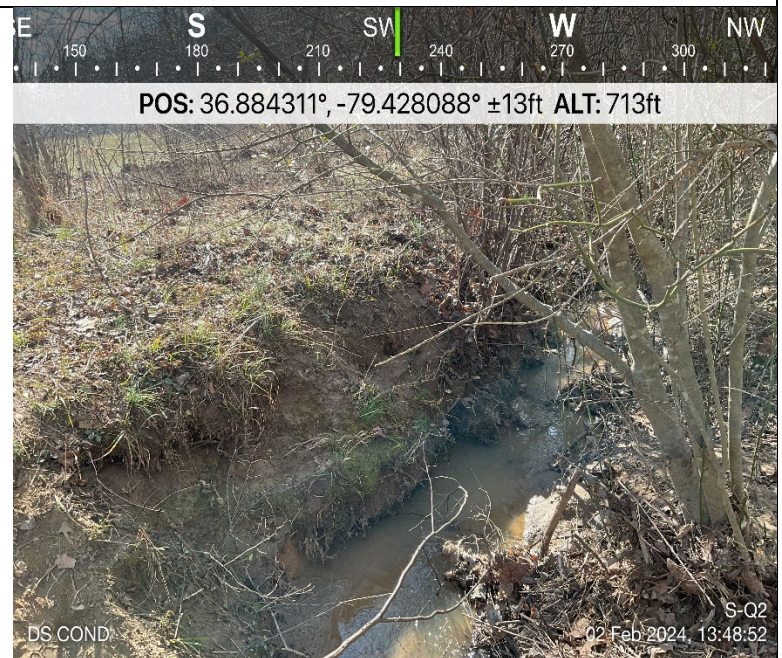
Photo Description: Conditions of the downstream area outside the ROW during post-construction assessment.

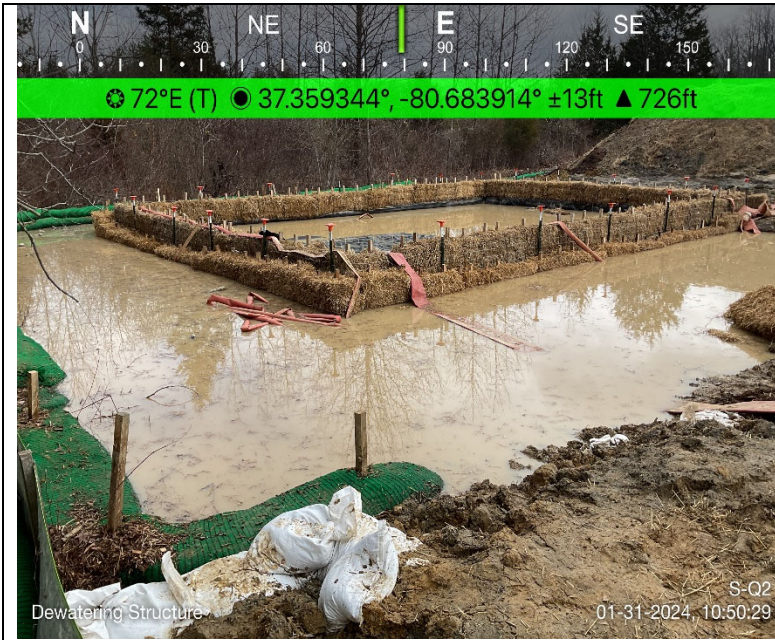
Photo Description: Dewatering operation required maintenance throughout crossing due to groundwater quantity, and controls were continually replaced/enhanced as needed to control turbidity to extent practicable.

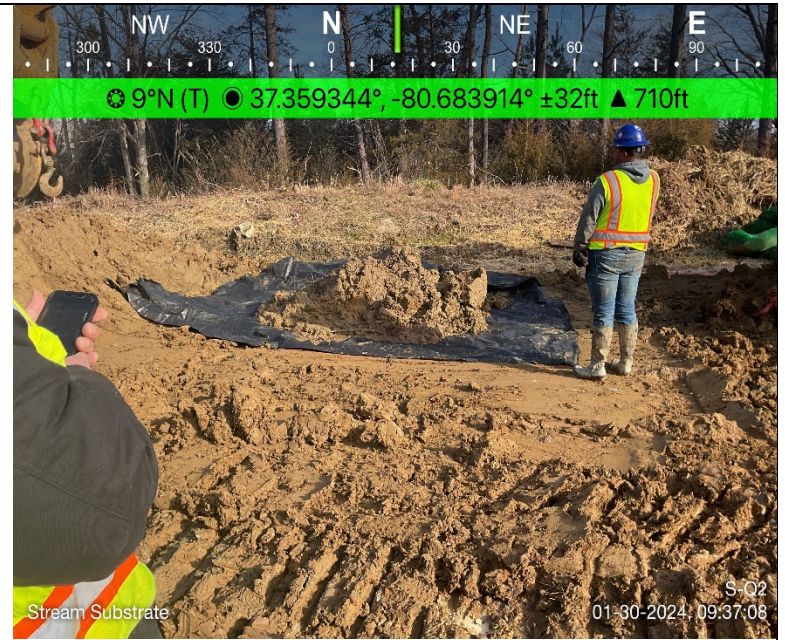
Photo Description: Stream substrate removed and stockpiled separately from sub soil.

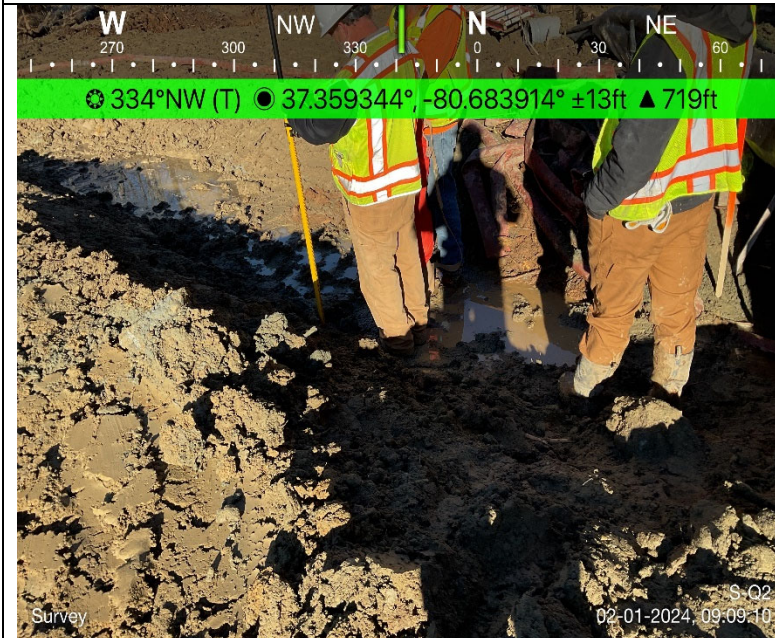
Photo Description: Survey team on site during restoration to assist with reconfiguring stream to pre-construction contours.

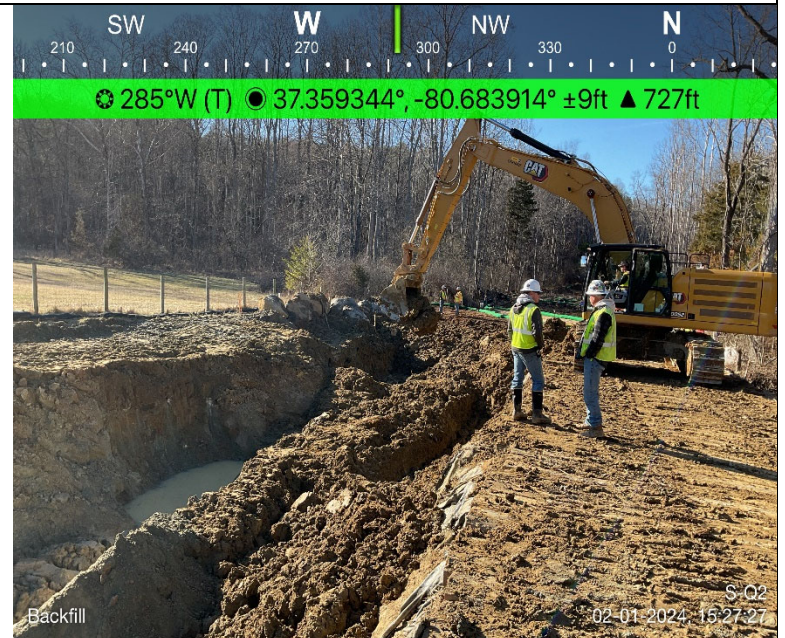
Photo Description: Backfill of trench with subsoil.
