Wetland Biological Conditions EA Report

Project Name	H-600 Pipeline Spread D	AFE	124300132	Spread	H-600 Pipeline Spread D
Contractor	Precision	Report #	161		
Environmental Auditor	Scott Wessel			Date/Time	1/15/2024 10:59 AM
Wetland ID	W-A15	Crossing Start Date	1/15/2024	Crossing Completion Date	2/1/2024
Milepost	115.14	Pre-Con Assessment Date	1/13/2024	Post-Con Assessment Date	2/2/2024
Station	6079+38	Cowardin Classification	PSS	Wetland Impact Area(acres)	0.0891
State	WV				
County	Nicholas

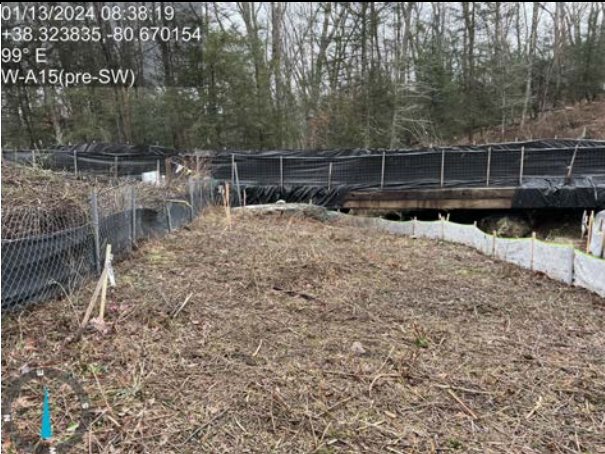
<p>01/13/2024 08:38:19 +38.323835,-80.670154 99° E W-A15(pre-SW)</p>

GPS Location	See coordinates in above photo.	GPS Location	See coordinates in above photo.
Description	View of permitted resource impact area during pre-construction assessment.	Description	At edge of LOD, view of unimpacted resource area conditions during pre-construction assessment.
<p>02/02/2024 14:18:26 +38.323834,-80.670108 91° E W-A15 (Post-SW)</p>

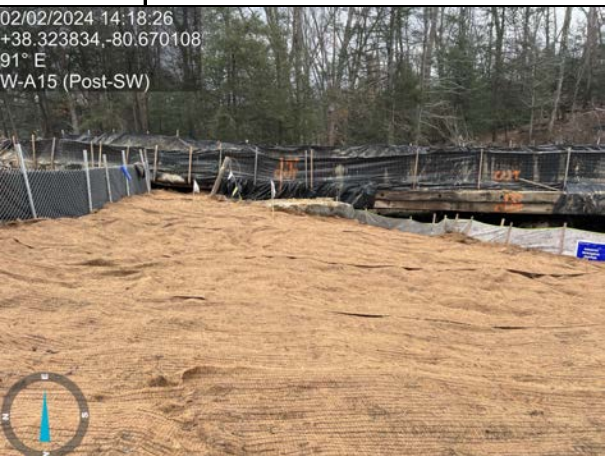
Conditions 18 and 19 were given a rating of 4 due to the lack of vegetation in the disturbed permitted impact area following completion of the crossing and restoration efforts. Wetland W-A15 PSS topsoil was properly stabilized and the disturbed area has been seeded with the appropriate permanent seed mix in accordance with Appendix B: Restoration Work Plan of the Mountain Valley Pipeline Comprehensive Stream and Wetland Monitoring, Restoration and Mitigation Framework.

GPS Location	See coordinates in above photo.	GPS Location	See coordinates in above photo.
Description	View of permitted resource impact area during post-construction assessment.	Description	At edge of LOD, view of unimpacted resource area conditions during post-construction assessment.
<p>01/15/2024 14:28:04 +38.324097,-80.670008 339° N W-A15(dur-SW)</p>

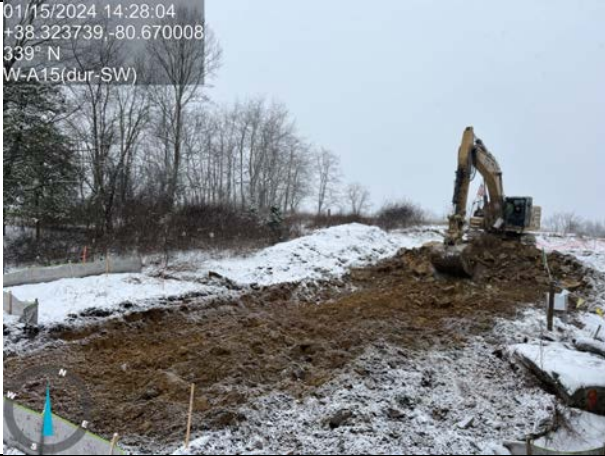
1/15/24 – The top 12" of wetland W-A15 soil was segregated and stockpiled on plastic in an upland area on the coming in side (CIS), while crews continued exposing the loose ends on the CIS and going away side (GAS) of the crossing. Stream crossing S-A73 is inside of the boundaries of wetland W-A15, therefore both resources will be carried out at the same time.

GPS Location	See coordinates in above photo.	GPS Location	See coordinates in above photo.
Description	Removing the topsoil from wetland to be segregated.	Description	Blasting crew on site drilling to set charges.

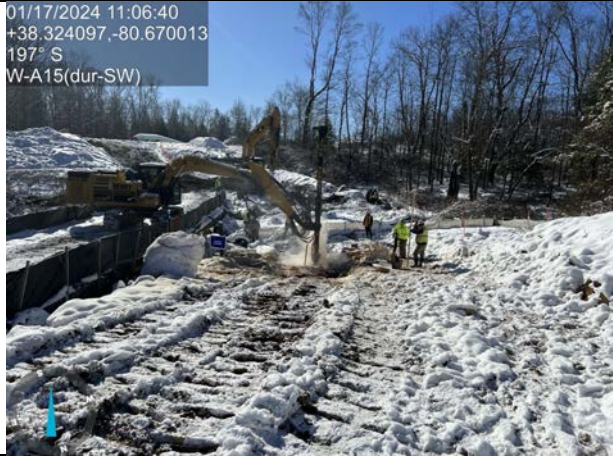
<p>01/17/2024 11:06:40 +38.324097,-80.670013 197° S W-A15(dur-SW)</p>

1/17/24 to 1/18/24 – Blasting operations were conducted throughout the resource area for the next few days.
