STREAM BIOLOGICAL CONDITIONS ENVIRONMENTAL AUDITOR REPORT

Stream ID: S-C19	Crossing Start Date: 01/15/2024	Crossing Completion Date: 02/24/2024
Milepost: 269.4	Pre-Con Assessment Date: 01/15/2024	Post-Con Assessment Date: 03/01/2024
Station: 14233+68	Stream Classification: Perennial (Perennial, Intermittent, Ephemeral)	Bankfull Width (ft.): 45
County: Franklin	303(d) Impairment Listing: Impaired	Riffle:Pool Complexes Present? Yes

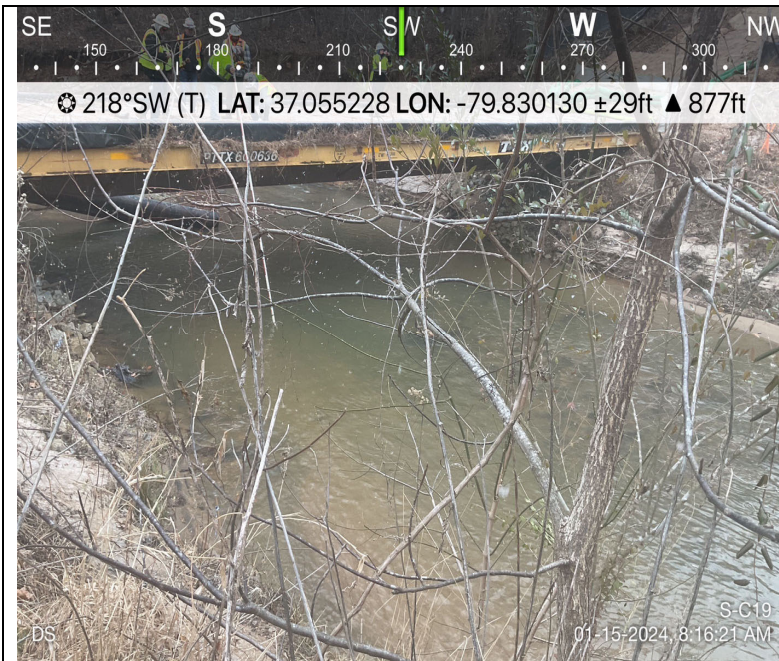
Photo Description: Downstream view of permitted impact area during pre-construction assessment.

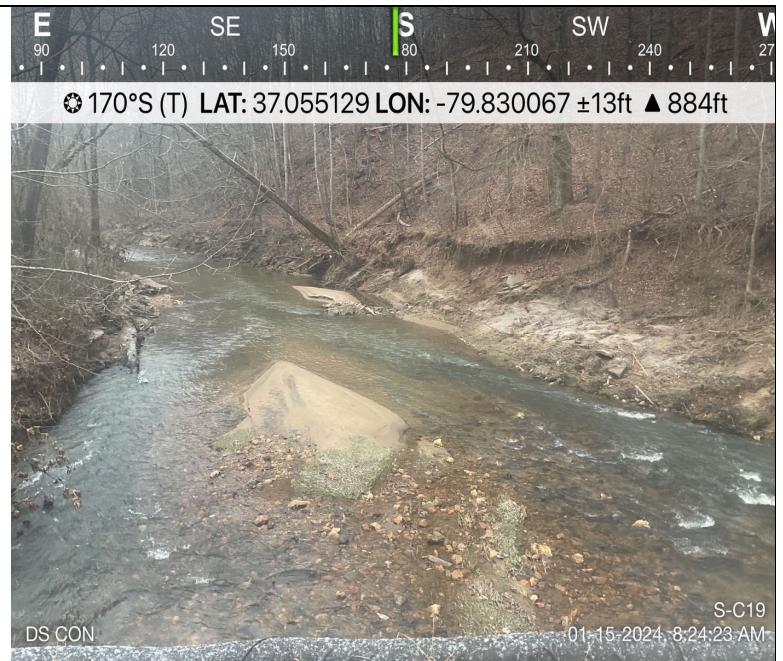
Photo Description: Conditions of the downstream area outside the ROW during pre-construction assessment.

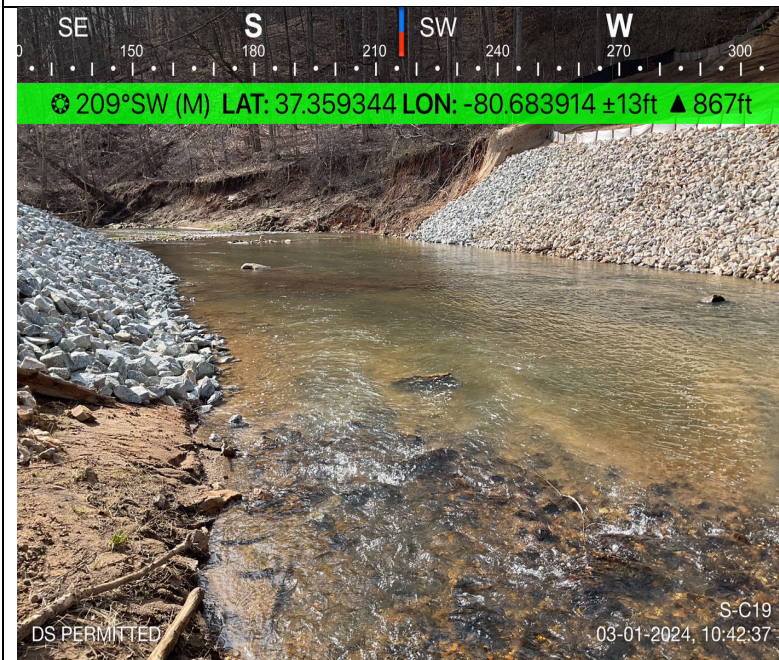
Photo Description: Downstream view of permitted impact area during post-construction assessment.

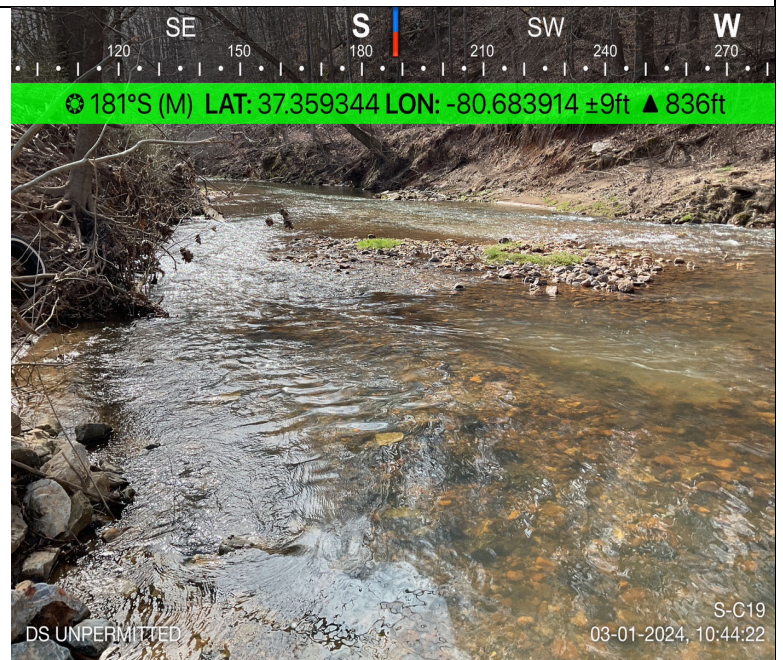
Photo Description: Conditions of the downstream area outside the ROW during post-construction assessment.

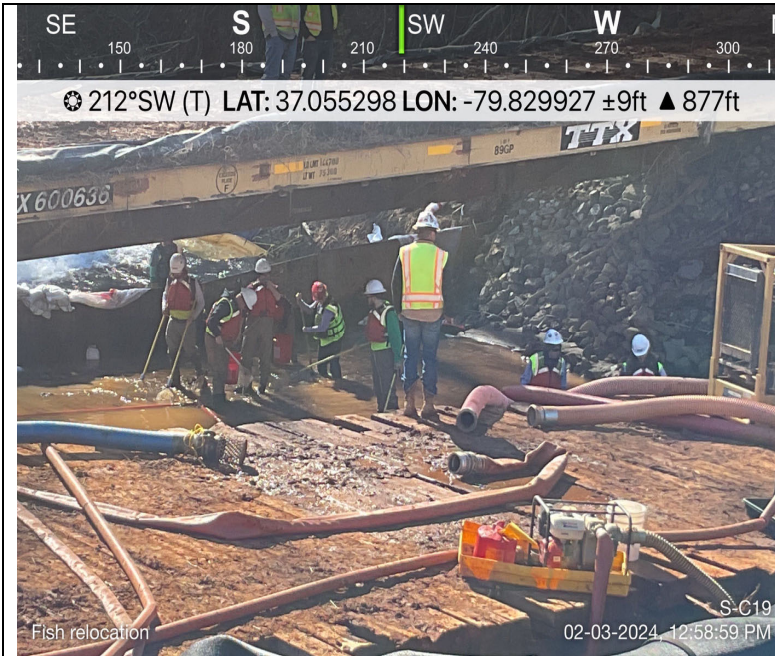
Photo Description: Fish relocation crew on-site removing fish after construction area isolated with dam & pump.

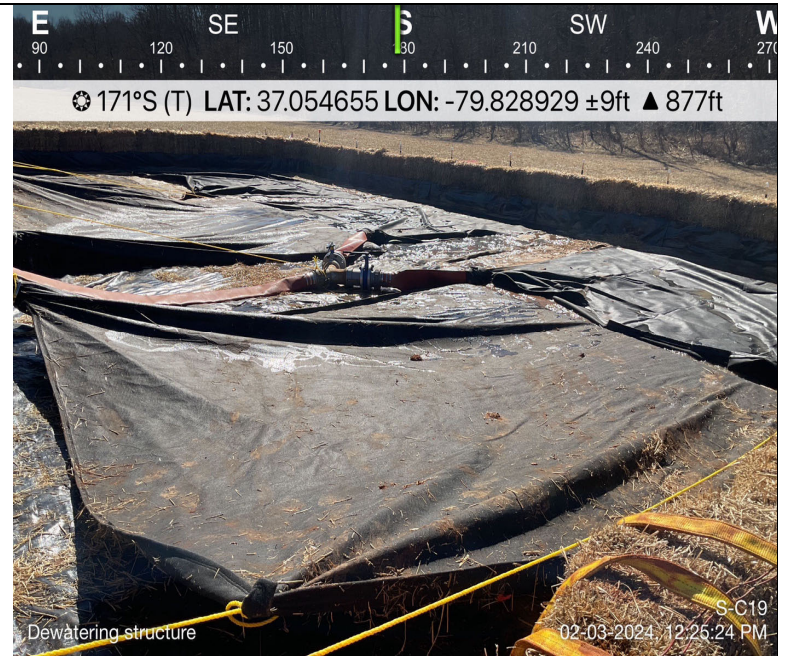
Photo Description: Dewatering structure installed and utilized on-site throughout pipe installation.

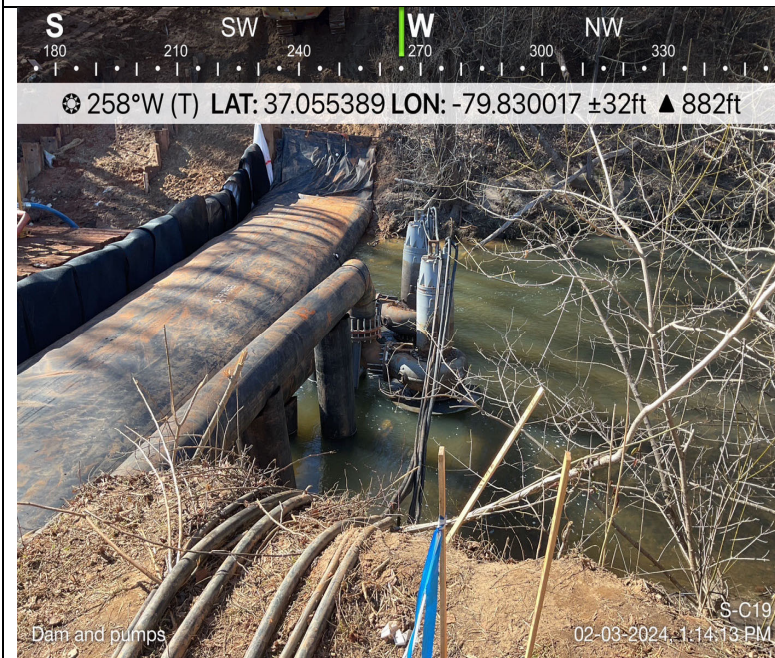
Photo Description: Bladder dam and two 24-inch pumps used for dam and pump around.

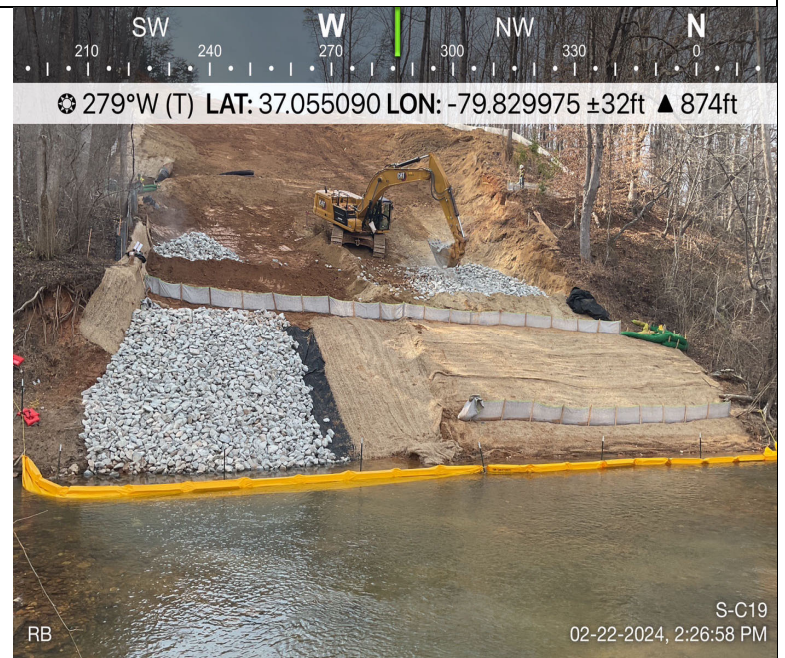
Item #8 & #19: Stream modifications and alterations include riprap streambank stabilizations on both right and left banks. -T. Turner Jr.

Photo Description: Installation of rip rap along stream banks to aid in long-term stability of pipeline crossing.

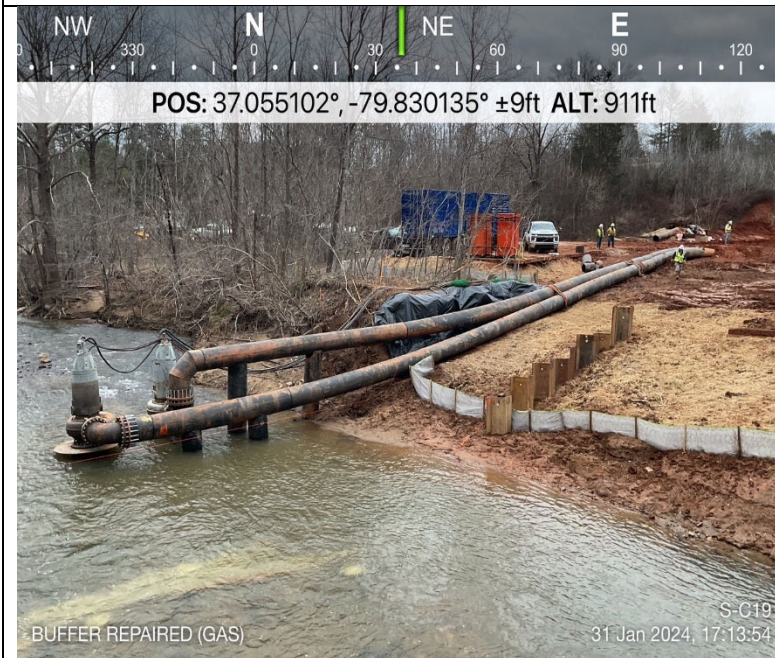
Photo Description: 10' FERC buffer restored (GAS).

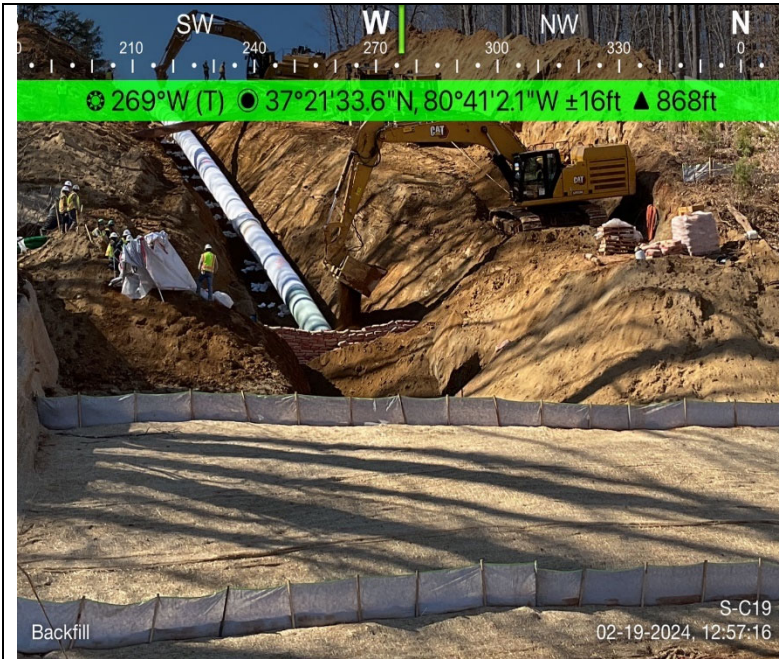
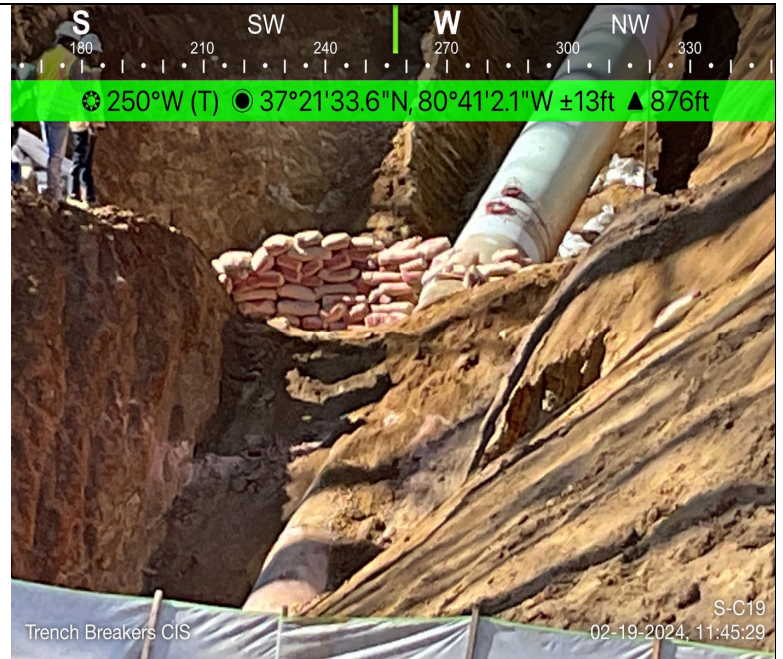
Photo Description: Trench breaker installation on CIS

Photo Description: Trench breakers installation on CIS.

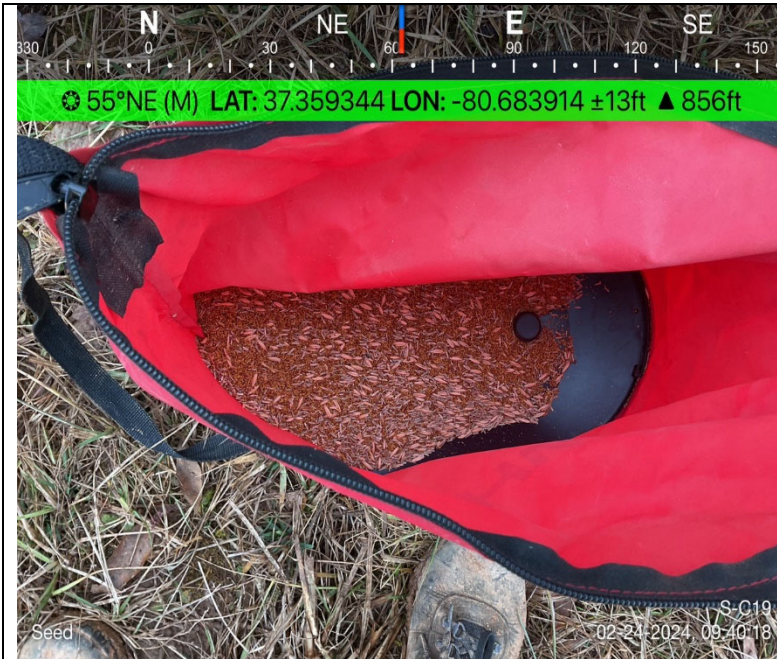
Photo Description: Seed mix applied to impacted area.

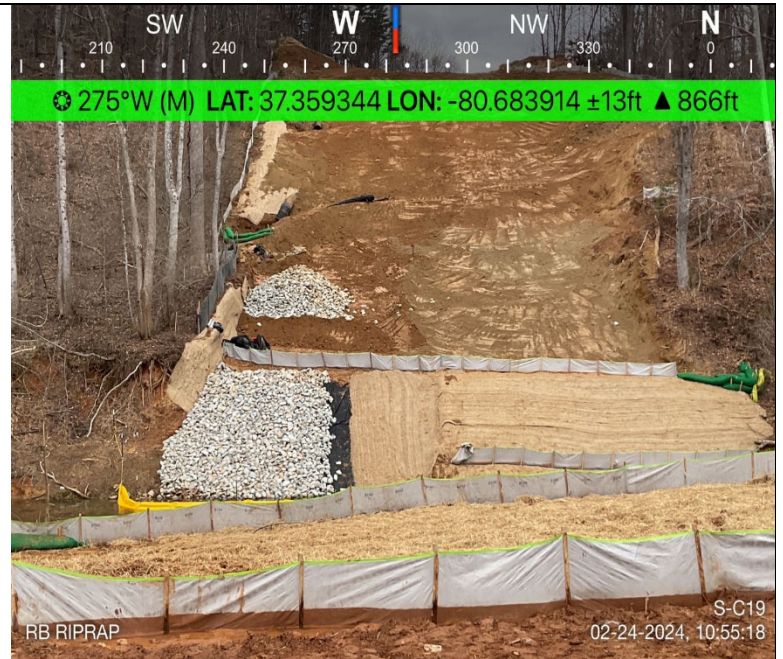
Photo Description: Riprap installation underway on right bank of resource.

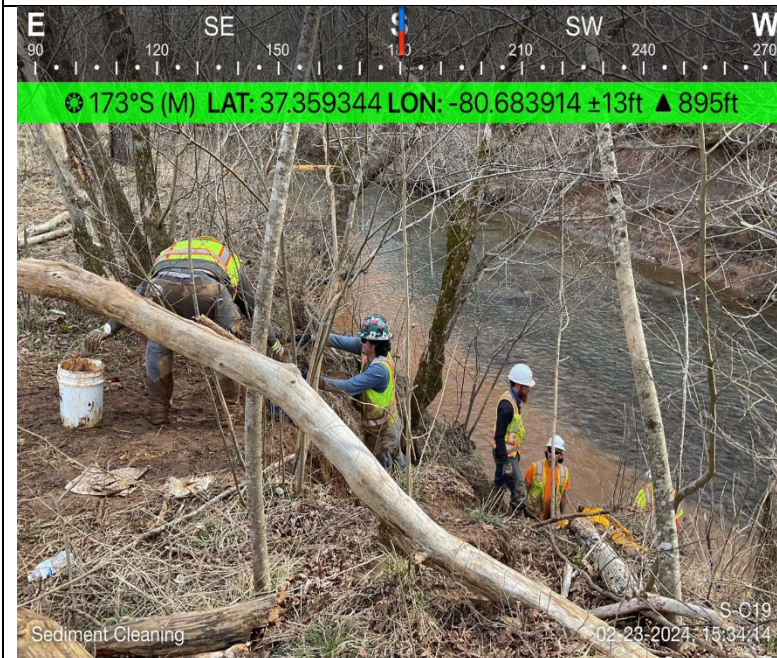
02-23-24: Inclement weather, crews mitigating sediment runoff that has entered resource. Turbidity curtain installed on RB of impact area to settle any sediment material, as well as, non-permitted downstream due to dewatering structure flow eroding bank. Riprap in staging to be installed on right bank of crossing impact area. Impact to resource notifications have been made with supporting photographs -T. Turner Jr.

Photo Description: Cleanup of sediment from downstream area from dewatering structure runoff.

02-24-24: Environmental crews continue with mitigation efforts to remove sediment from resource. Seed and straw (Landowner preferred seed-mix) placed in vegetated areas outside of dewatering structure where sedimentation deposition settled. DEQ staff on-site inspected and cleared restoration effort. Crews removed turbidity curtains from downstream off-ROW area. -T. Turner Jr.

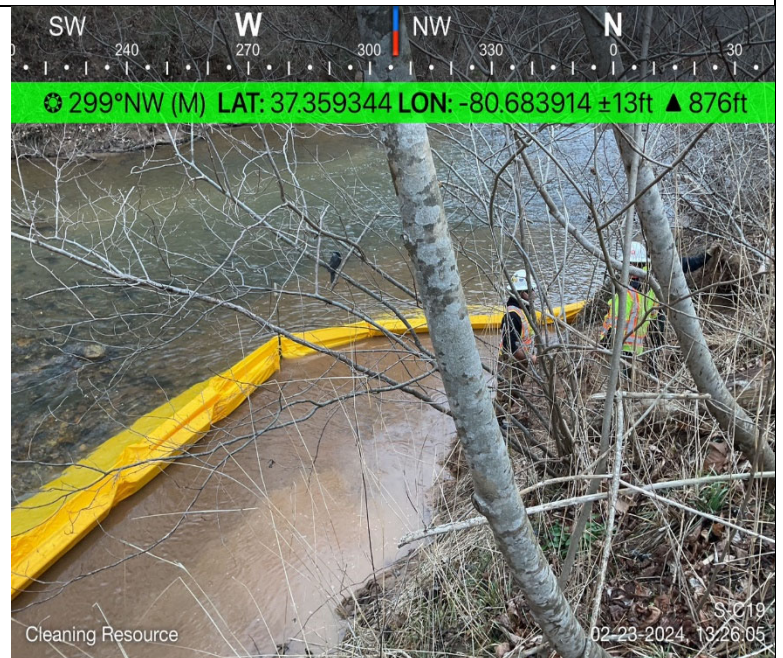
Photo Description: Turbidity curtain installed at areas where streambank erosion or remediations are observed or completed.

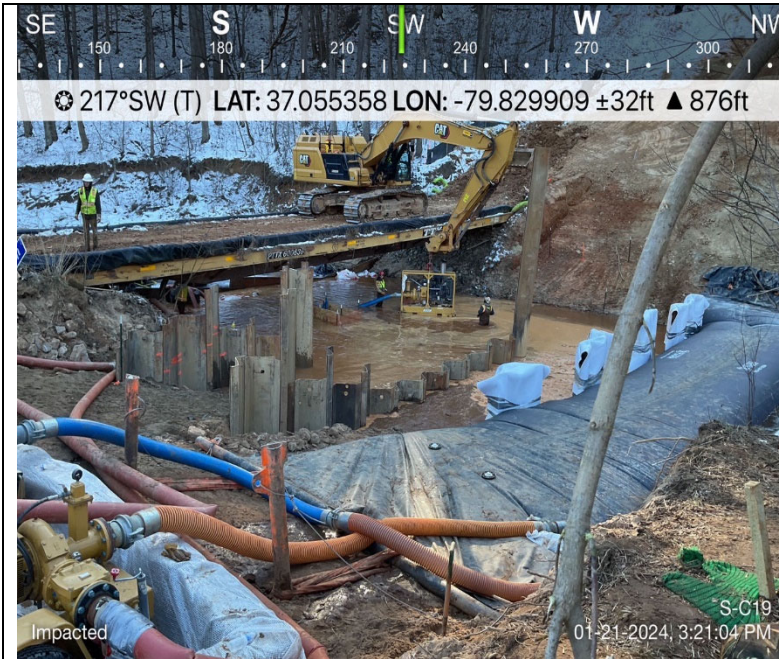
Item #14: During evening site work, the pumps for pump around malfunctioned and had issues staying operational. Stream overflowed bladder dam despite crews adding two 8-inch pumps as support, and flooded the work zone. Unfiltered construction water discharged around downstream dam, but Auditor did not observed sediment accumulate within the observable area from the LOD. 24-inch pumps are back operational, water flow pumped down off of bladder. Crew removed both 8-inch pumps from resource. -D. Fraise

Photo Description: Stream overflowed downstream dam.

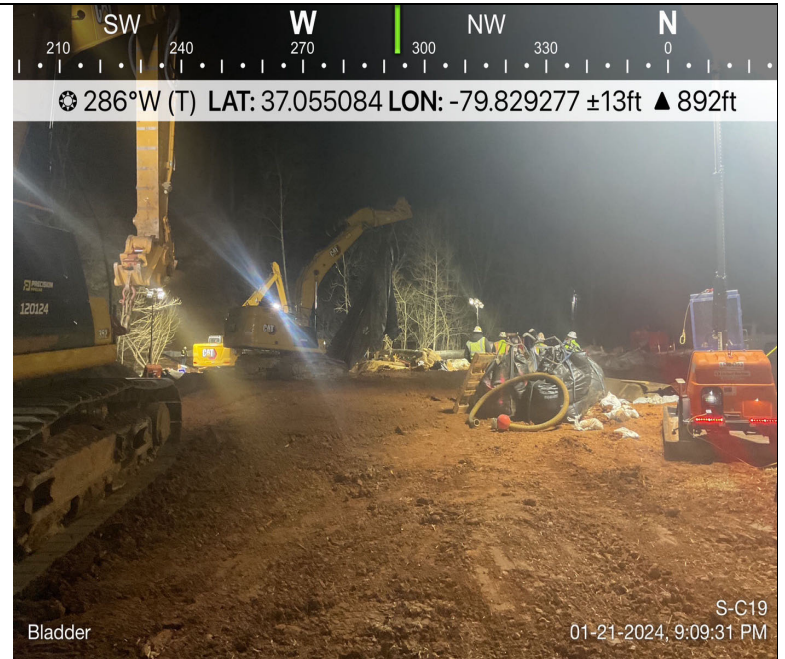
Photo Description: Bladder didn't seal

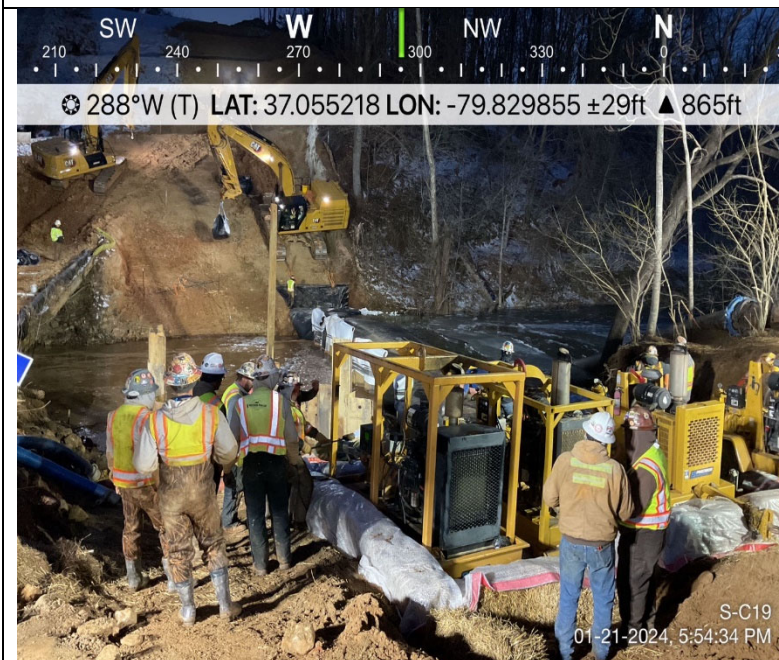
Photo Description: Tried to use back up pumps to hold water off bladder.

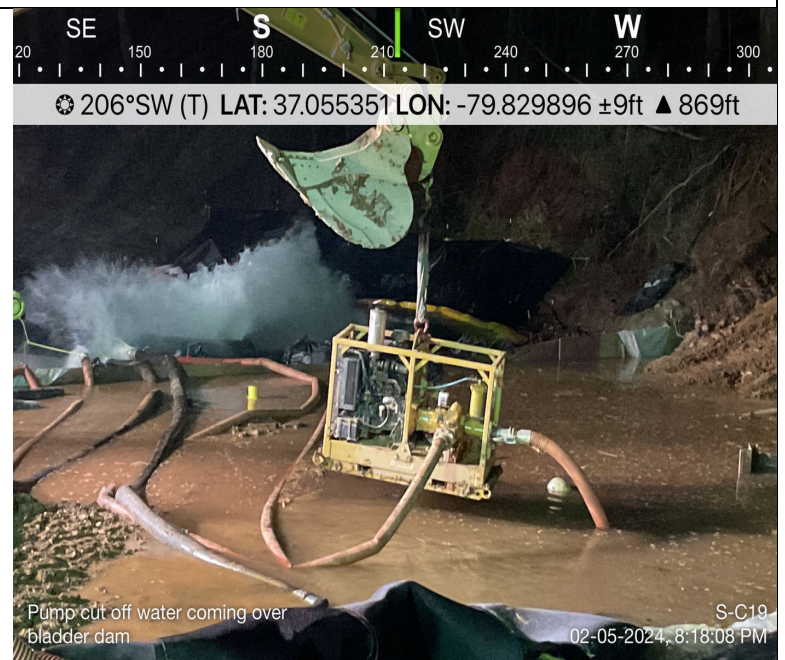
Photo Description: Holding pump in air so stream does not contact or contaminant stream. Streamflow entered into the workspace and discharge downstream.
