# STREAM BIOLOGICAL CONDITIONS ENVIRONMENTAL AUDITOR REPORT

| <b>Stream ID:</b> S-GH15 | <b>Crossing Start Date:</b> 03/05/2024 | <b>Crossing Completion Date:</b> 03/08/2024 |
| <b>Milepost:</b> 252.1 | <b>Pre-Con Assessment Date:</b> 03/05/2024 | <b>Post-Con Assessment Date:</b> 03/08/2024 |

This resource was initially crossed from 11/04/23-11/09/23 and the official report was submitted on 11/10/23. This report documents the effort to repair channel erosion that occurred within the stream after the crossing was completed.

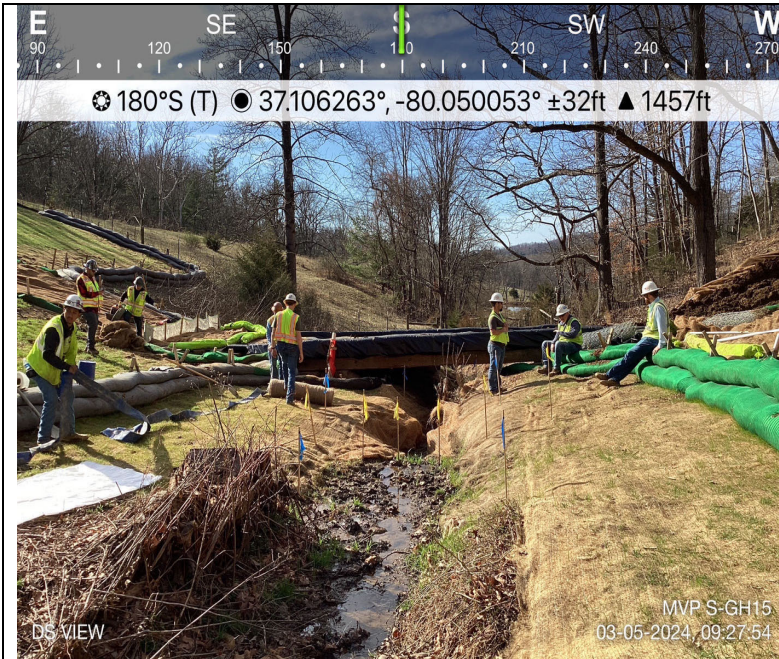
**Photo Description:** Downstream view of permitted impact area during pre-construction assessment.

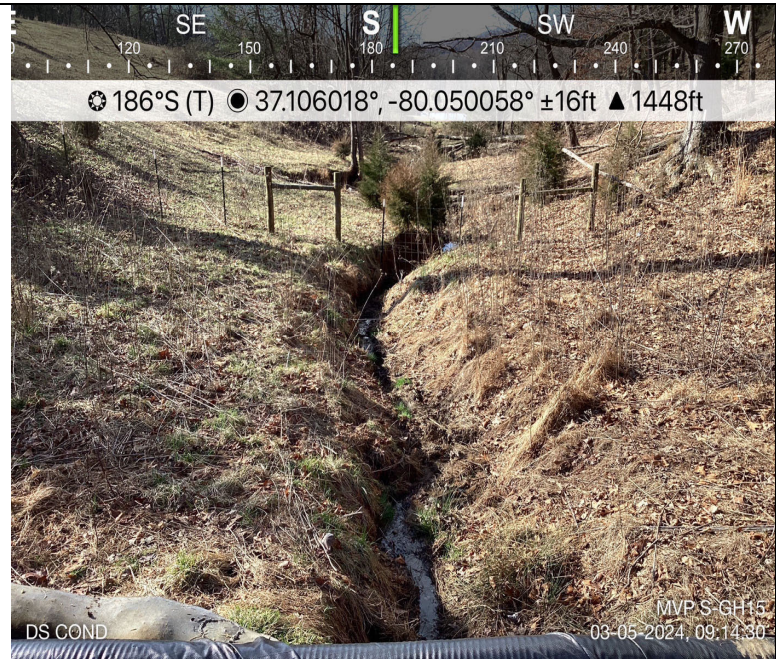
**Photo Description:** Conditions of the downstream area outside the ROW during pre-construction assessment.

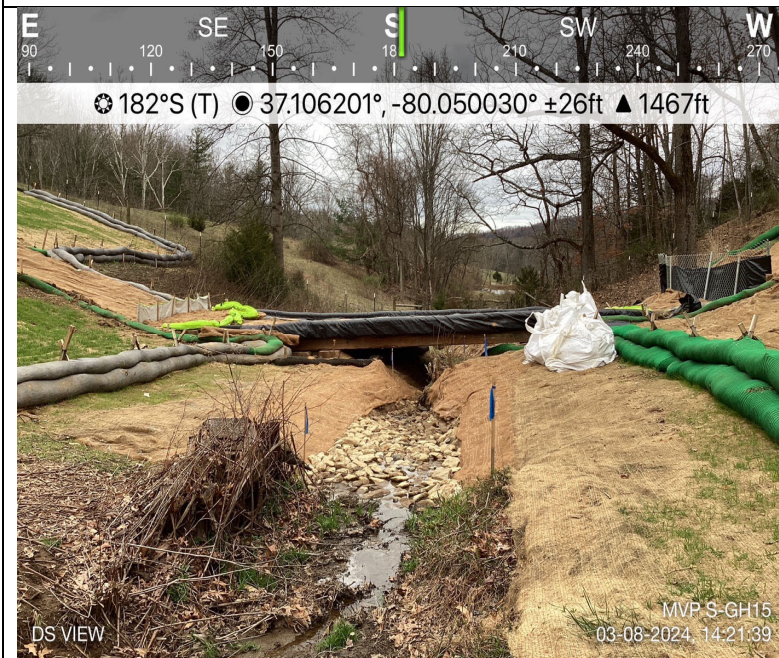
**Photo Description:** Downstream view of permitted impact area during post-construction assessment.

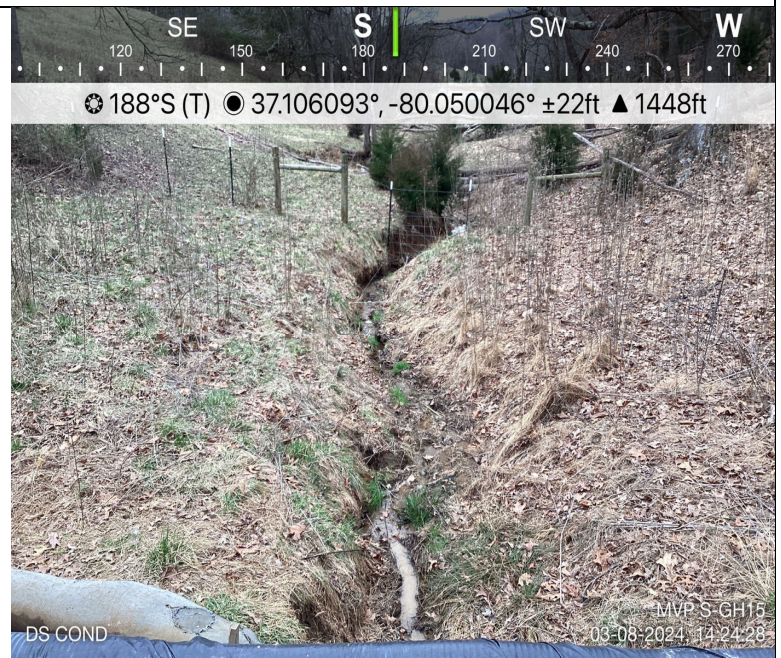
**Photo Description:** Conditions of the downstream area outside the ROW during post-construction assessment.

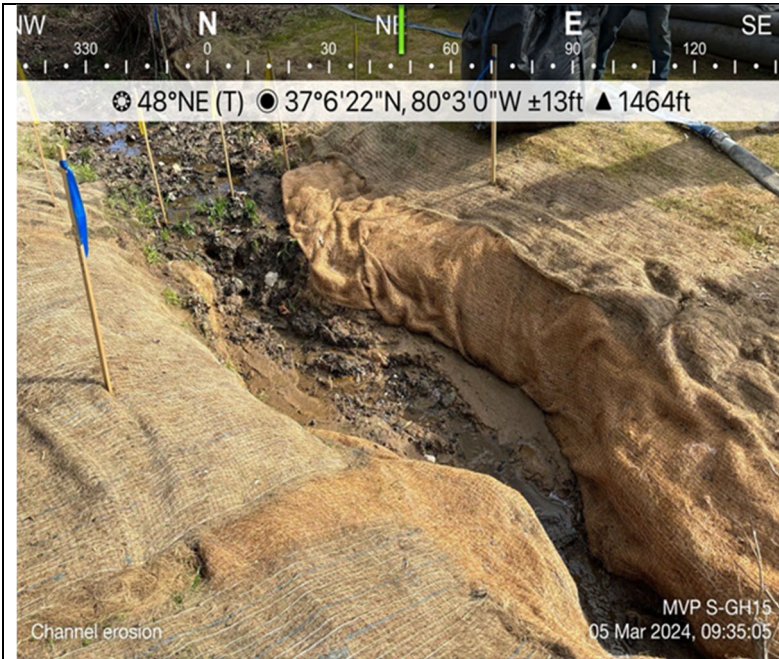
Channel erosion was noted in the middle of the stream bank and the erosion continued to worsen with every rain event. The restoration plan includes shaving the cut bank down, grading the vertical drop to a more gradual slope, armoring the stream bed and banks with native rock from S-D11, and stabilizing the stream bed and banks with biodegradable jute matting.

**Photo Description:** Channel erosion in the stream bed that has worsened over time.

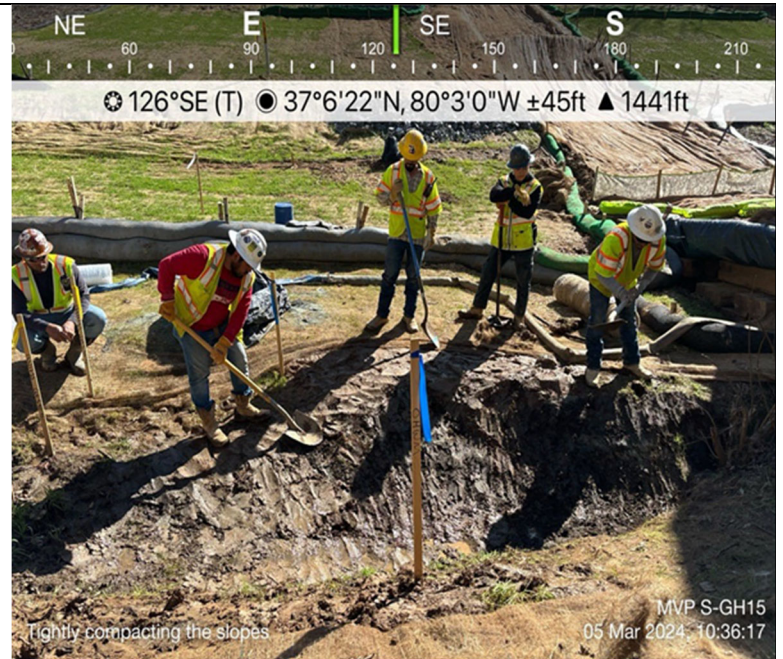
**Photo Description:** Both banks were graded to a more gradual slope and compacted.

A dam & pump were installed upstream and a dam, energy dissipator, and pump were installed downstream. A secondary dam was installed at the centerline of the stream to account for groundwater accumulation and the upstream pump was reinstalled at the midstream dam. The existing curlex covering the banks was removed to expose the unstable soil. The left cut bank was shaved back by hand, and the soil was restored in a stair-step configuration. This creates a more gradual slope on the bank while restoring the section that eroded previously. The right bank was shaved back, and the vertical drop in the stream bed was graded to a gradual slope to enhance channel stability.

The restored bank's slopes were compacted by hand to ensure stability, and jute matting was installed on both banks and the stream bed. Native stream bed rocks were configured in the stream bed to enhance stabilization. The survey team was on-site and verified the grade was consistent with pre-construction conditions. To further enhance the stability of the temporarily impacted resource, the remainder of the pre-existing curlex was removed, the banks were re-seeded, and curlex was placed over the jute matting. All dams were removed, and flow was returned to the stream. Post-construction photos and the auditor assessment were completed shortly after work was completed in the resource. -A. Thorpe

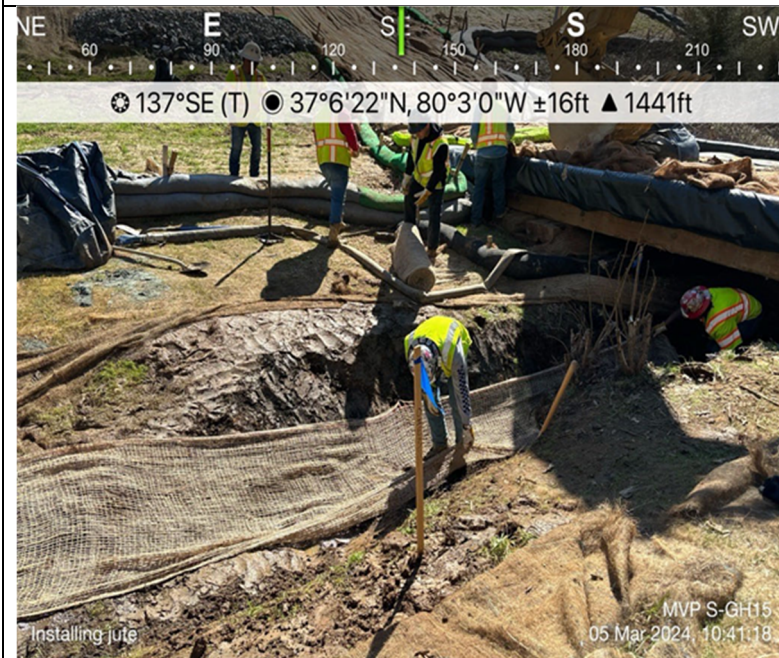
**Photo Description:** The stream bed and its banks were stabilized with biodegradable jute.

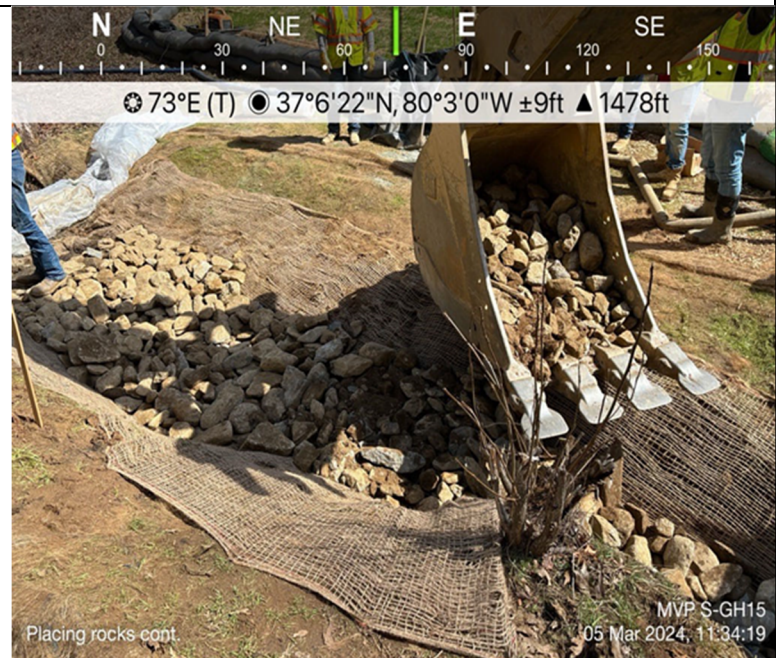
**Photo Description:** Native stream bed rock from S-D11 crossing was placed in the stream bed to enhance stabilization.
