WETLAND BIOLOGICAL CONDITIONS ENVIRONMENTAL AUDITOR REPORT

Wetland ID: W-KL50	Crossing Start Date: 02/19/2024	Crossing Completion Date: 02/23/2024
Milepost: 243.8	Pre-Con Assessment Date: 02/18/2024	Post-Con Assessment Date: 02/23/2024
Station: 12885+00	Cowardin Classification: PEM (PEM, PFO, PSS, POW)	Wetland Impact Area (sq ft.): 1777.25
County: Roanoke

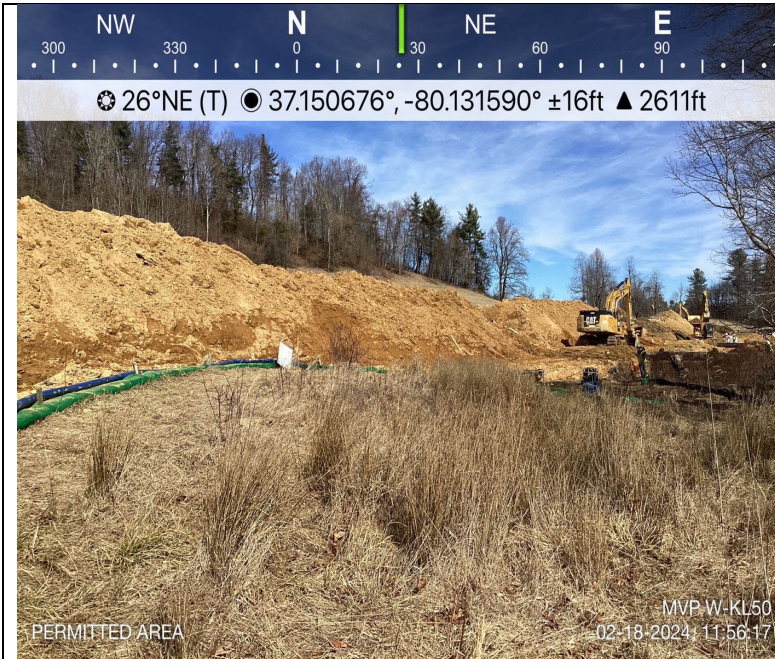
Photo Description: View of permitted resource impact area during pre-construction assessment.

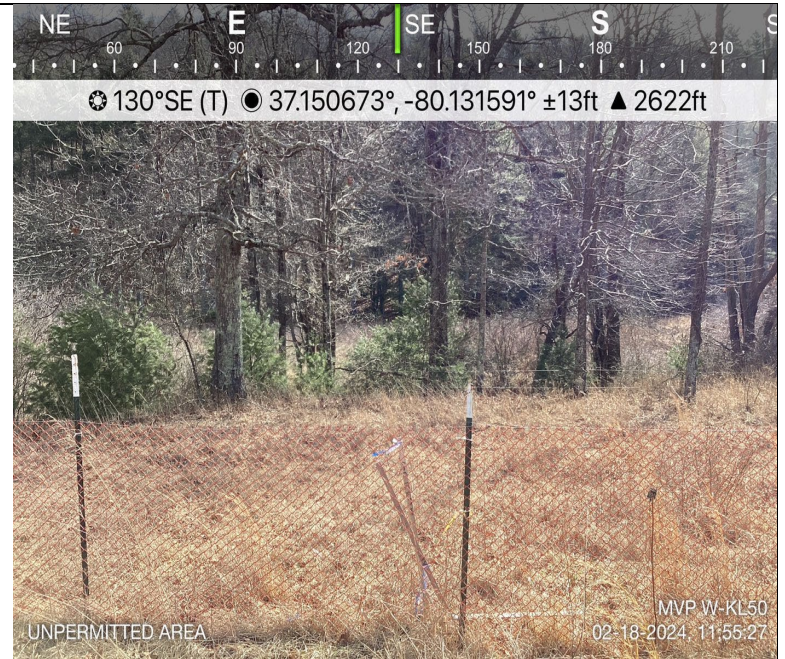
Photo Description: At edge of LOD, view of unpermitted resource area conditions during pre-construction assessment.

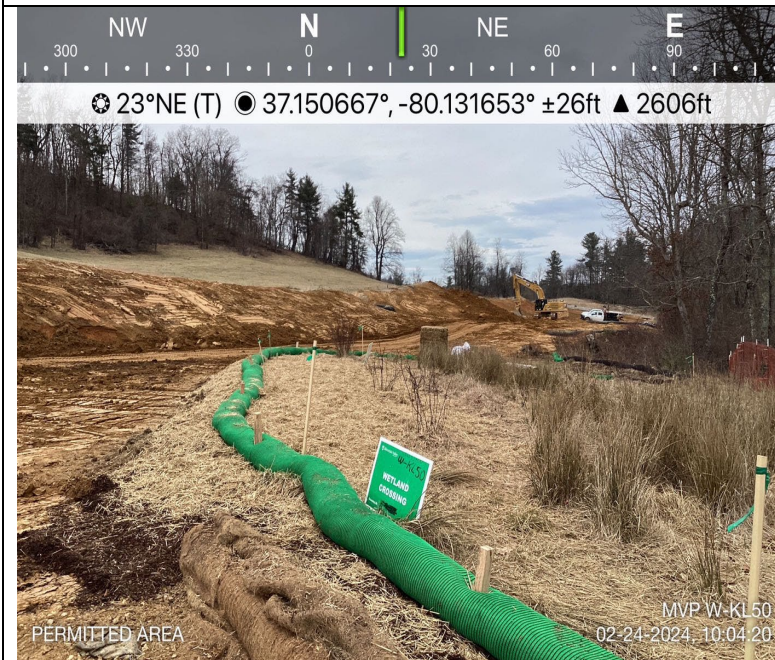
Photo Description: View of permitted resource impact area during post-construction assessment.

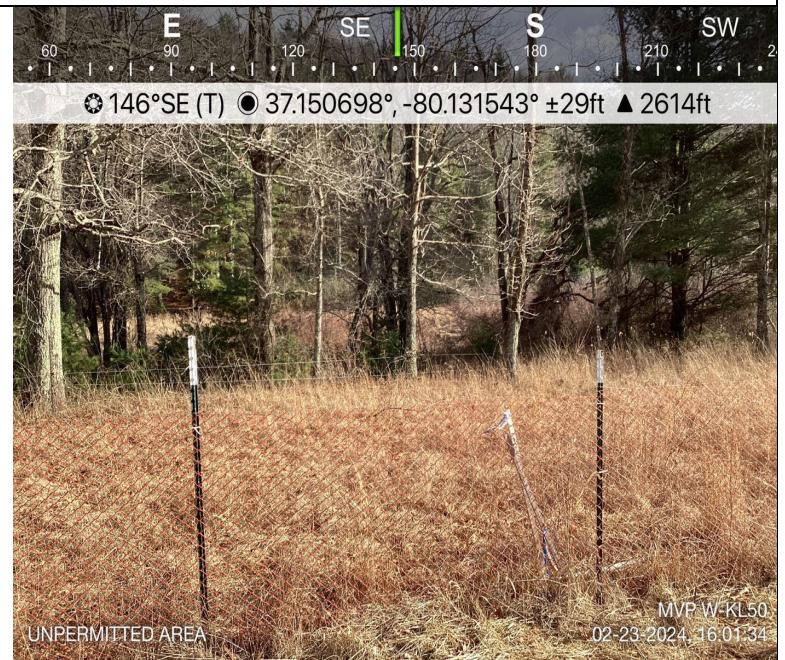
Photo Description: At edge of LOD, view of unpermitted resource area conditions during post-construction assessment.

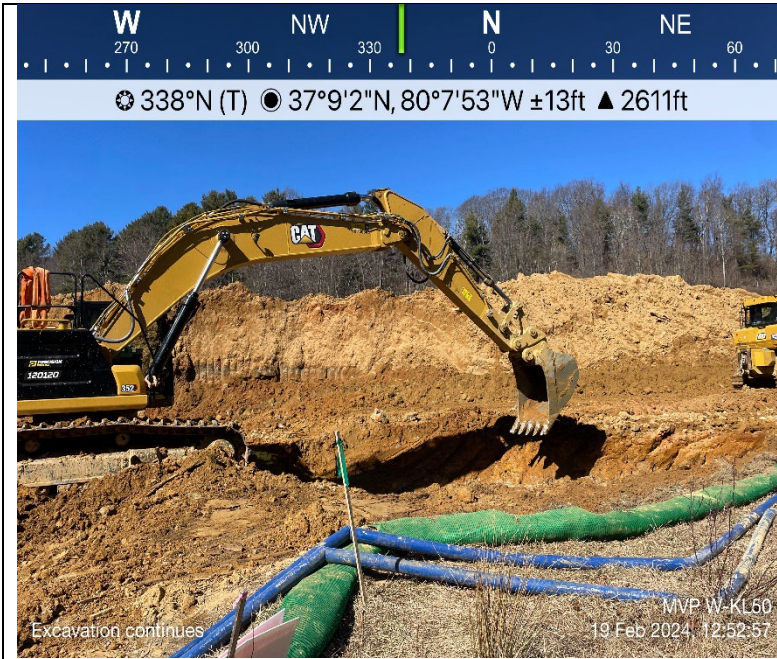
Photo Description: The topsoil was excavated.

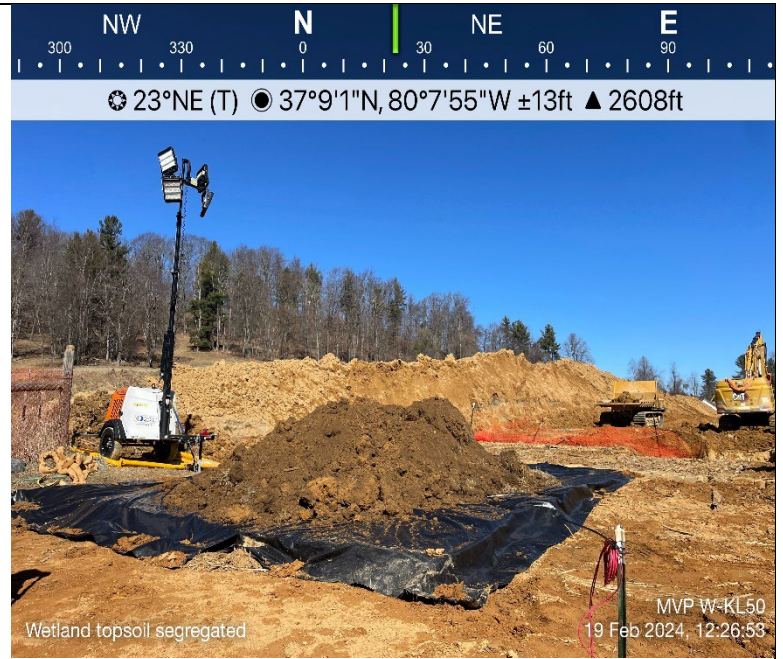
Photo Description: The wetland topsoil was segregated and stockpiled on top of Geotech fabric.

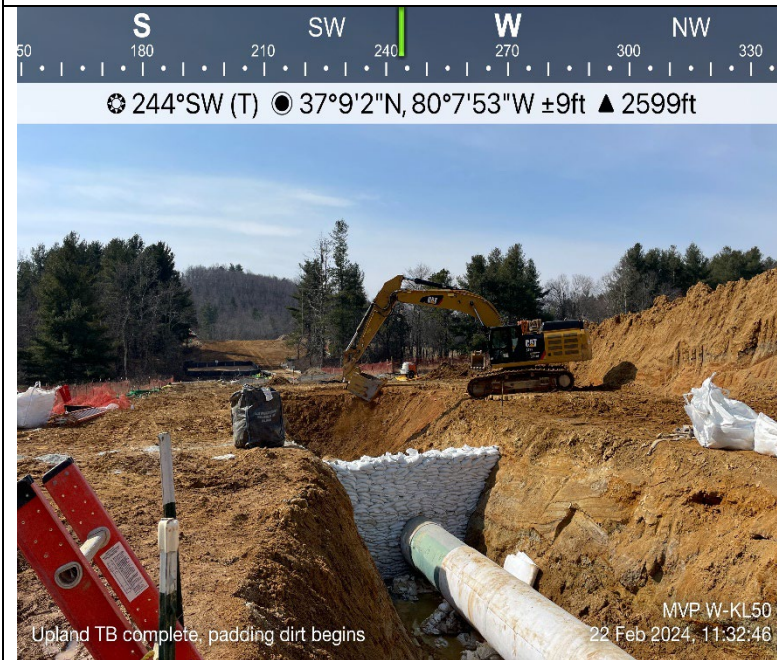
2/22/24: QA/QC was completed on the weld and a trench breaker was constructed in the Going Away Side (GAS) upland. As this wetland was only impacted for the construction of a bell hole and the centerline does not go through the wetland, it was not deemed necessary to construct impervious trench breakers on each side of the resource. Dirt was padded over the pipe and subsoil backfill began. -A. Thorpe

Photo Description: An upland trench breaker was installed, and the soil was padded during backfill.

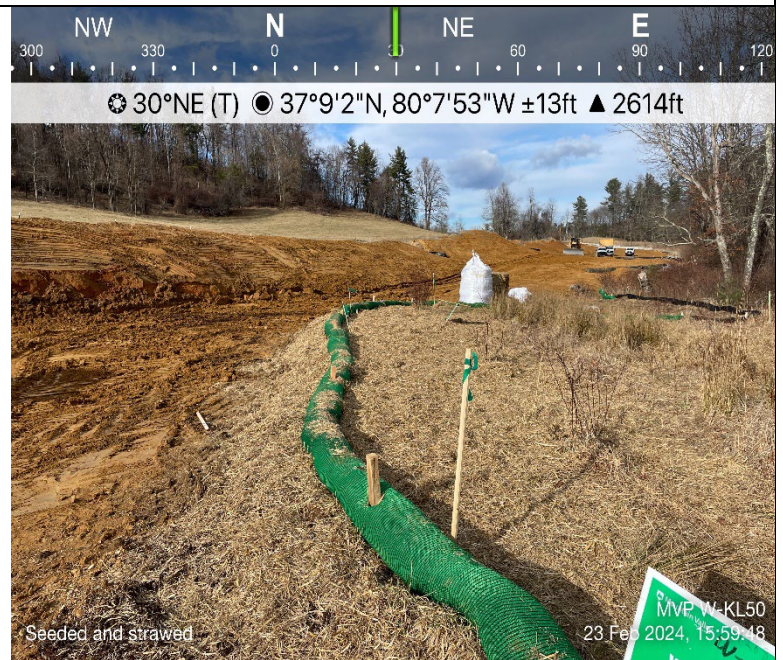
Photo Description: The area was restored with seed, straw mulch, and compost filter sock.
