# STREAM BIOLOGICAL CONDITIONS ENVIRONMENTAL AUDITOR REPORT

Version 2.3

<b>Stream ID:</b> S-CD8	<b>Crossing Start Date:</b> 04/02/2024	<b>Crossing Completion Date:</b> 04/06/2024
<b>Milepost:</b> 281.7	<b>Pre-Con Assessment Date:</b> 04/02/2024	<b>Post-Con Assessment Date:</b> 04/06/2024
<b>Station:</b> 14881+45	<b>Stream Classification:</b> Intermittent (Perennial, Intermittent, Ephemeral)	<b>Bankfull Width (ft.):</b> 4.5
<b>County:</b> Franklin	<b>303(d) Impairment Listing:</b> Not Impaired	<b>Riffle:Pool Complexes Present?</b> No

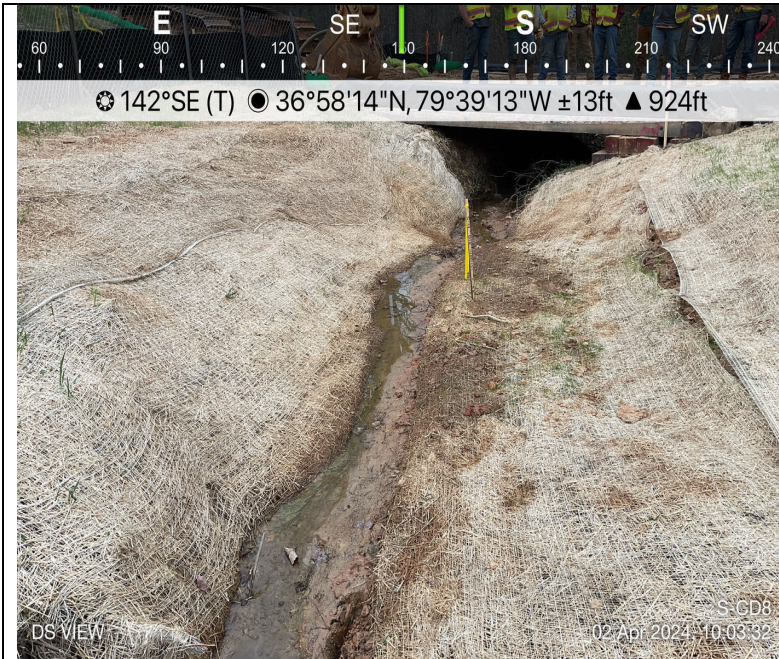
**Photo Description:** Downstream view of permitted impact area during pre-construction assessment.

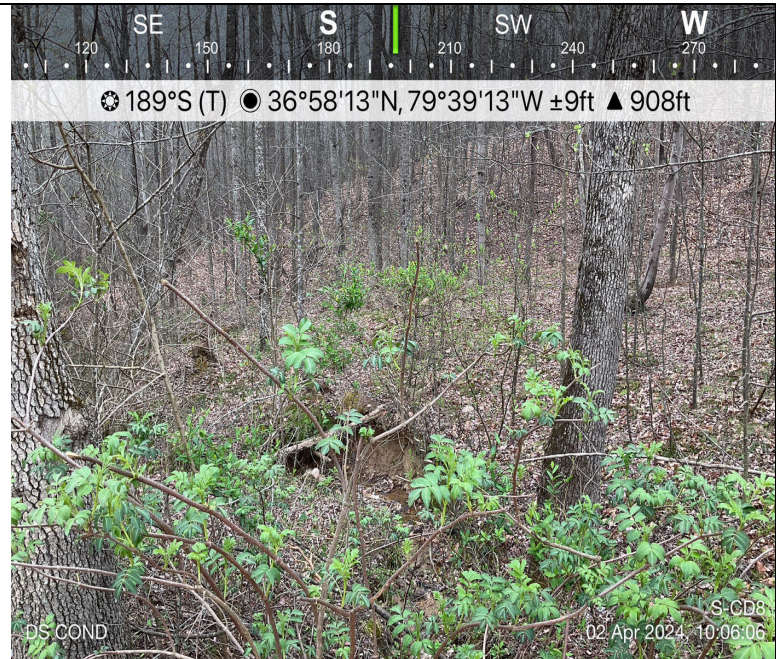
**Photo Description:** Conditions of the downstream area outside the ROW during pre-construction assessment.

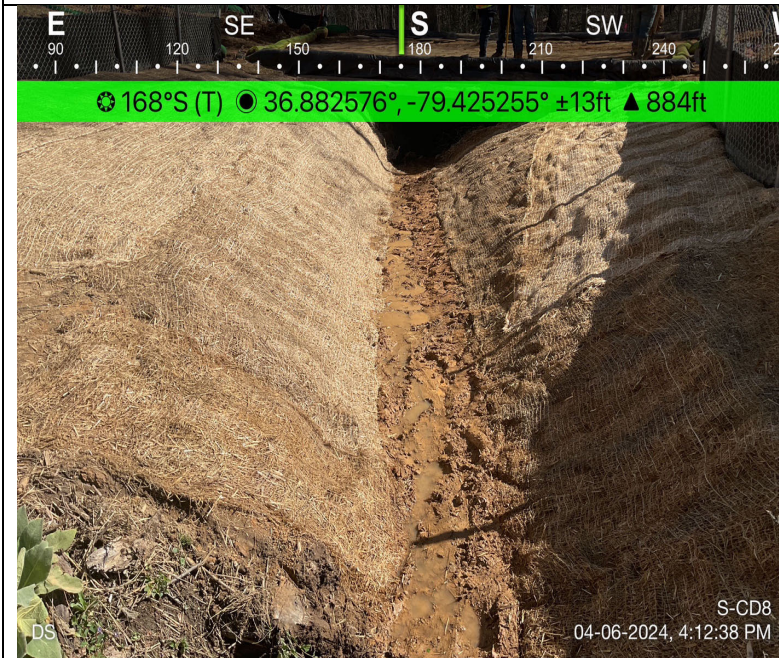
**Photo Description:** Downstream view of permitted impact area during post-construction assessment.

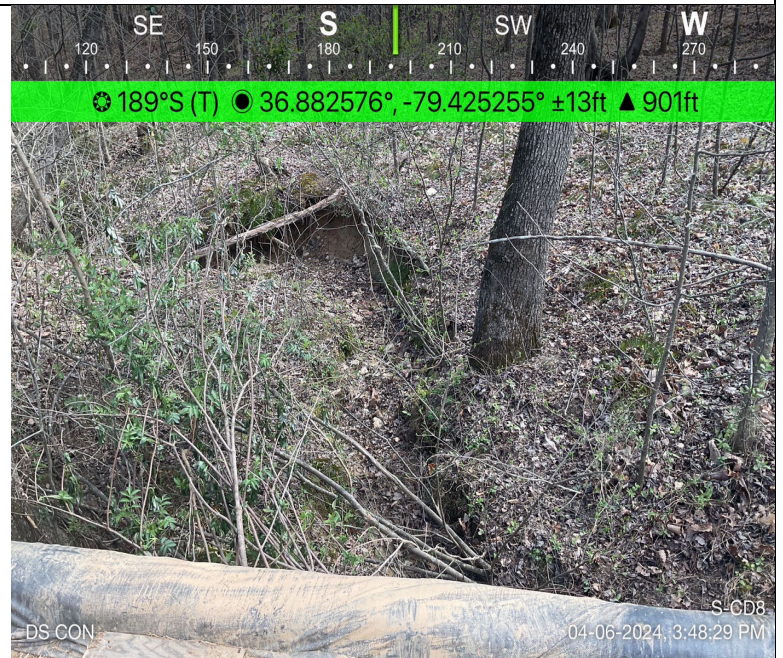
**Photo Description:** Conditions of the downstream area outside the ROW during post-construction assessment.

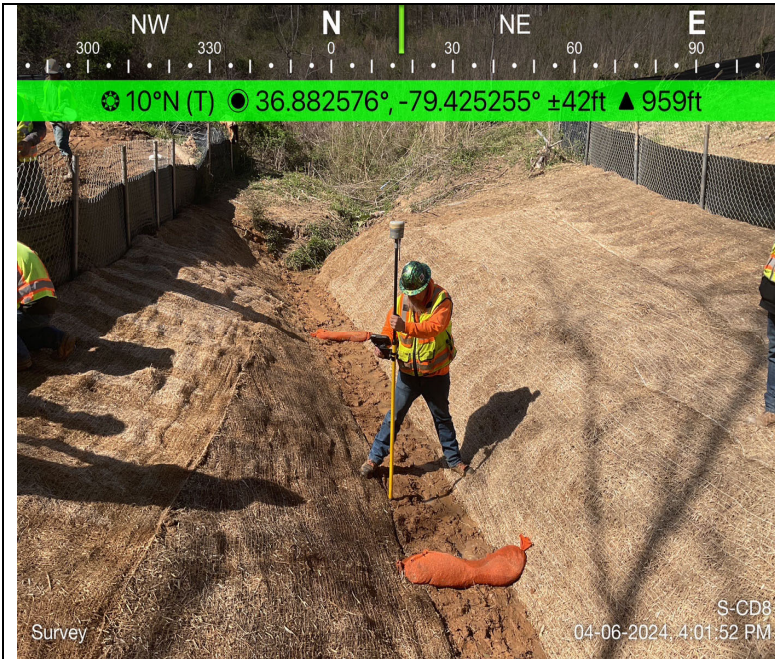
**Photo Description:** Survey of the substrate post-construction.

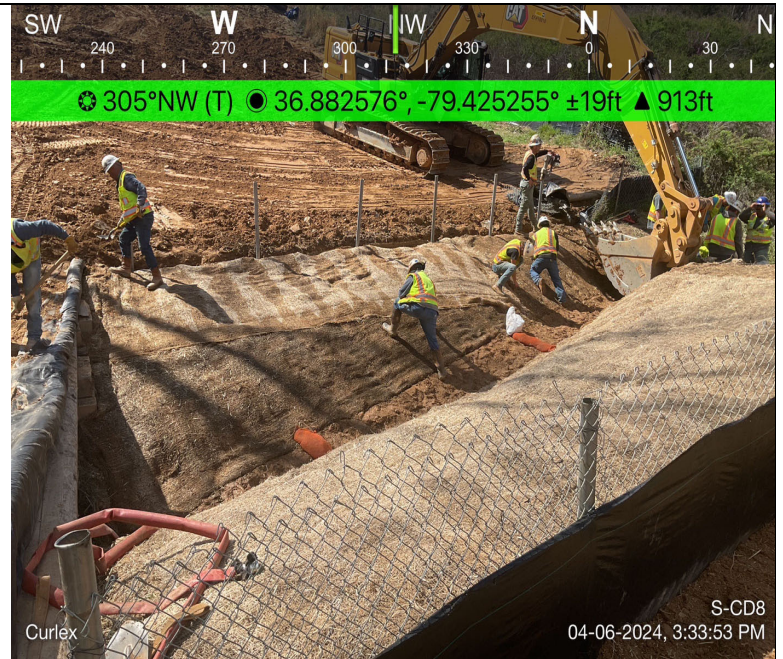
**Photo Description:** Curlex matting was installed along the stream bank.

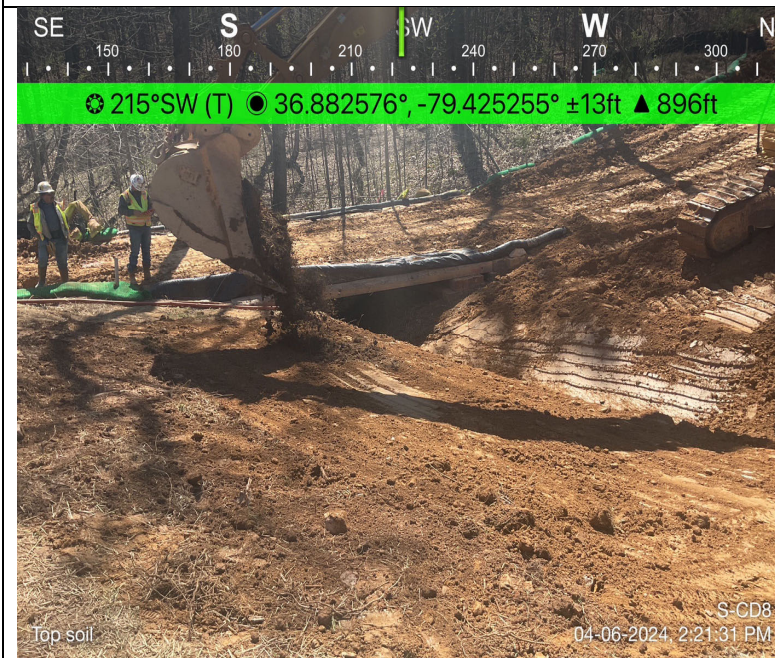
**Photo Description:** Topsoil was returned to the stream bank and graded.

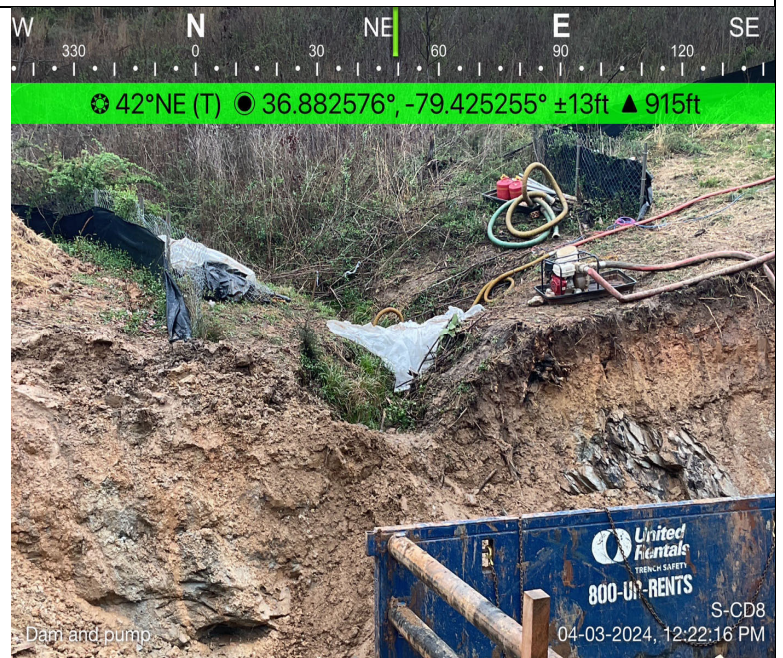
**Photo Description:** An overview of the dam and pump.
