STREAM BIOLOGICAL CONDITIONS ENVIRONMENTAL AUDITOR REPORT

Stream ID: S-D4	Crossing Start Date: 03/25/2024	Crossing Completion Date: 04/02/2024
Milepost: 284.4	Pre-Con Assessment Date: 03/22/2024	Post-Con Assessment Date: 04/02/2024
Station: 15027+37	Stream Classification: Intermittent (Perennial, Intermittent, Ephemeral)	Bankfull Width (ft.): 6
County: Pittsylvania	303(d) Impairment Listing: Not Impaired	Riffle: Pool Complexes Present? No

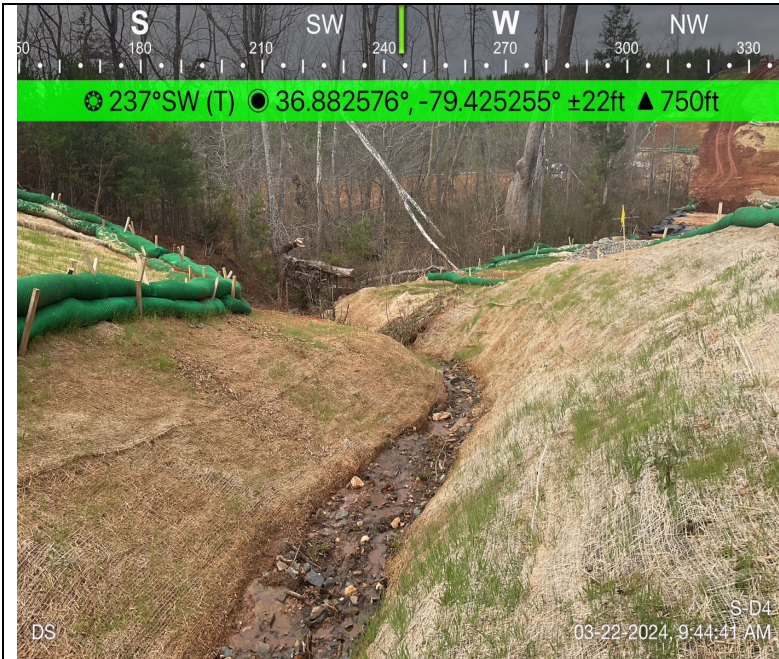
Photo Description: Downstream view of permitted impact area during pre-construction assessment.

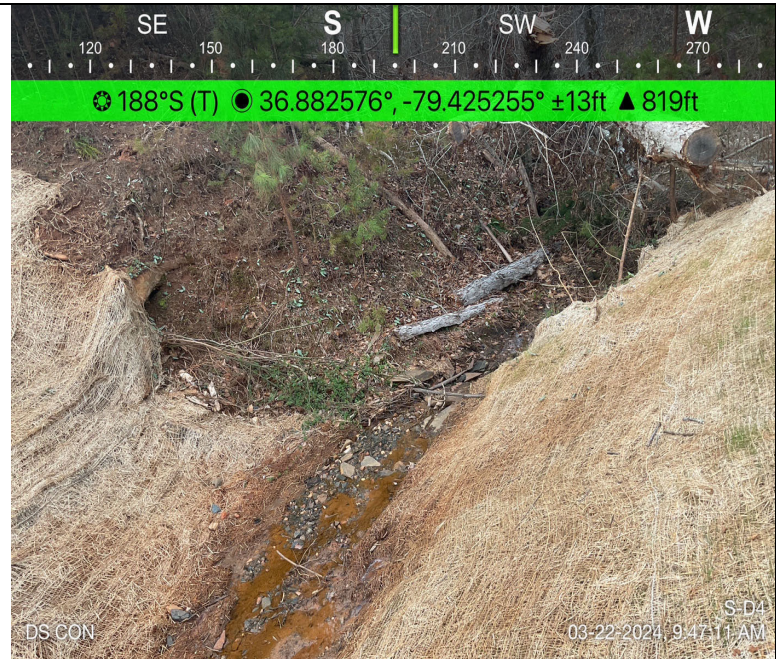
Photo Description: Conditions of the downstream area outside the ROW during pre-construction assessment.

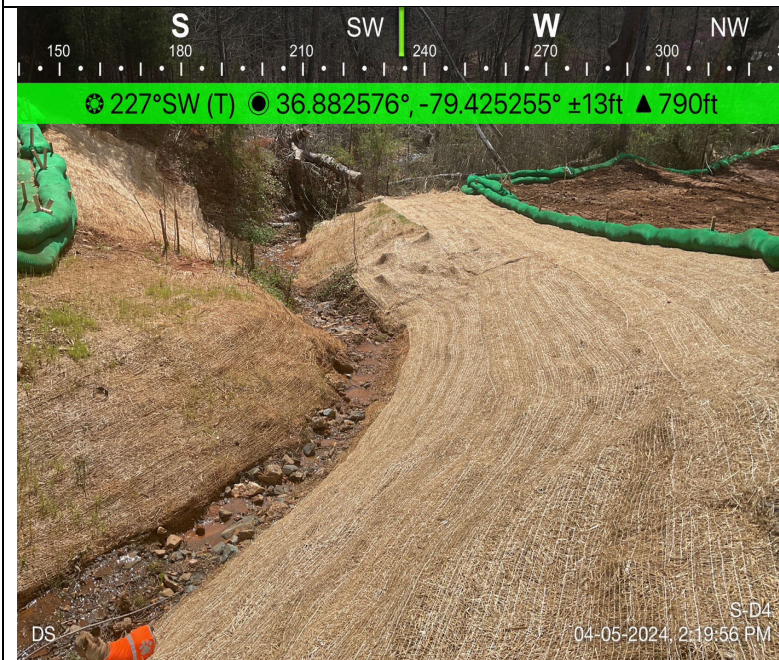
Photo Description: Downstream view of permitted impact area during post-construction assessment.

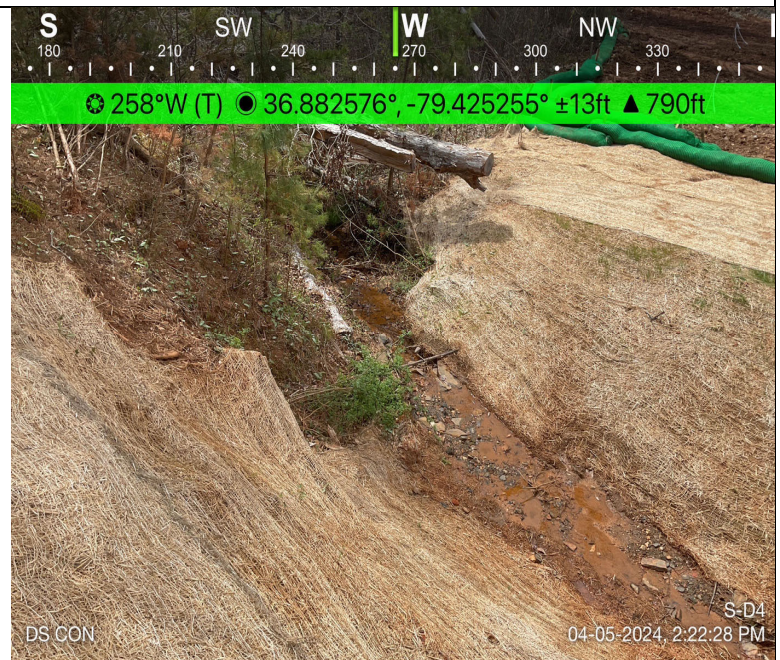
Photo Description: Conditions of the downstream area outside the ROW during post-construction assessment.

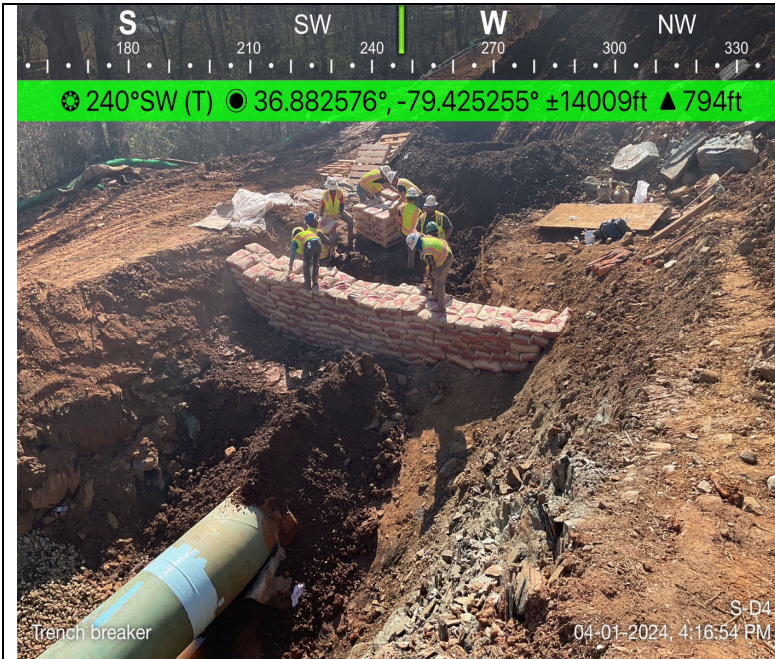
Photo Description: The trench breaker was installed along the pipe.

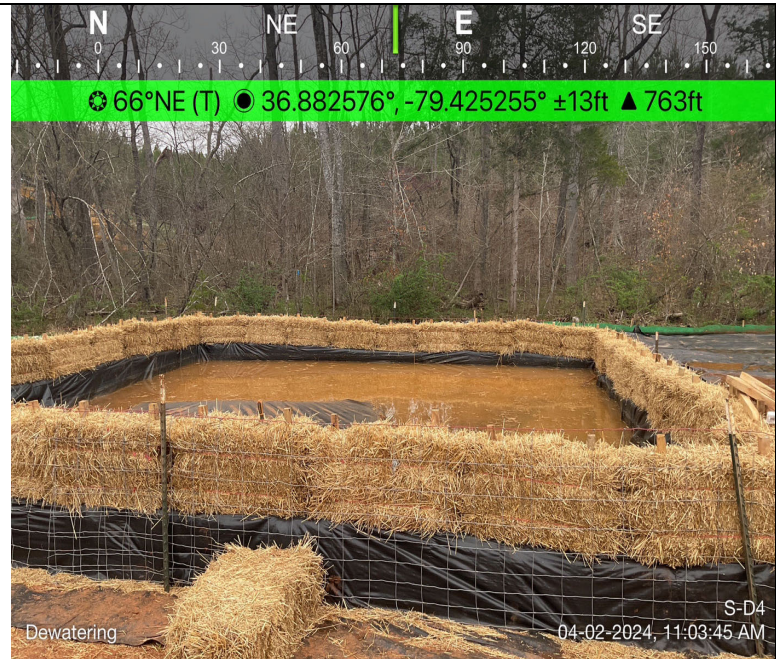
Photo Description: An overview of the dewatering structure utilized during work activities.

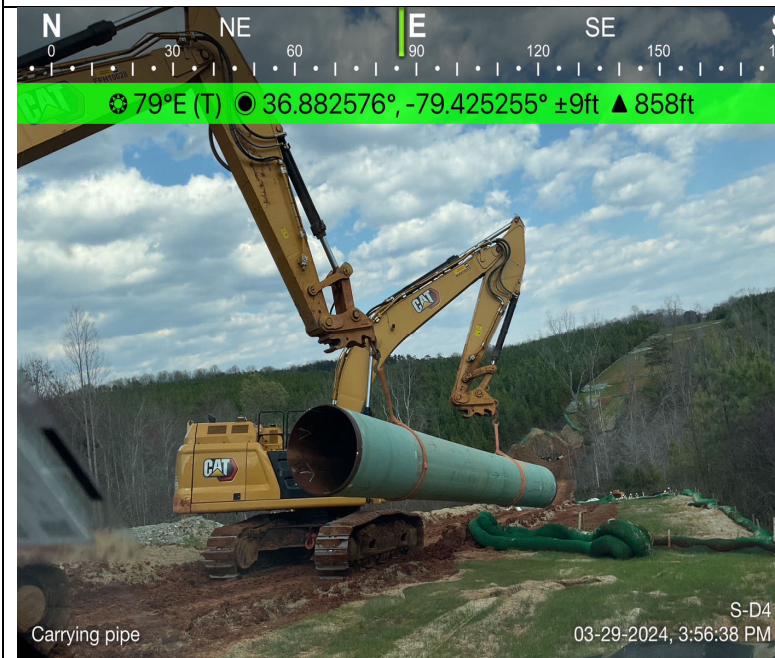
Photo Description: Pipe being transported to the trench for anomaly replacement.

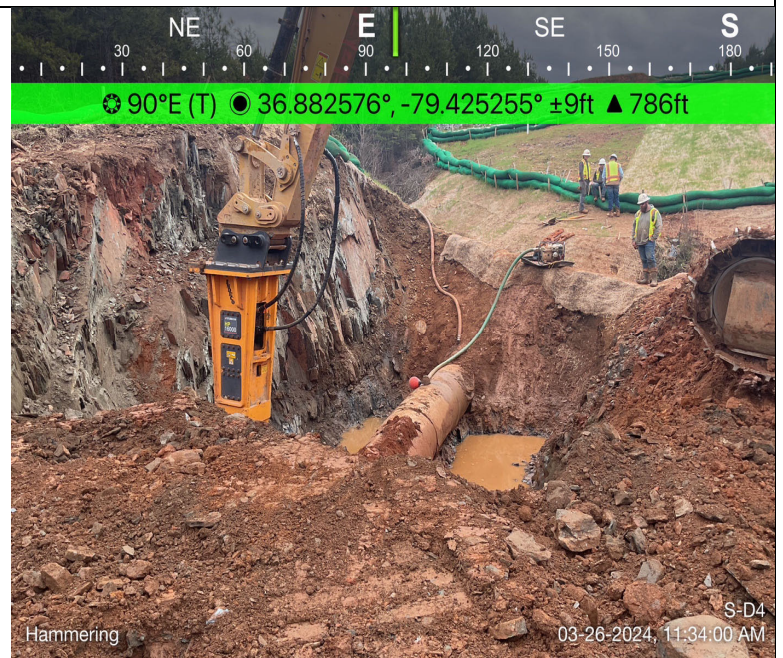
Photo Description: An overview of the dam and pump during hammering activities.
