# STREAM BIOLOGICAL CONDITIONS ENVIRONMENTAL AUDITOR REPORT

<b>Stream ID:</b> S-EF19	<b>Crossing Start Date:</b> 02/08/2024	<b>Crossing Completion Date:</b> 03/29/2024
<b>Milepost:</b> 236.9	<b>Pre-Con Assessment Date:</b> 02/05/2024	<b>Post-Con Assessment Date:</b> 03/29/2024
<b>Station:</b> 12519+41	<b>Stream Classification:</b> Ephemeral (Perennial, Intermittent, Ephemeral)	<b>Bankfull Width (ft.):</b> 5
<b>County:</b> Montgomery	<b>303(d) Impairment Listing:</b> Not Impaired	<b>Riffle:Pool Complexes Present?</b> No

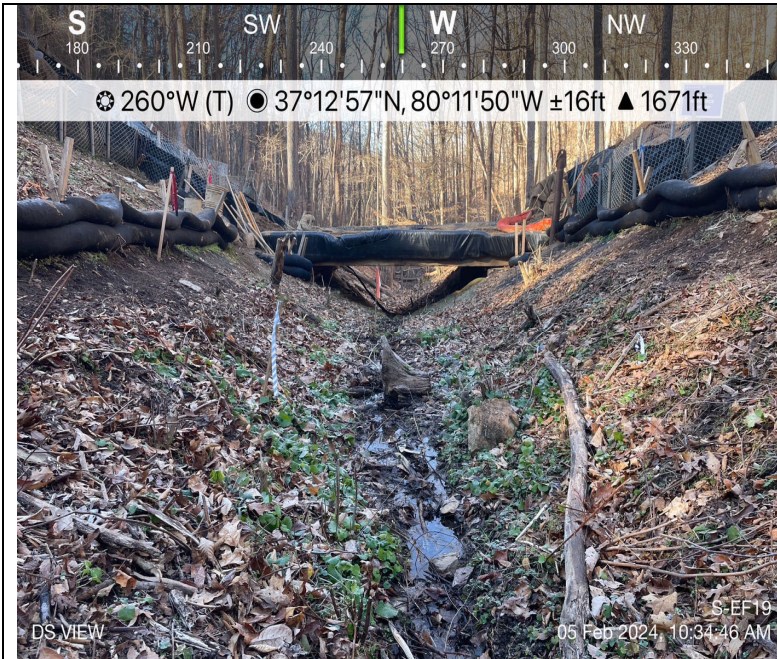
**Photo Description:** Downstream view of permitted impact area during pre-construction assessment.

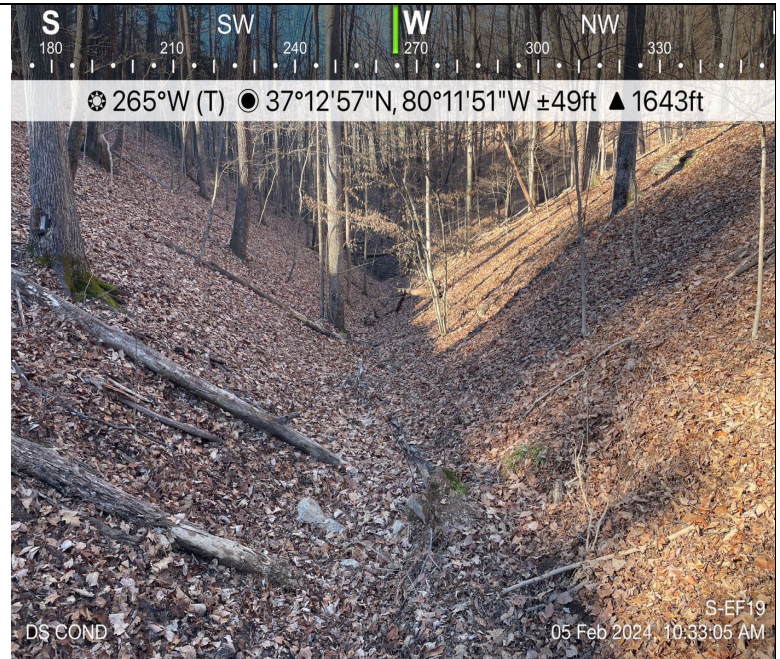
**Photo Description:** Conditions of the downstream area outside the ROW during pre-construction assessment.

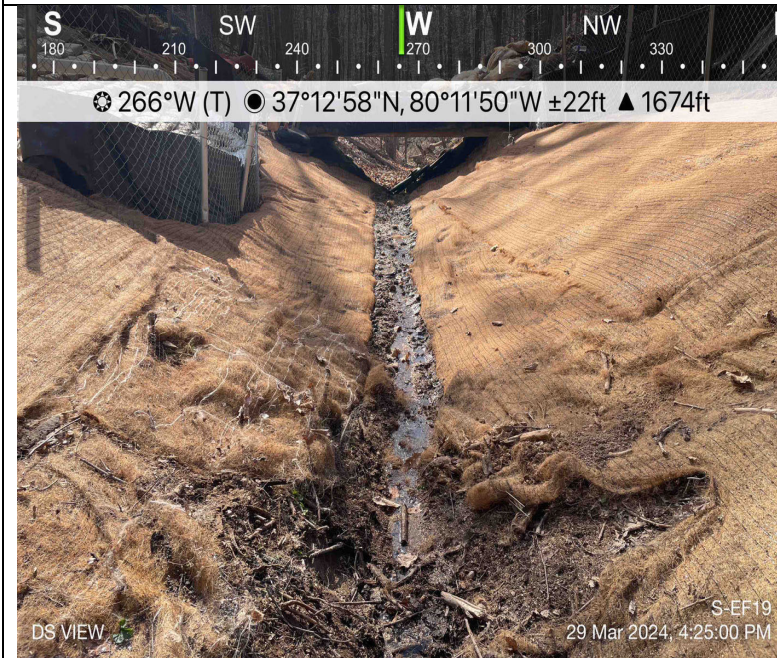
**Photo Description:** Downstream view of permitted impact area during post-construction assessment.

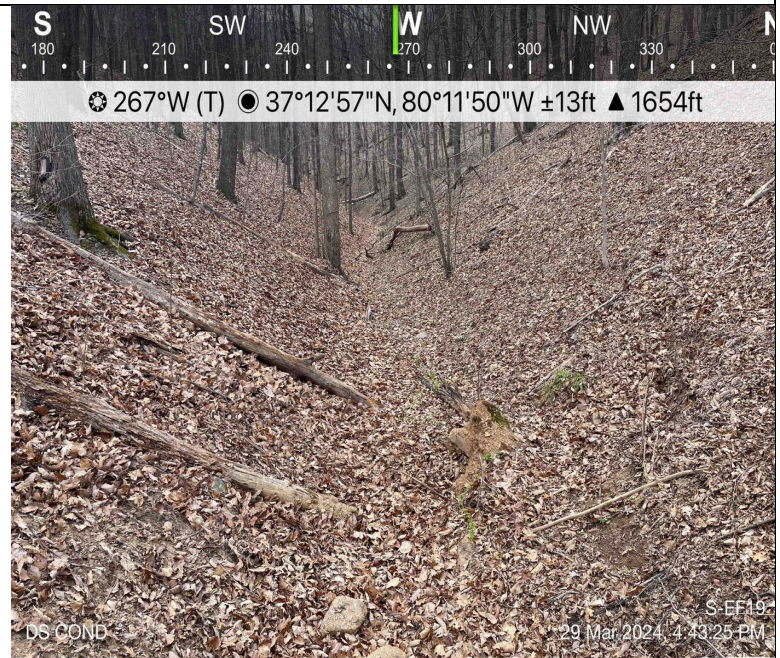
**Photo Description:** Conditions of the downstream area outside the ROW during post-construction assessment.

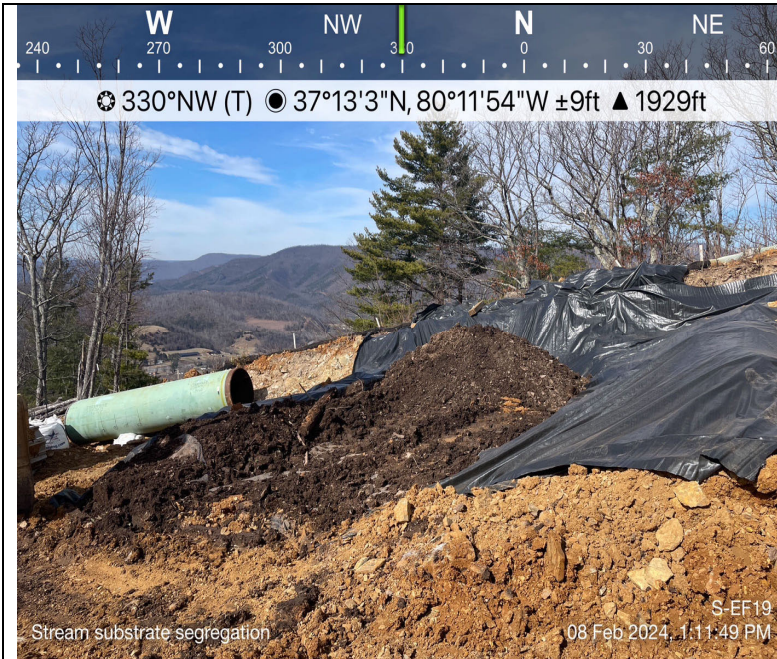
02/08/24- Dewatering sled set in place outside of the 50ft buffer in an upland area. 12 inches of stream substrate removed and segregated on timber mats and geotech in an upland and stabilized with Kerlex. 12 inches of buffer topsoil on the C.I.S. segregated and stockpiled outside of the 50ft buffer. Flume was installed with sandbags to divert flow to the downstream energy dissipater. Downstream flow remains consistent and biological conditions remain stable. - S. Frost

**Photo Description:** Stream substrate segregation and stockpiled on fabric in upland area.

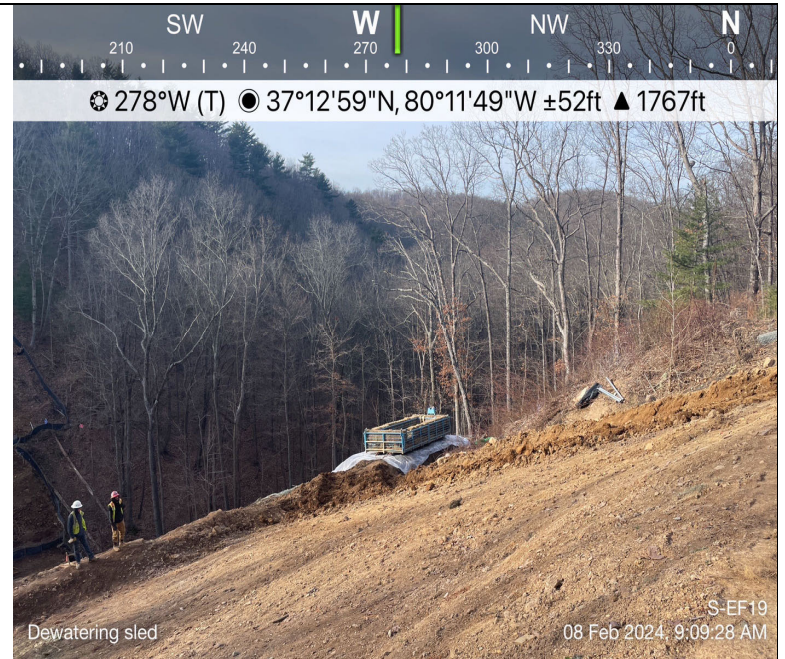
**Photo Description:** Dewatering sled on-site throughout the crossing activities.

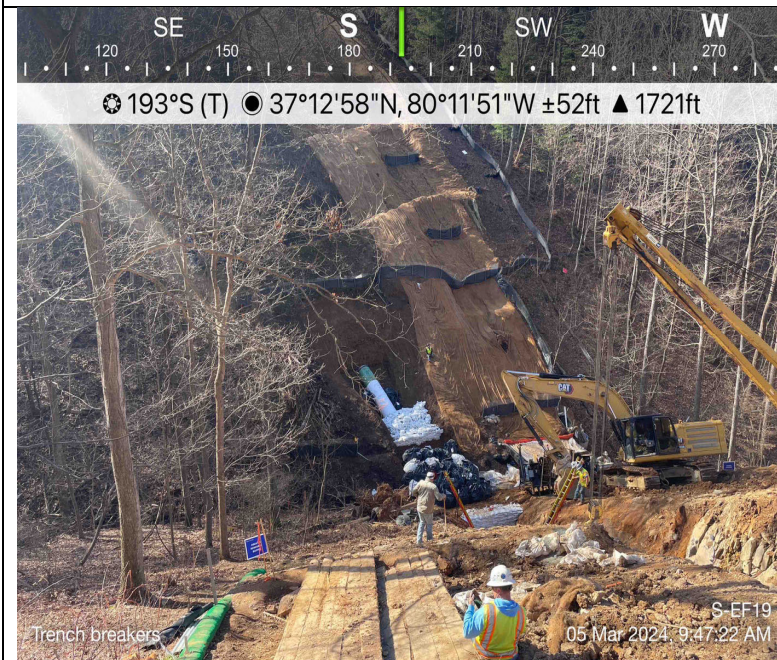
02/24/24- Concrete bags were brought down slope in preparation for trench breaker installation. Trench breakers were installed on both sides of the resource with 25ft of the resource area. Subsoil backfill continued. Biological conditions remain stable. - S. Frost

**Photo Description:** Trench breakers for G.A.S. & C.I.S installed prior to backfill of pipe.

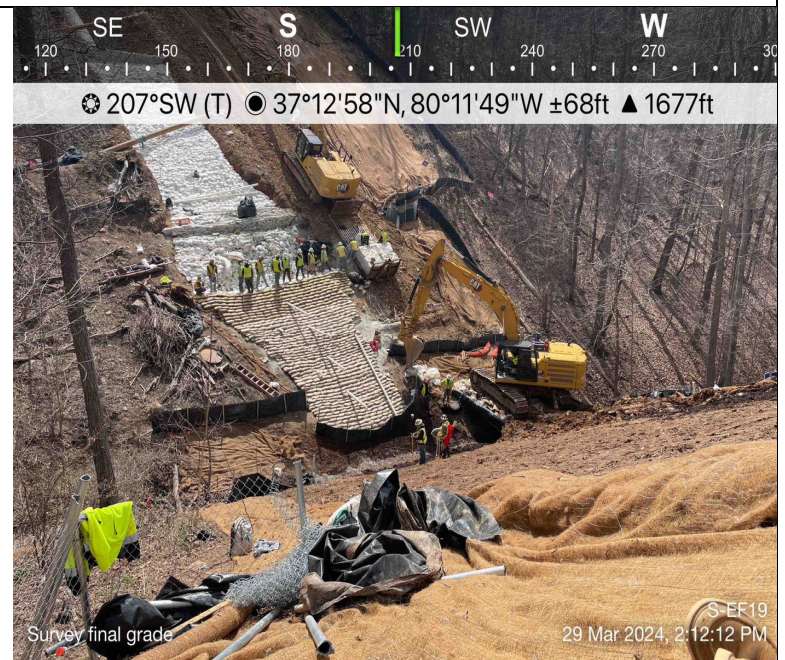
03/29/24- G.A.S. concrete revetment construction continues through the 50 ft buffer area. C.I.S. buffer area 12in of topsoil restoration completed. The stream flume was removed and the dams were left in place. 12in of stream substrate restored to pre-construction elevation per survey data. Shovel work on the G.A.S. was utilized to restore the stream bank topsoil up to the 10 ft buffer area. Super silt fencing was installed at the 10ft and 50ft buffer areas. Seeding and stabilization matting was applied to the buffer areas. Dams were removed and flow was restored. Post Con assessment completed. Continued auditor monitoring will be done while the concrete revetment construction continues throughout the 50 ft buffer area on the G.A.S. No unauthorized discharges were observed during construction activities. Biological conditions remain stable. -S. Frost

**Photo Description:** Final grade survey of stream restoration. Installation of the revetment wall continues while resource restoration completed.
