STREAM BIOLOGICAL CONDITIONS ENVIRONMENTAL AUDITOR REPORT

Stream ID: S-F11	Crossing Start Date: 02/15/2024	Crossing Completion Date: 02/26/2024
Milepost: 269.7	Pre-Con Assessment Date: 02/09/2024	Post-Con Assessment Date: 03/05/2024
Station: 14240+15	Stream Classification: Perennial (Perennial, Intermittent, Ephemeral)	Bankfull Width (ft.): 90
County: Franklin	303(d) Impairment Listing: Impaired	Riffle:Pool Complexes Present? No

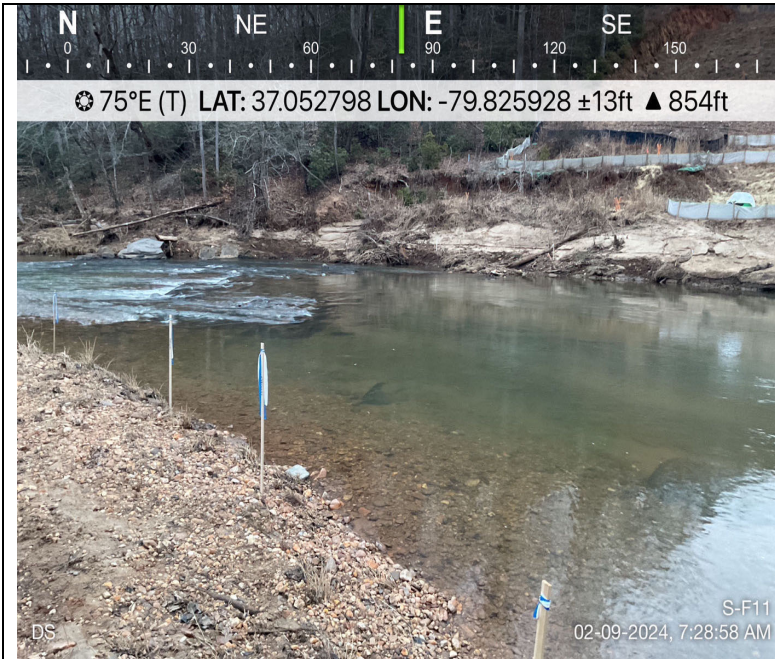
Photo Description: Downstream view of permitted impact area during pre-construction assessment.

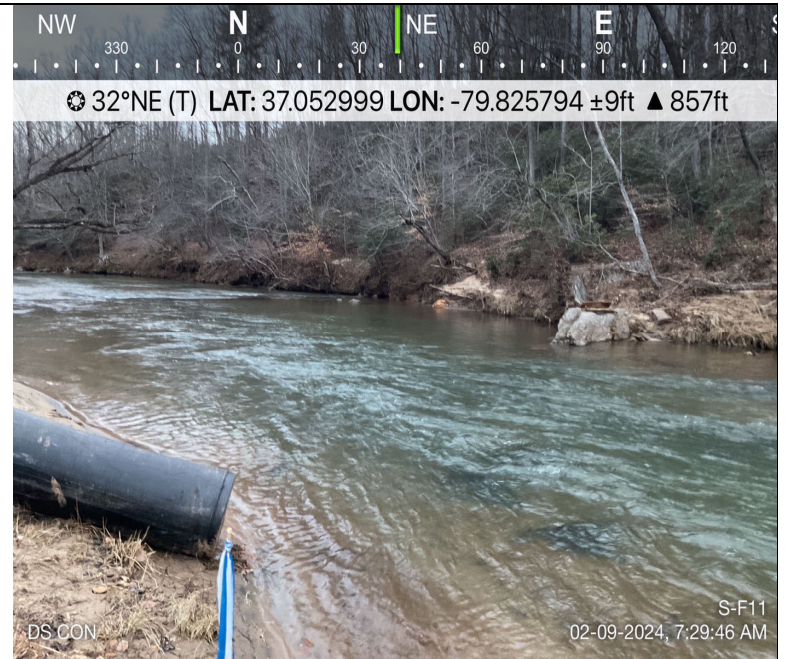
Photo Description: Conditions of the downstream area outside the ROW during pre-construction assessment.

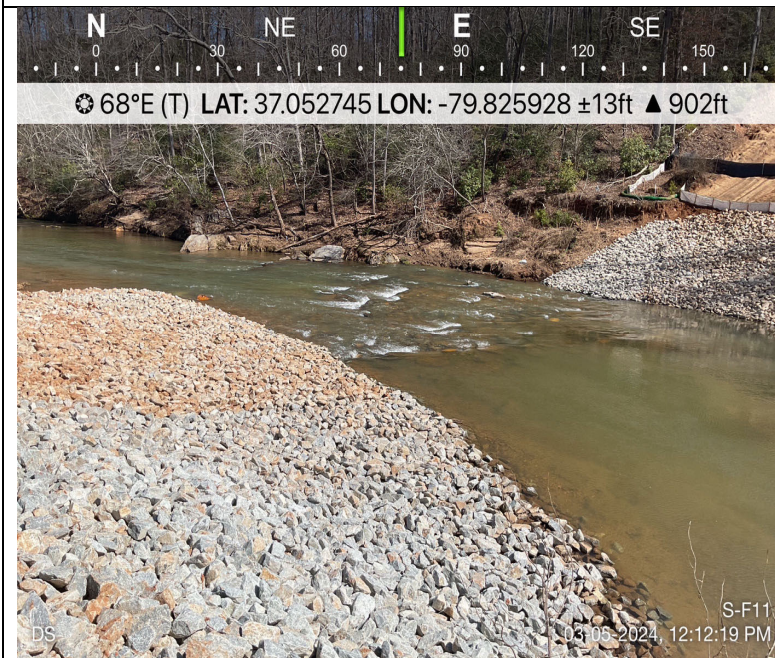
Impacts to riparian buffer zone vegetation and channel alterations were observed. No unauthorized discharges were observed during the crossing activities.

Photo Description: Downstream view of permitted impact area during post-construction assessment.

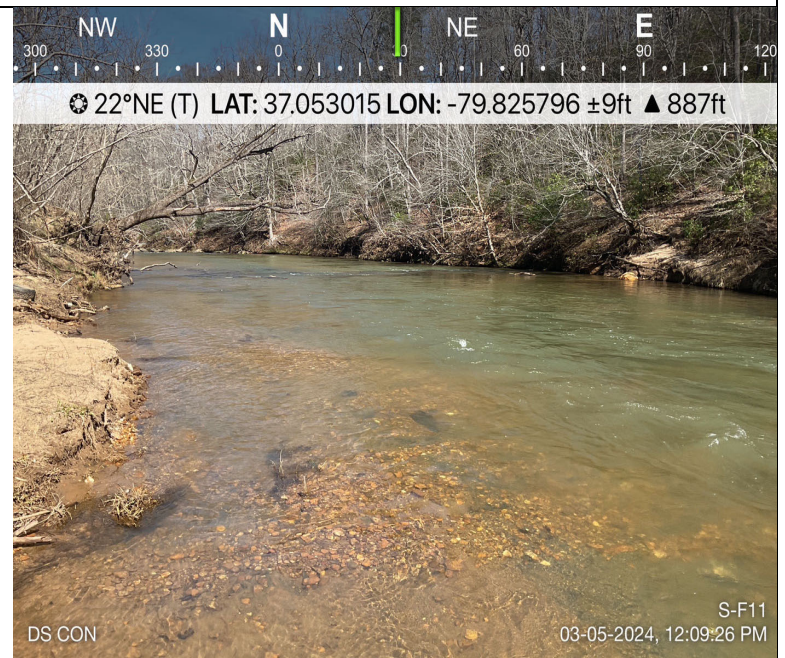
Photo Description: Conditions of the downstream area outside the ROW during post-construction assessment.

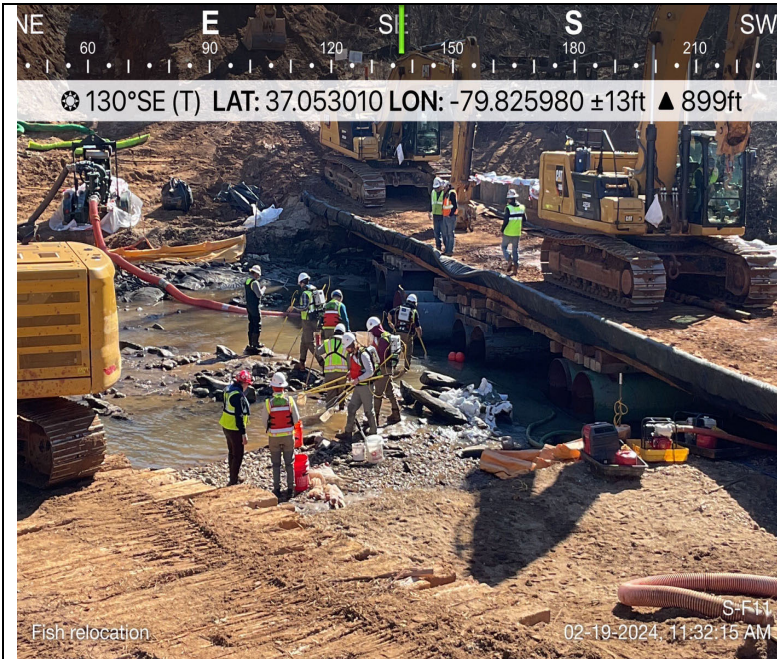
Photo Description: The fish relocation was conducted after installation of the dam and pump around.

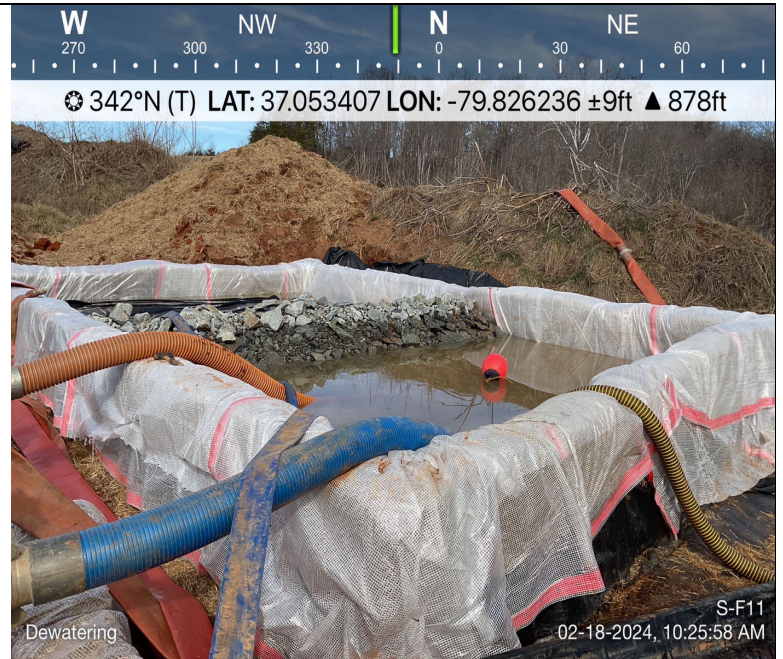
Photo Description: An overview of one of the the dewatering structures used on-site during the crossing.

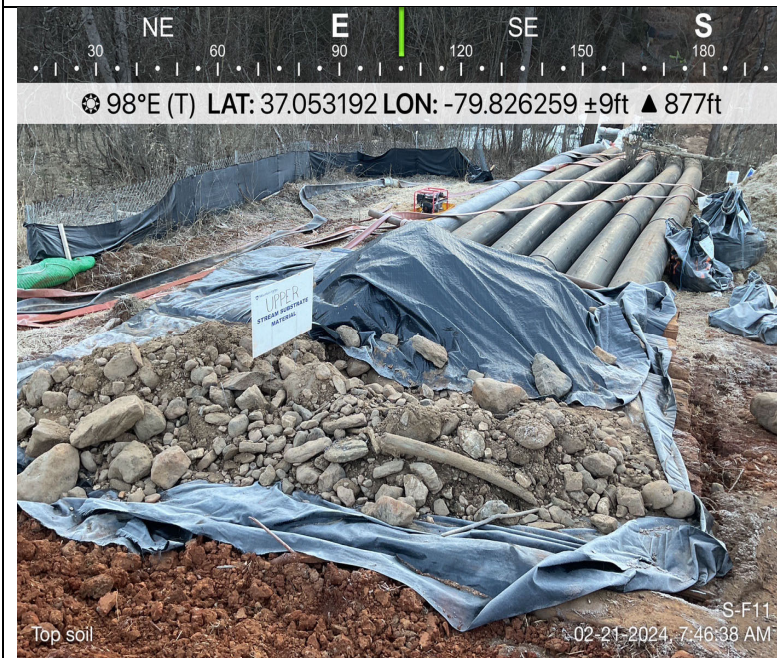
Photo Description: The top 12" of stream substrate was stockpiled on Geotech fabric during the crossing activities.

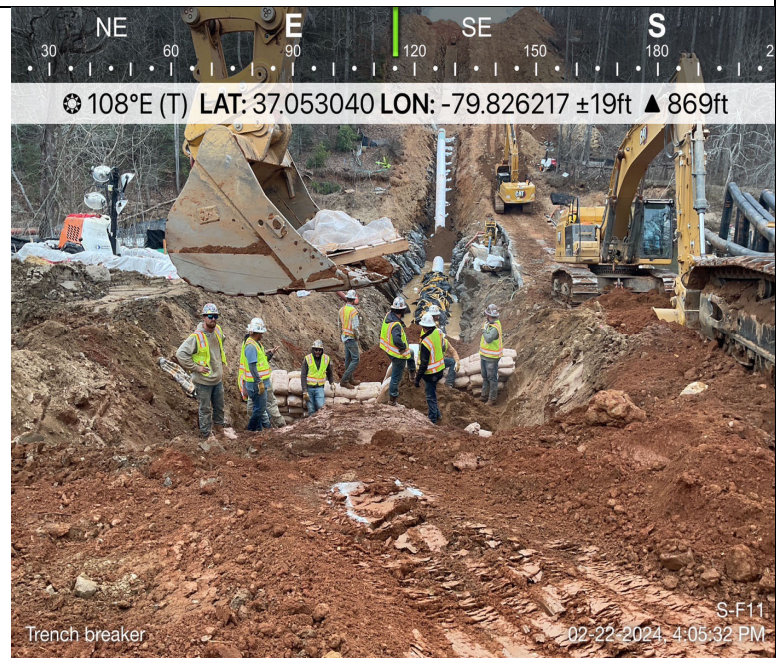
Photo Description: The trench breaker was installed around the pipe on the GAS & CIS of the resource.
