# STREAM BIOLOGICAL CONDITIONS ENVIRONMENTAL AUDITOR REPORT

<b>Stream ID:</b> S-G39	<b>Crossing Start Date:</b> 11/07/2023	<b>Crossing Completion Date:</b> 02/05/2024
<b>Milepost:</b> 227.7	<b>Pre-Con Assessment Date:</b> 10/30/2023	<b>Post-Con Assessment Date:</b> 03/20/2024
<b>Station:</b> 12030+31	<b>Stream Classification:</b> Intermittent (Perennial, Intermittent, Ephemeral)	<b>Bankfull Width (ft.):</b> 6
<b>County:</b> Montgomery	<b>303(d) Impairment Listing:</b> Not Impaired	<b>Riffle:Pool Complexes Present?</b> No

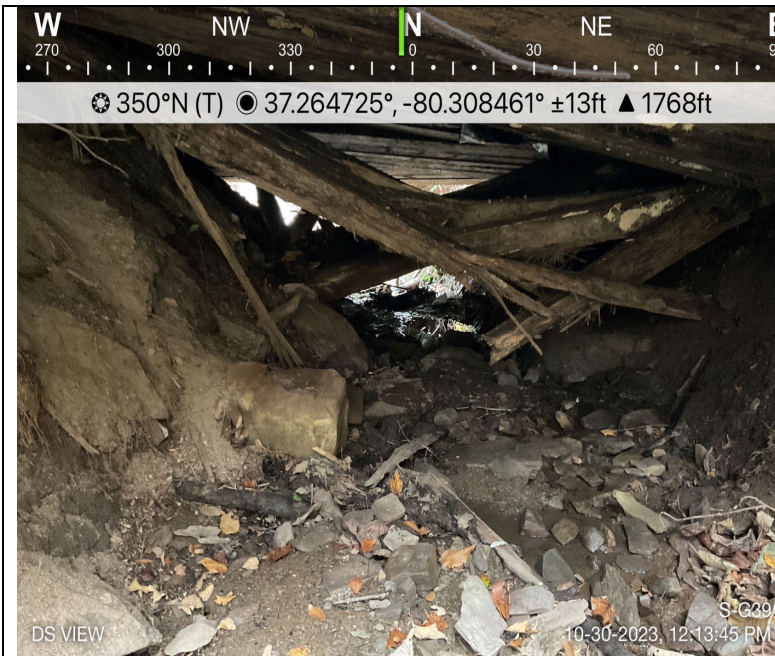
**Photo Description:** Downstream view of permitted impact area during pre-construction assessment.

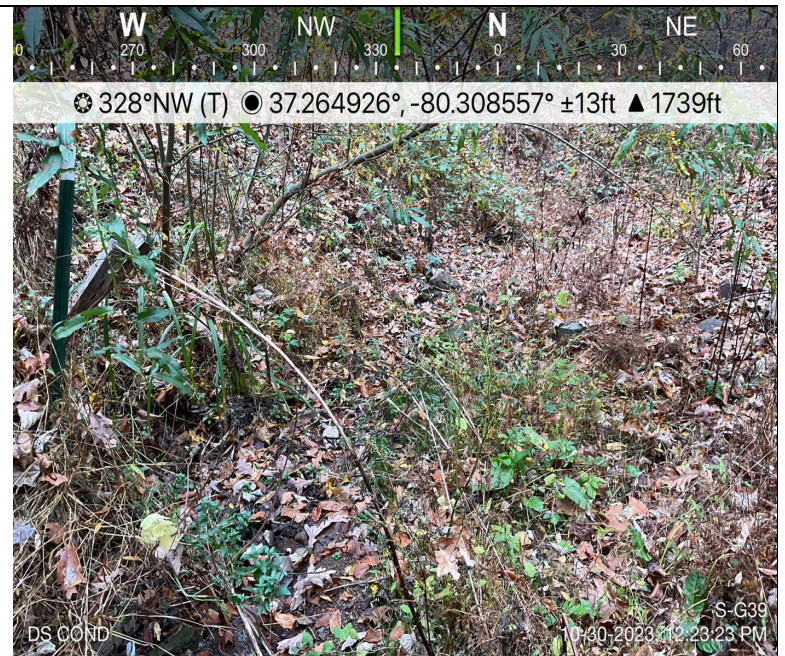
**Photo Description:** Conditions of the downstream area outside the ROW during pre-construction assessment.

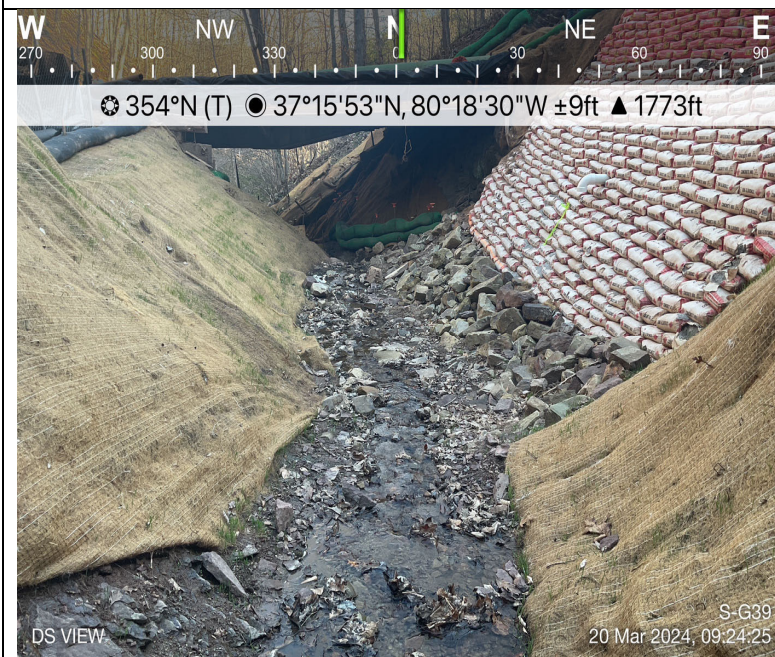
**Photo Description:** Downstream view of permitted impact area during post-construction assessment.

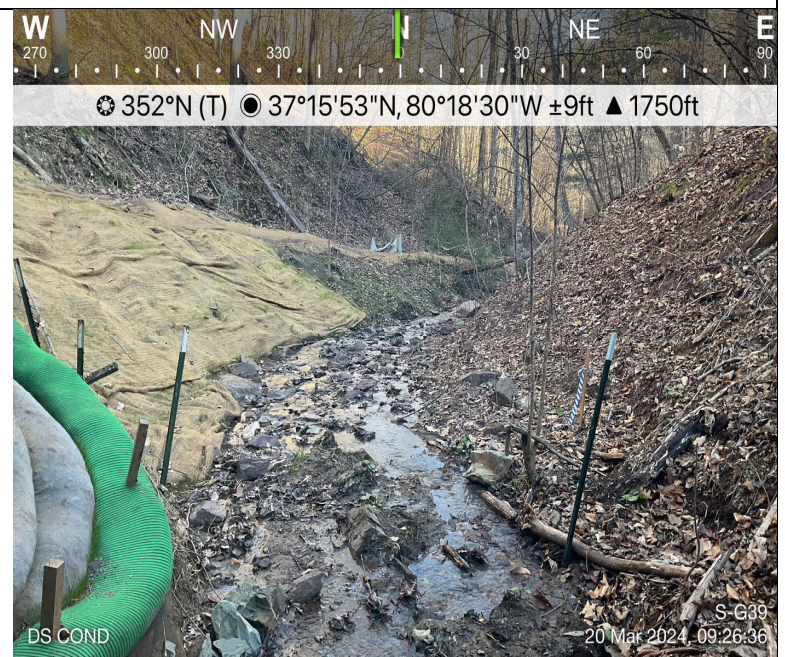
**Photo Description:** Conditions of the downstream area outside the ROW during post-construction assessment.

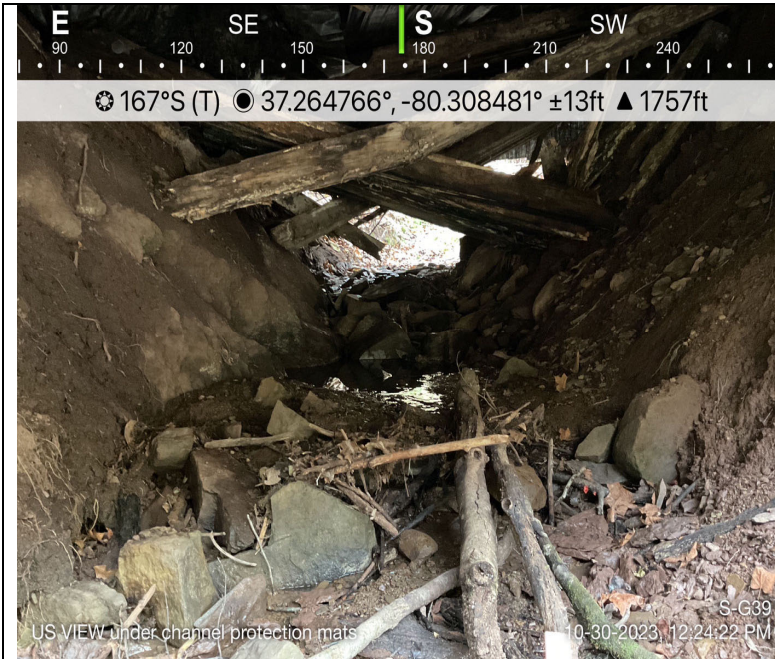
**Photo Description:** Upstream view under channel protection mats.

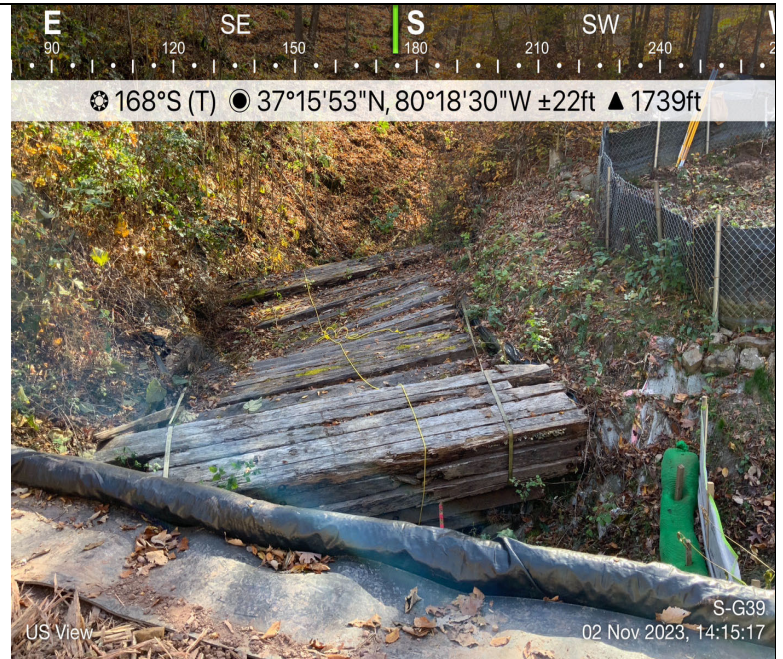
**Photo Description:** Upstream view with old deck mats to be removed.

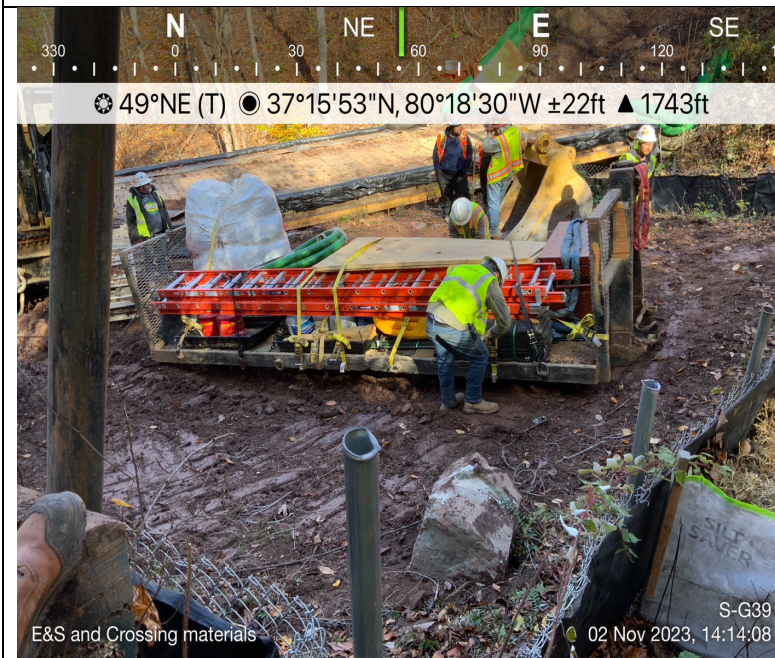
**Photo Description:** Sled with E&S and crossing materials

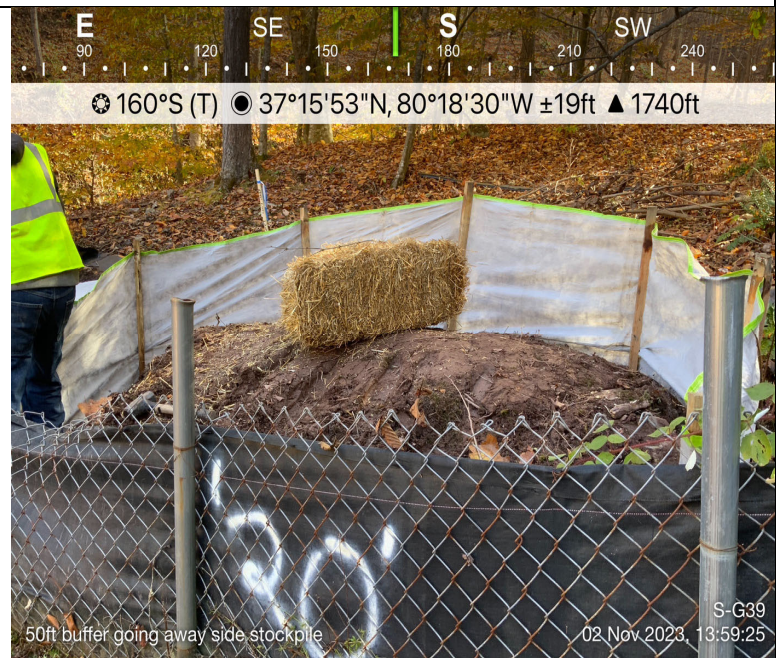
**Photo Description:** Top soil stockpile on the going away side of the pipe.

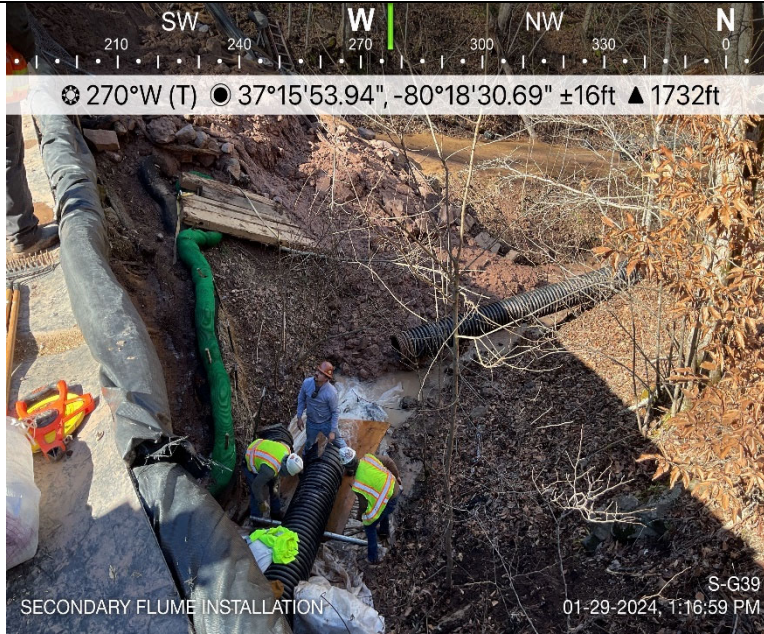
**Photo Description:** Secondary flume installation to extend flume past the area needed to be disturbed for remediation.

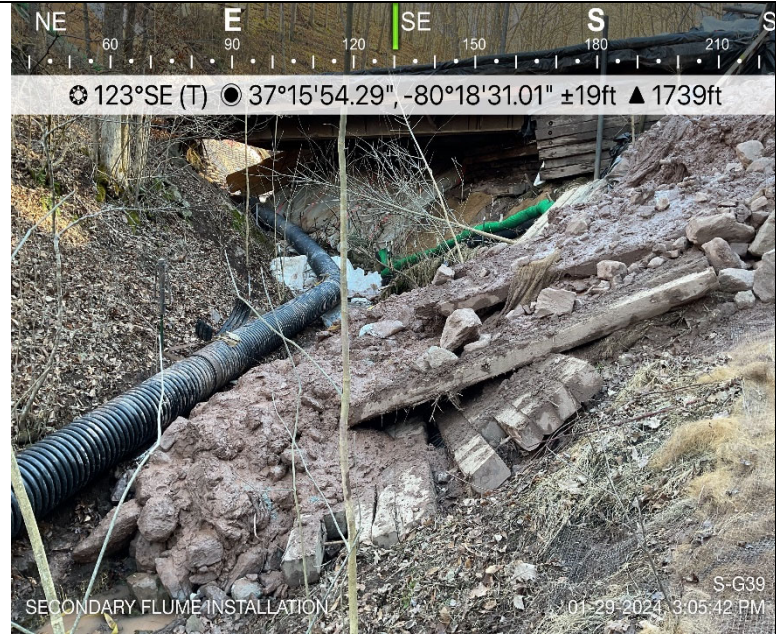
\*ITEM 14\* Accumulation of 1.5 inches of rain on Saturday 1-28-24, caused the protection walls to give way under pressure of mud and water, causing a mudslide that fell into the resource. The mudslide covered the walking path and fell left side into the downstream part out of Right-Of-Way. Accumulation of 4 wooden protection boards fell into the resource with the mud, 39x42 feet out of right away, 4 feet in height was in the resource. Mitigation plan is to work their way down CIS slope, clearing away loose and saturated mud. Flume pipes will be installed for the stream while mitigation is in progress. Estimated 3 days till finish. - G. Aceves

**Photo Description:** Alternative angle of the right of way slip into the downstream area of S-G39.

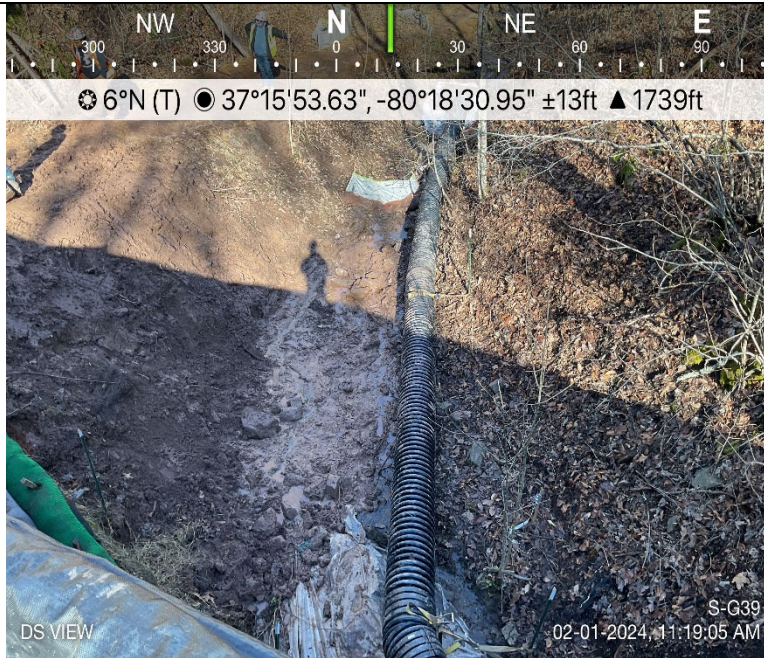
**Photo Description:** Material from right of way slip was retrieved down to the original stream substrate.

2-1-24 - Continue to build on highwall on GAS. restoration on damage to stream and stream bank continued. Restoration crew using shovels and hand removing rocks. Also restored socks for right-of-way limits. Seeded and placed erosion blanket for stability in all places disturbed by impact. -G. Aceves

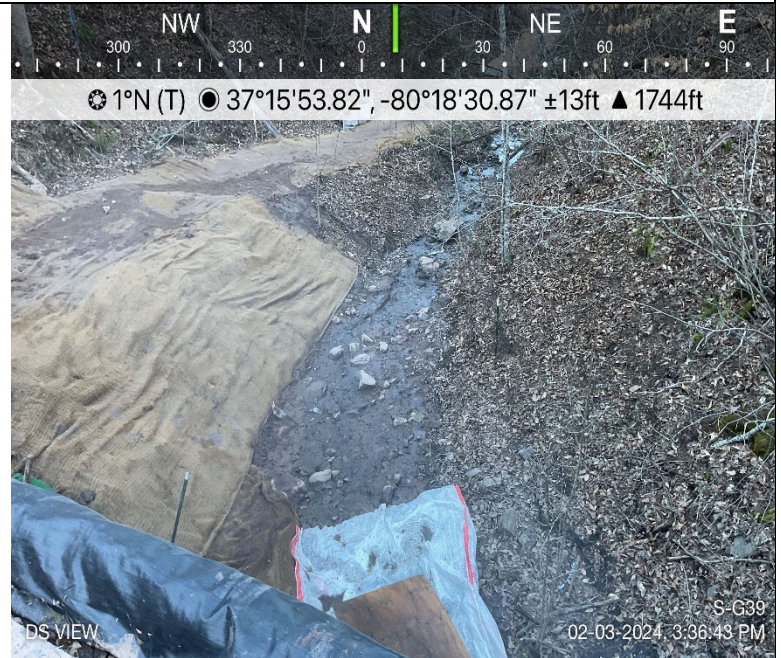
**Photo Description:** Areas impacted for the remediation effort were seeded and stabilized with erosion control matting.

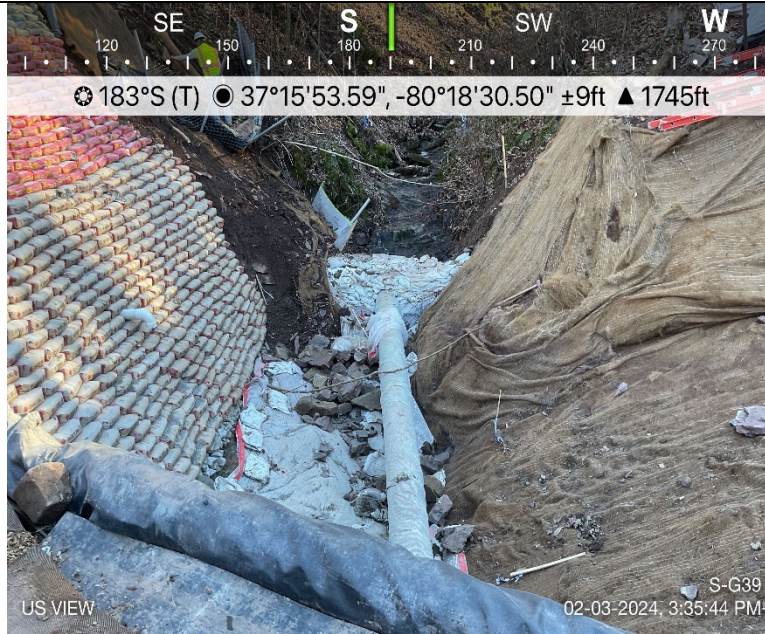
**Photo Description:** Upstream view of the resource impact area from the timber mat bridge. Highwall installation continues while resource is flumed and plastic in resource to catch debris from upslope.

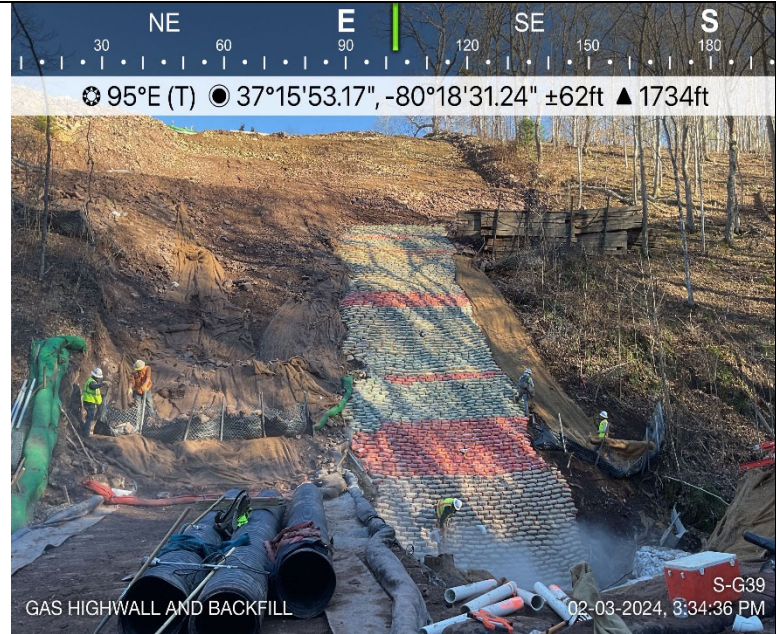
\*ITEM 8\* Change to restoration of GAS slope due to slope stability and resource being at bottom. Potential for erosion and impact to resource. Adding a highwall of cement bags to mimic angle of slope, 67ft high. Also being installed is pvc pipes acting as drainage for being the highwall every 7-10ft. Due to the steep slope conditions, a slip mitigation wall is to be installed in accordance with MVP Annual Standard and Specification MVP-44A, MVP-44B, and MVP-45 for Slide Mitigation Highwall Revetment & Steep Slope Revetment. – G. Aceves

**Photo Description:** Highwall construction was completed on the GAS of the resource. MVP Specification MVP-44A, 44B, & 45.

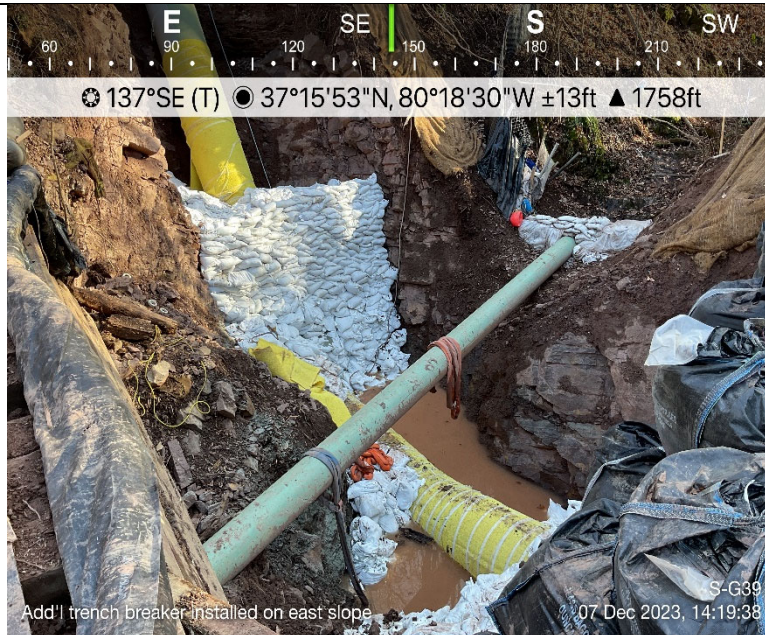
**Photo Description:** Pipe lowered into trench and beginning of sandbag backfilling on GAS of resource. Resource flumed throughout crossing activities.

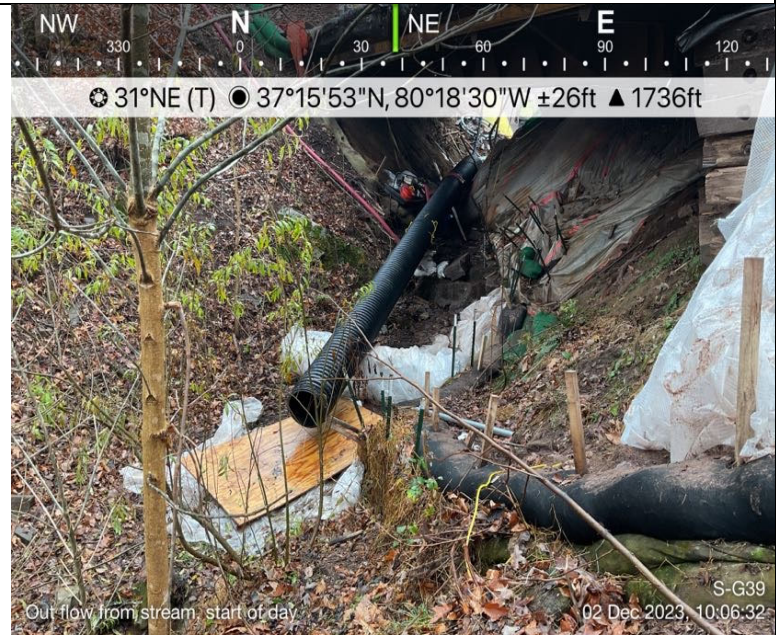
**Photo Description:** Flume outfall onto non-erodible material to prevent downstream scour.
