STREAM BIOLOGICAL CONDITIONS ENVIRONMENTAL AUDITOR REPORT

Version 2.3

Stream ID: S-H37	Crossing Start Date: 04/08/2024	Crossing Completion Date: 04/10/2024
Milepost: 277.7	Pre-Con Assessment Date: 04/06/2024	Post-Con Assessment Date: 04/10/2024
Station: 14673+10	Stream Classification: Ephemeral (Perennial, Intermittent, Ephemeral)	Bankfull Width (ft.): 6
County: Franklin	303(d) Impairment Listing: Not Impaired	Riffle:Pool Complexes Present? No

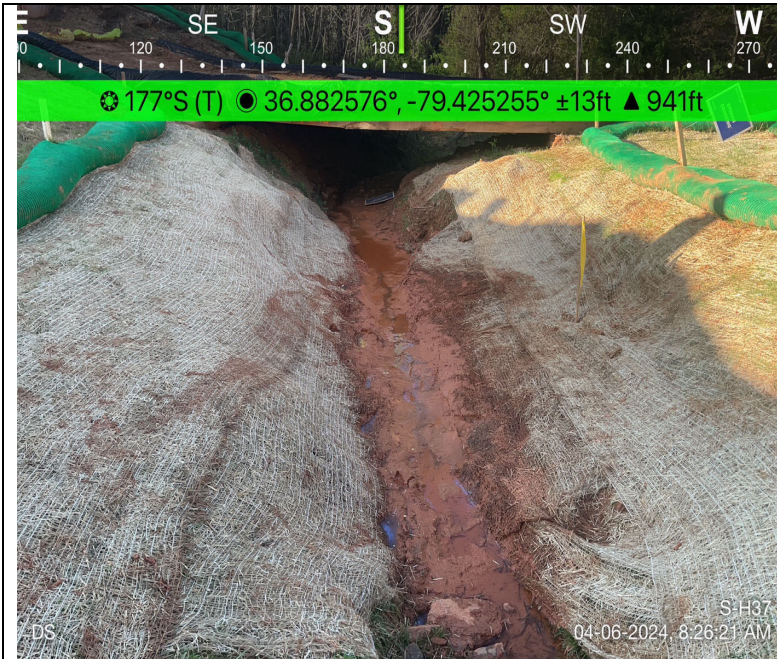
Photo Description: Downstream view of permitted impact area during pre-construction assessment.

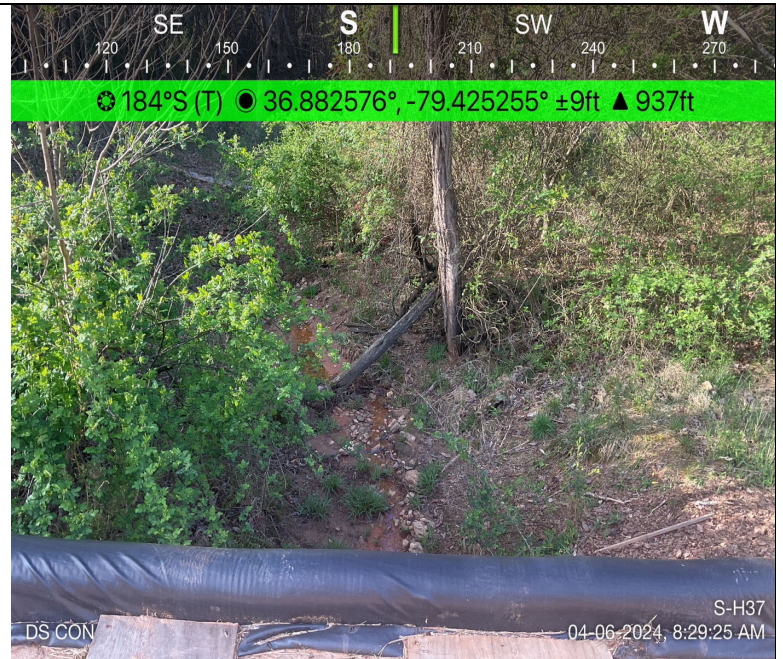
Photo Description: Conditions of the downstream area outside the ROW during pre-construction assessment.

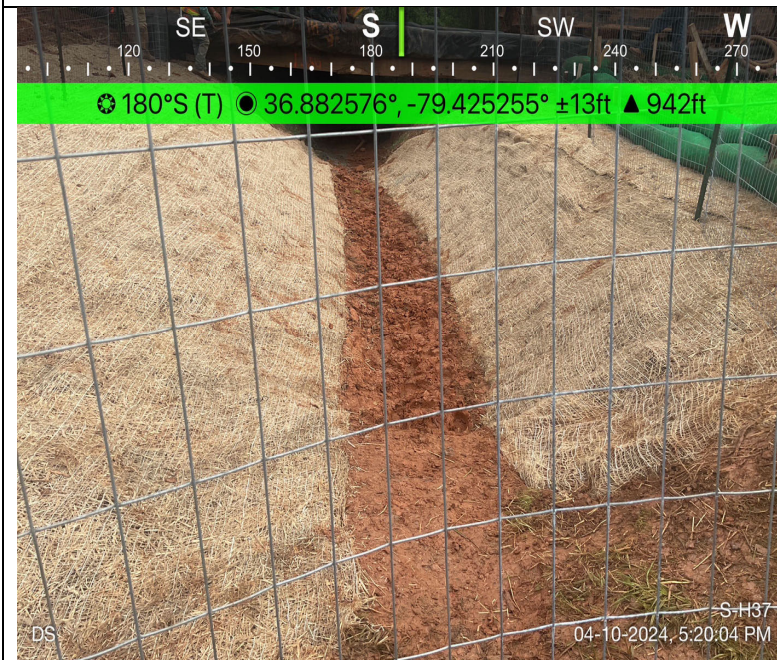
Photo Description: Downstream view of permitted impact area during post-construction assessment.

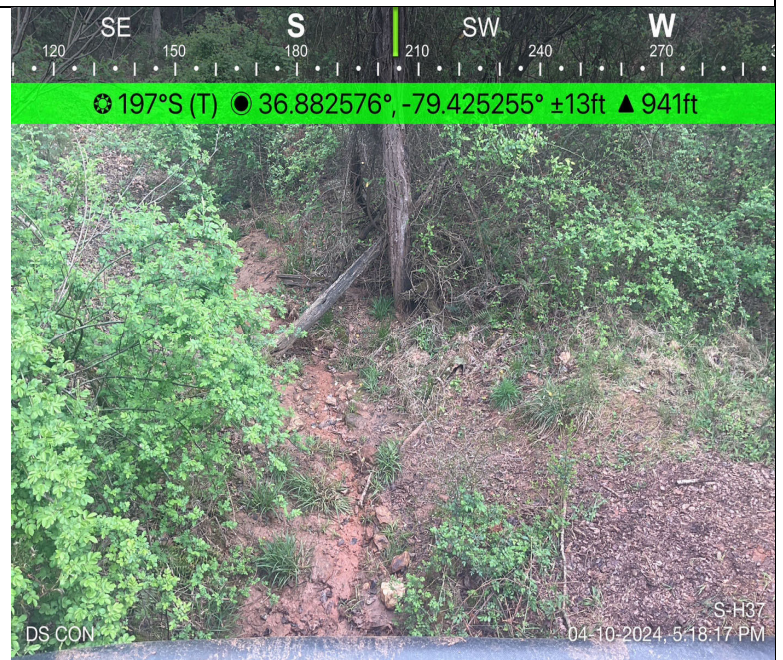
Photo Description: Conditions of the downstream area outside the ROW during post-construction assessment.

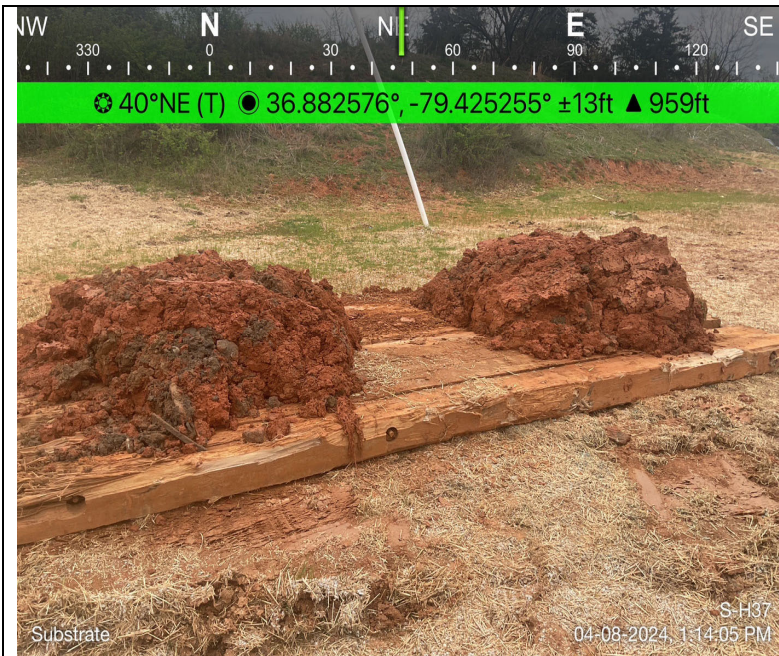
Photo Description: Substrate segregation from other soils during work activities.

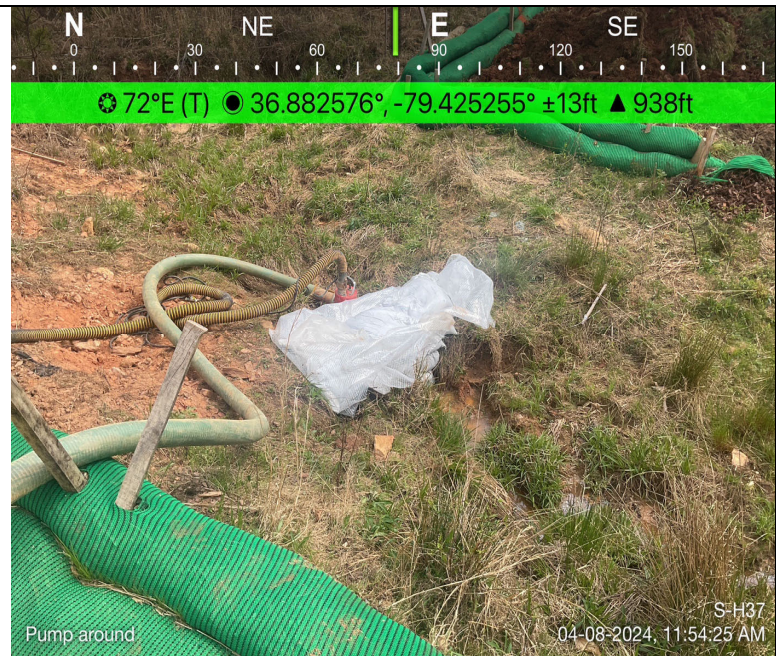
Photo Description: Dam and pump installed prior to resource disturbance.

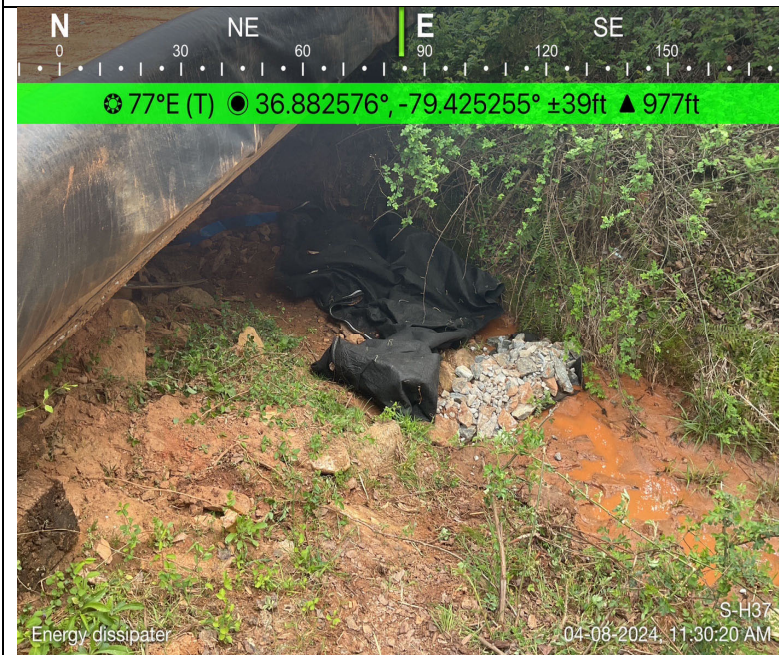
Photo Description: Energy dissipater for dam and pump around.

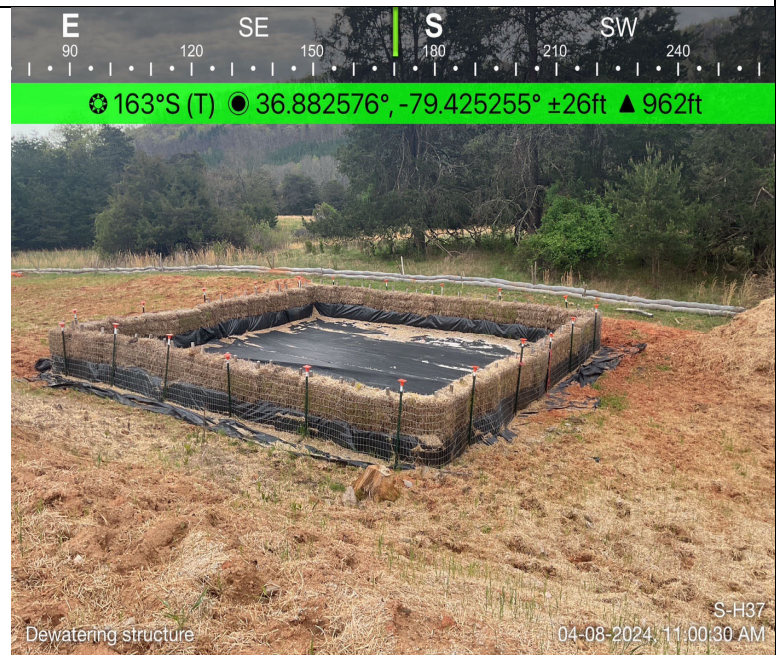
Photo Description: Dewatering structure installed on-site.
