STREAM BIOLOGICAL CONDITIONS ENVIRONMENTAL AUDITOR REPORT

Stream ID: S-IJ50	Crossing Start Date: 01/19/2024	Crossing Completion Date: 03/15/2024
Milepost: 239.5	Pre-Con Assessment Date: 01/03/2024	Post-Con Assessment Date: 03/16/2024
Station: 12655+75	Stream Classification: Perennial (Perennial, Intermittent, Ephemeral)	Bankfull Width (ft.): 25
County: Roanoke	303(d) Impairment Listing: Not Impaired	Riffle:Pool Complexes Present? No

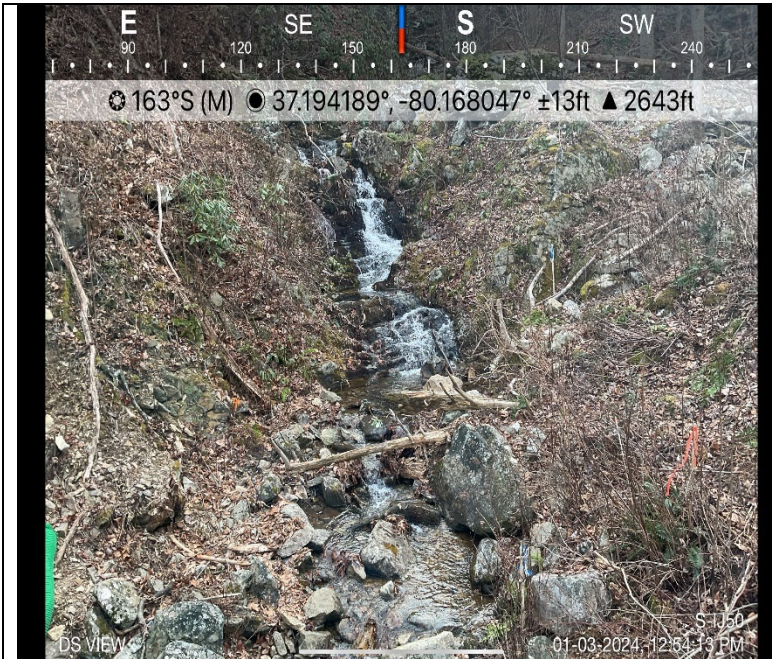
Photo Description: Upstream view of permitted impact area during pre-construction assessment.

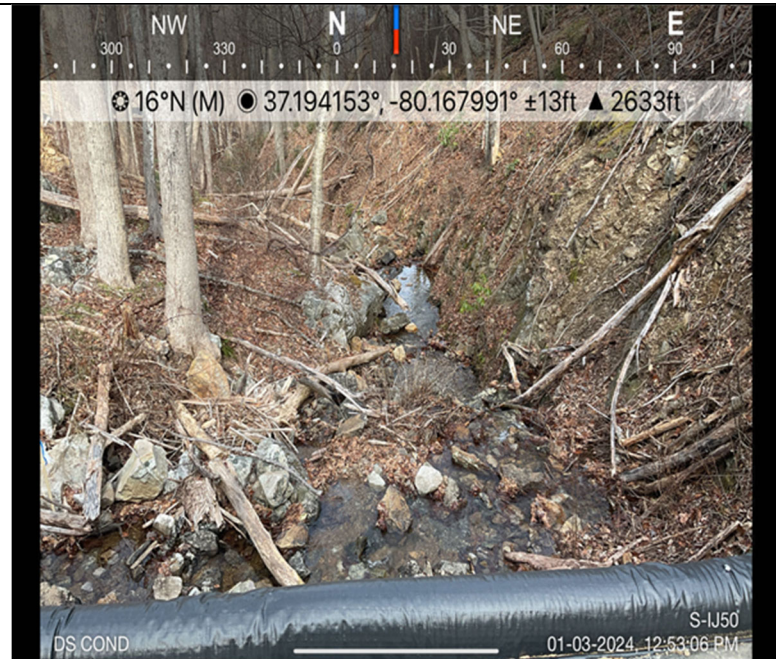
Photo Description: Conditions of the downstream area outside the ROW during pre-construction assessment.

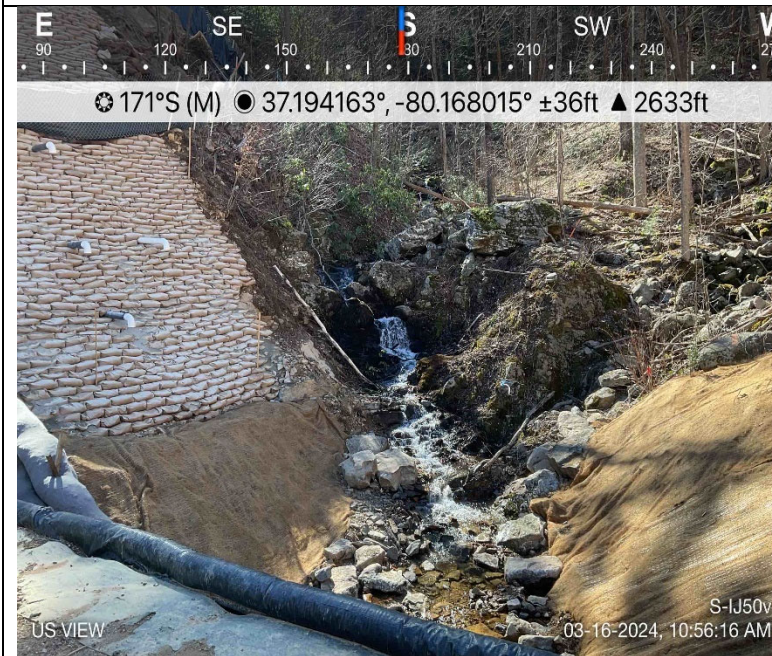
Impacts to biological conditions (riparian buffer vegetation) were observed. No unauthorized discharges were observed during the crossing activities.

Photo Description: Upstream view of permitted impact area during post-construction assessment.

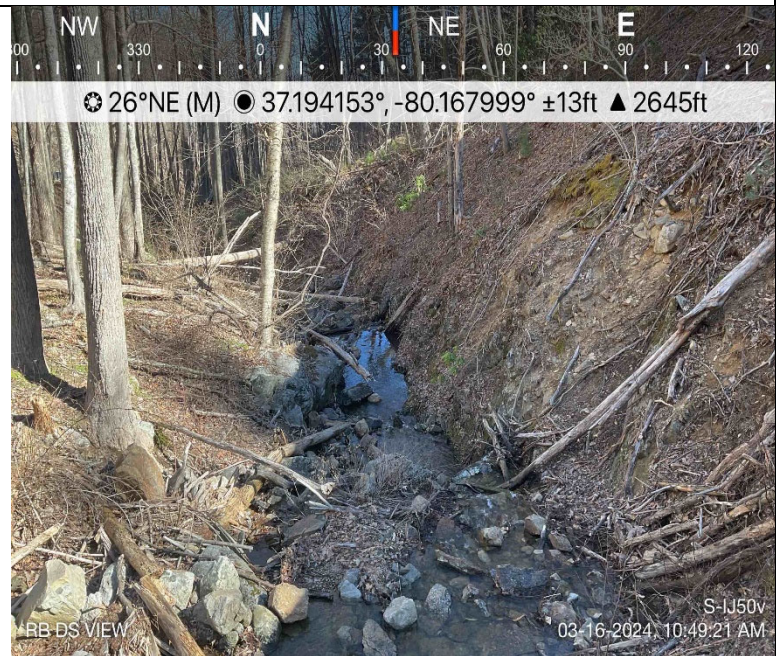
Photo Description: Conditions of the downstream area outside the ROW during post-construction assessment.

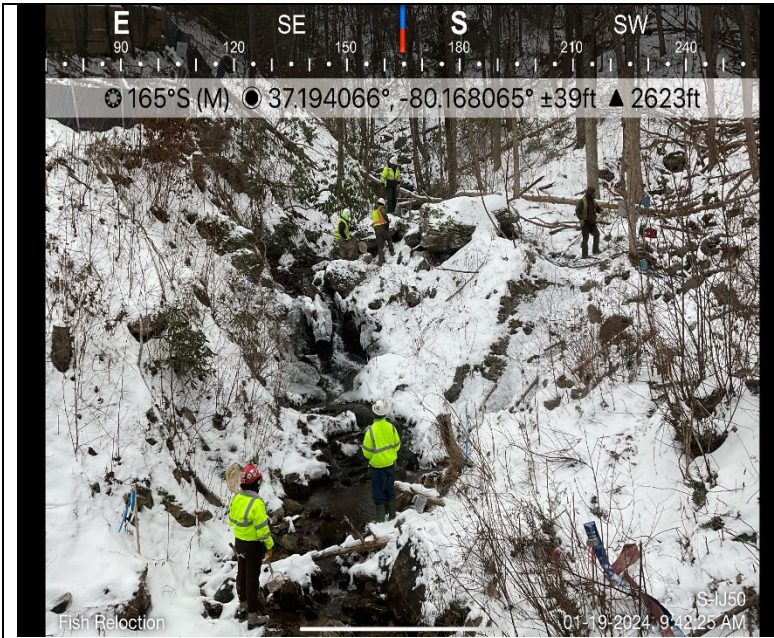
Photo Description: The fish survey and relocation was conducted.

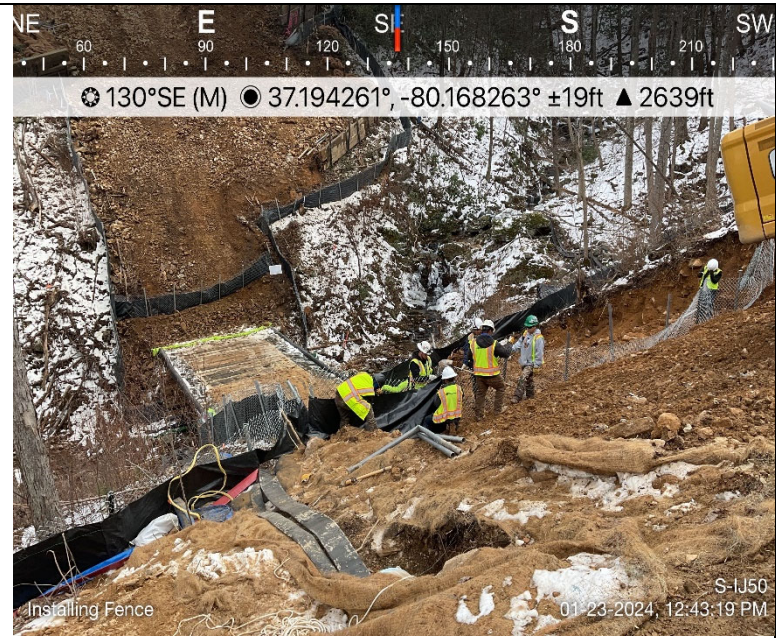
Photo Description: Super silt fence was installed around the workspace and maintained as needed throughout the crossing duration.

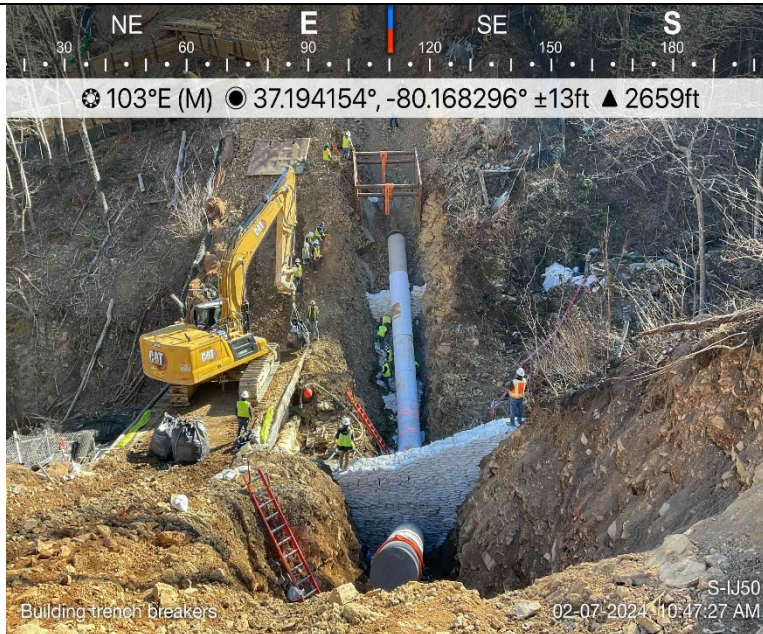
Photo Description: The trench breakers were constructed around the pipe on both the CIS and GAS of the resource.

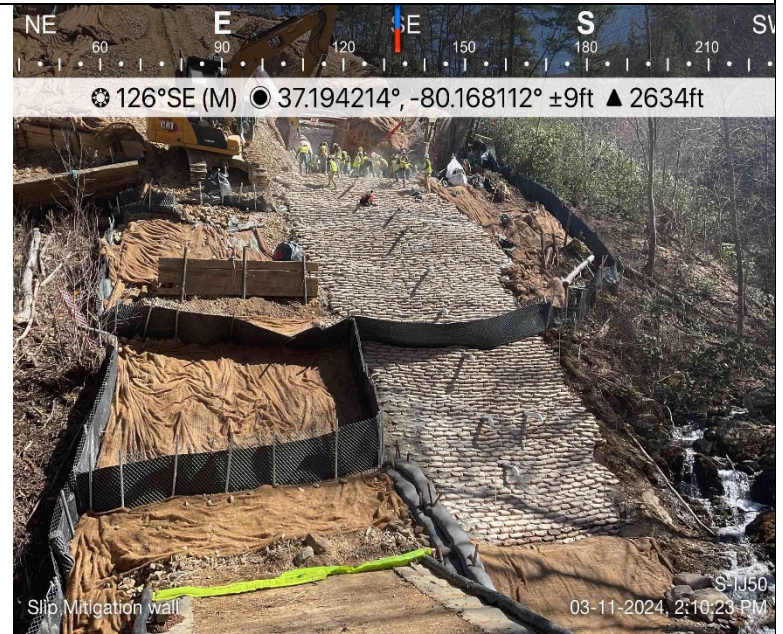
Item #8: Resource buffer zone modifications due to wall installation. Potential for 50-foot buffer zone vegetation re-establishment is reduced from preconstruction conditions.

Photo Description: The slip mitigation wall during construction. Wall construction began outside the OHWM of resource.

02/18/24 – Dewatering continued. The CIS was coated. The GAS was backfilled with sandbags, and construction began on the slip mitigation wall. Due to the steep slope conditions, a slip mitigation wall is to be installed in accordance with MVP Annual Standard and Specification MVP-44A, MVP-44B, and MVP-45 for Slide Mitigation Highwall Revetment & Steep Slope Revetment. - T. Brodbeck
