# STREAM BIOLOGICAL CONDITIONS ENVIRONMENTAL AUDITOR REPORT

| <b>Stream ID:</b> S-KL39 | <b>Crossing Start Date:</b> 03/15/2024 | <b>Crossing Completion Date:</b> 03/18/2024 |
| <b>Milepost:</b> 265.6 | <b>Pre-Con Assessment Date:</b> 03/14/2024 | <b>Post-Con Assessment Date:</b> 03/20/2024 |

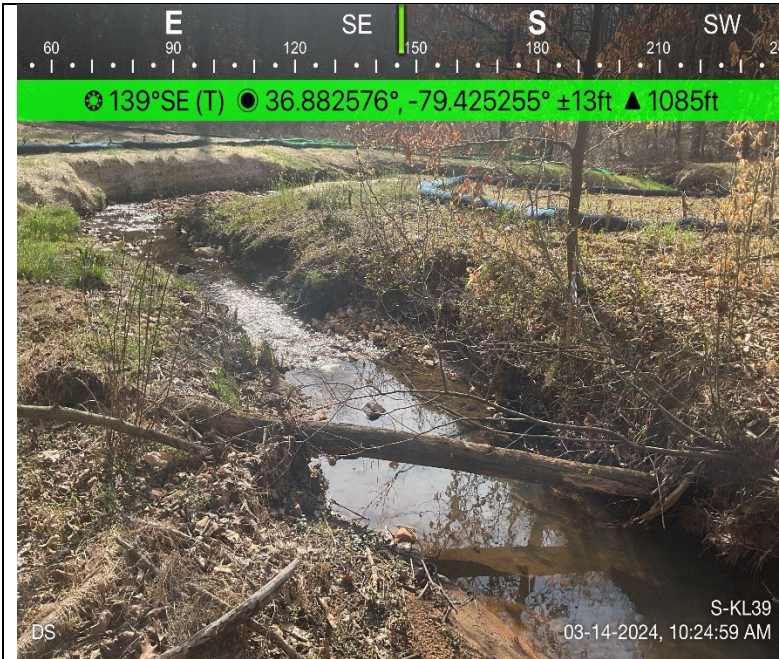
**Photo Description:** Downstream view of permitted impact area during pre-construction assessment.

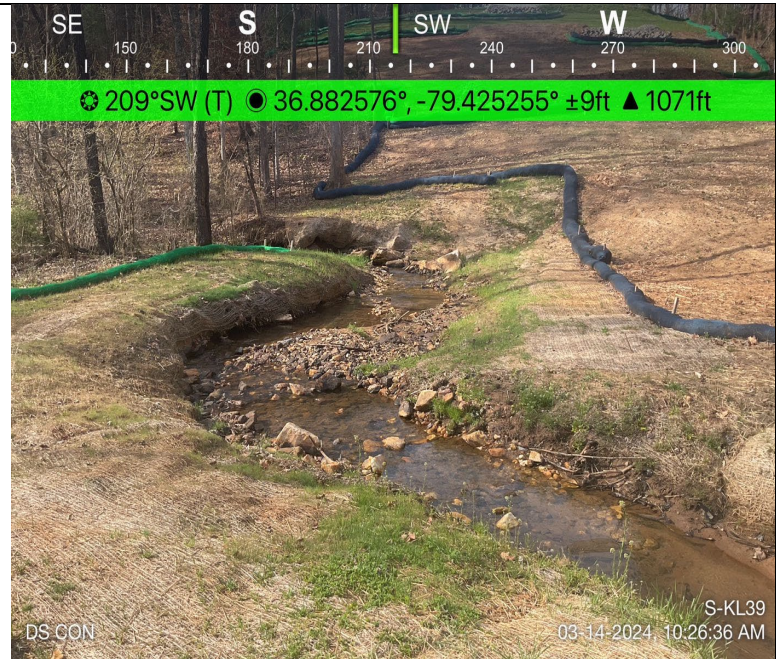
**Photo Description:** Conditions of the downstream area outside the ROW during pre-construction assessment.

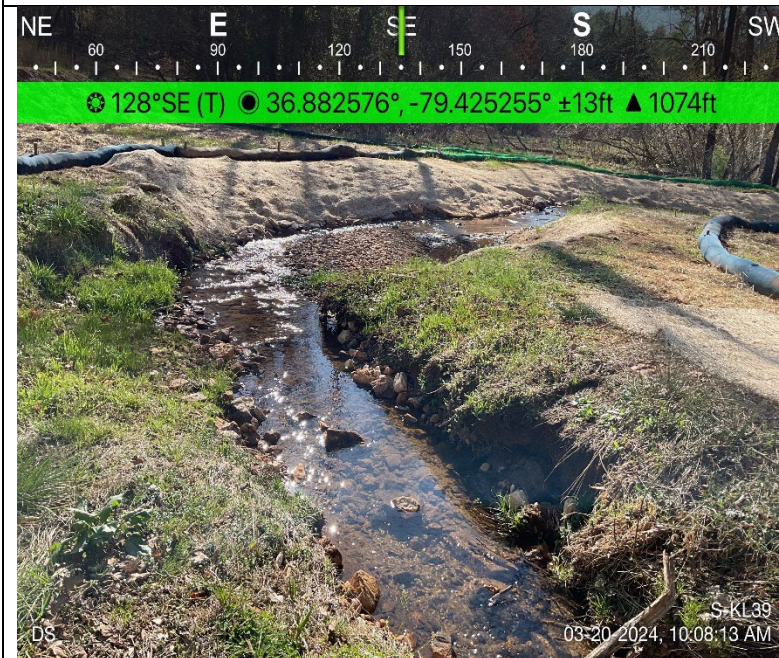
**Photo Description:** Downstream view of permitted impact area during post-construction assessment.

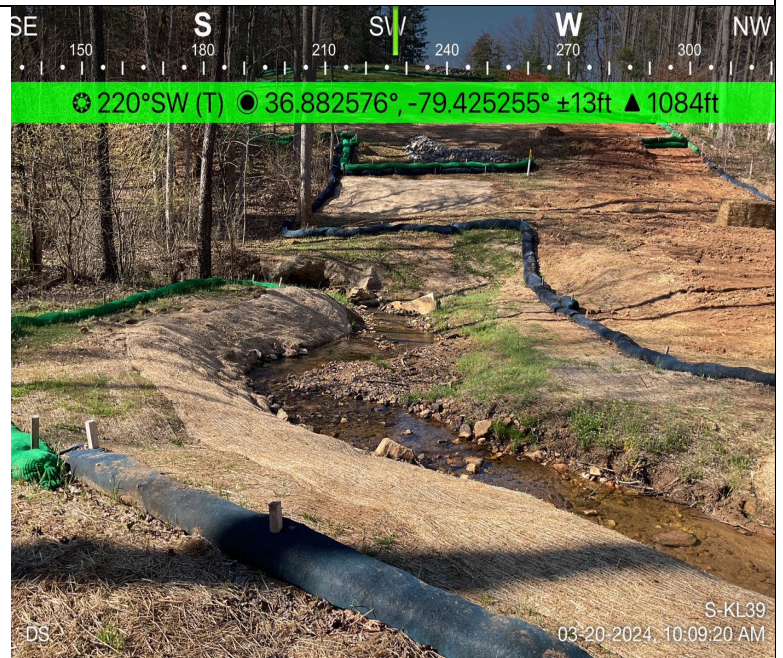
**Photo Description:** Conditions of the downstream area outside the ROW during post-construction assessment.

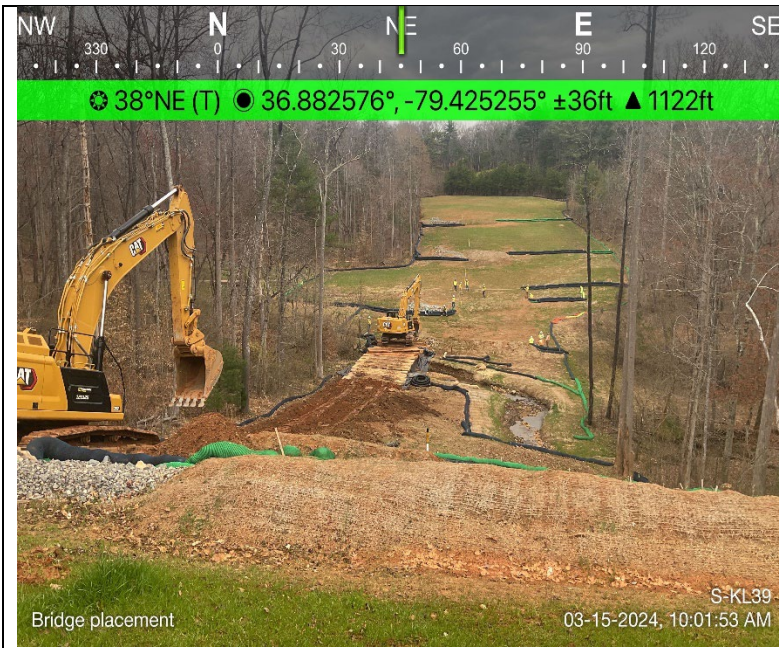
**Photo Description:** Timber mat bridge installed across resource for anomaly dig and bank erosion repairs.

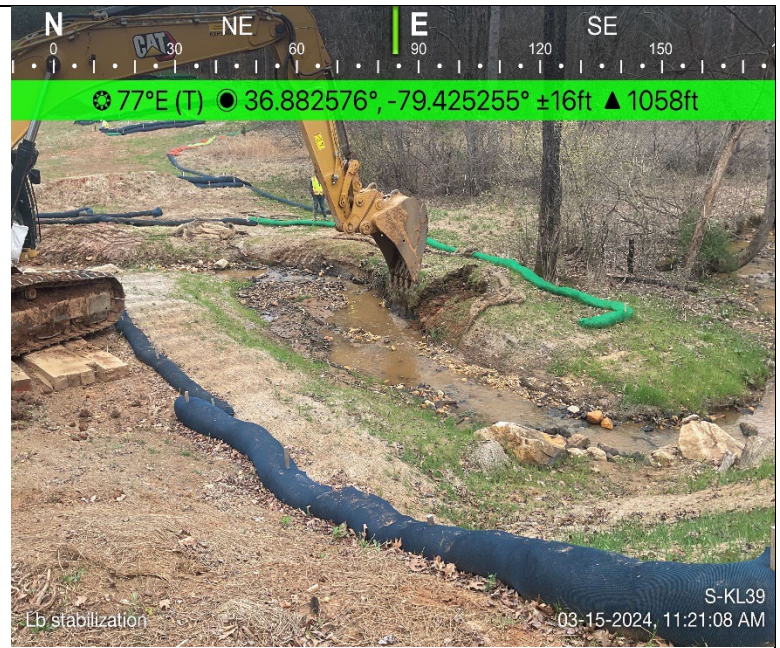
Item #14: Unauthorized discharge of sediment was observed during the work activities due in-stream work being performed without an approved crossing method installed.

**Photo Description:** Bank stabilization work completed within the resource without an approved crossing method installed. Sediment from bank repairs flowed into stream and off-LOD during repair activities.

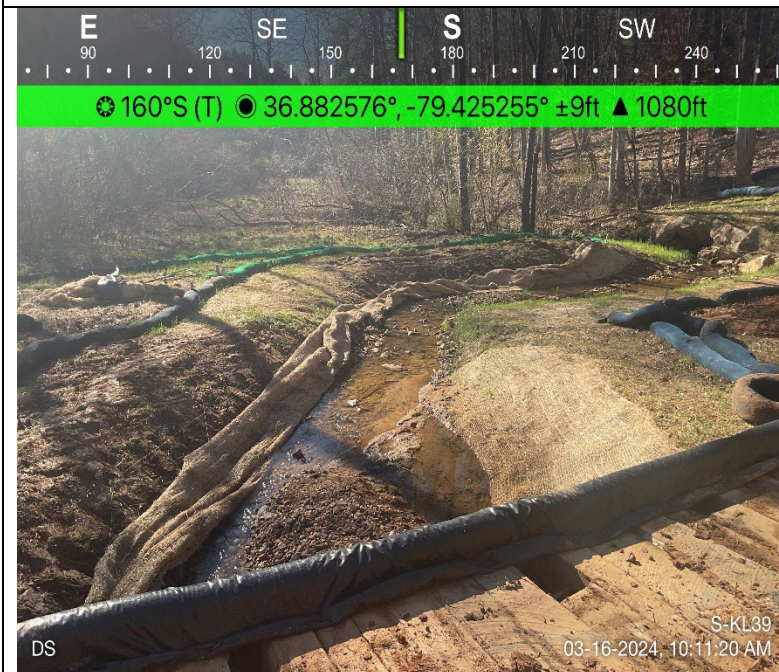
**Photo Description:** Denuded banks exposed to stream flow without an approved crossing method installed.

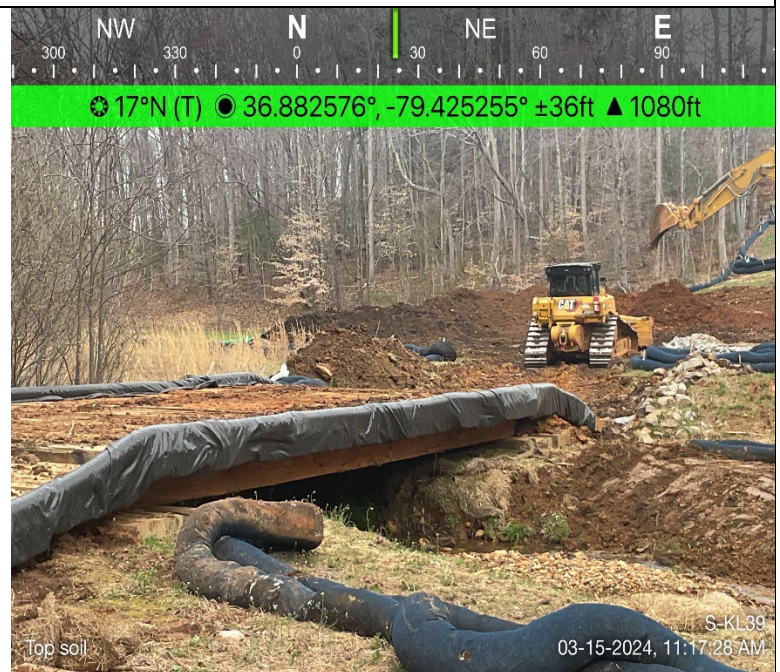
03-15-2024: Crews removed topsoil and stockpiled on subsoil with no fabric underlayment, adjacent to resource. No approved crossing method installed for in-stream work. Contractor installed bridge over stream. Removed topsoil from left bank and stockpiled adjacent to resource. Laid back bank in two separate areas to 3 to 1 slope as a stable angle of repose. -D. Fraise

**Photo Description:** Topsoil stockpiled on subsoil without underlayment, adjacent to resource without sediment controls installed.
