Re: Mountain Valley Pipeline, LLC
Docket No. CP16-10-000
Weekly Status Report No. 51

Docket No. CP16-10-000
Weekly Report No. 51
Report Period: 10/13/18 - 10/19/18

Non-Compliance Report

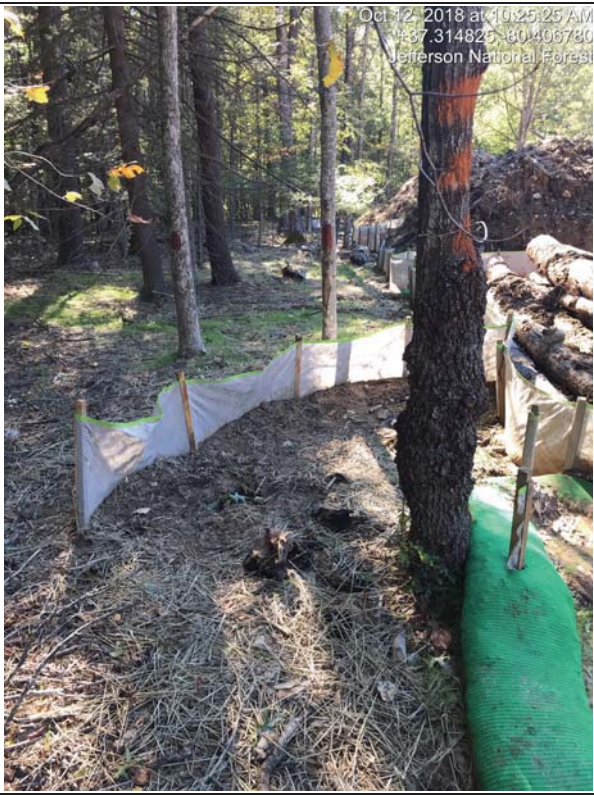
This non-compliance is issued for work that took place outside of the Limits of Disturbance (LOD) near MP 219.35 on October 11, 2018. MVP installed one silt fence that extended 6' outside the LOD without first requesting authorization.

<p>Oct 12, 2018 at 10:25:25 AM +37.314825,-80.406730 Jefferson National Forest</p>	<p>GPS Coordinates: See photo</p> <p>Aspect: Facing Southeast</p> <p>Photo Number: 3</p> <p>Mile Post: 219.35</p> <p>Description: One run of silt fence was installed on 10/11 that was installed outside of the LOD. The silt fence run stretches from inside the LOD to 6' outside of the LOD, and caused disturbance where the silt fence was trenched.</p>
<p>Photograph</p>

1. MVP will inform their contractors and staff to remain within the LOD unless they have prior approval from the FS.

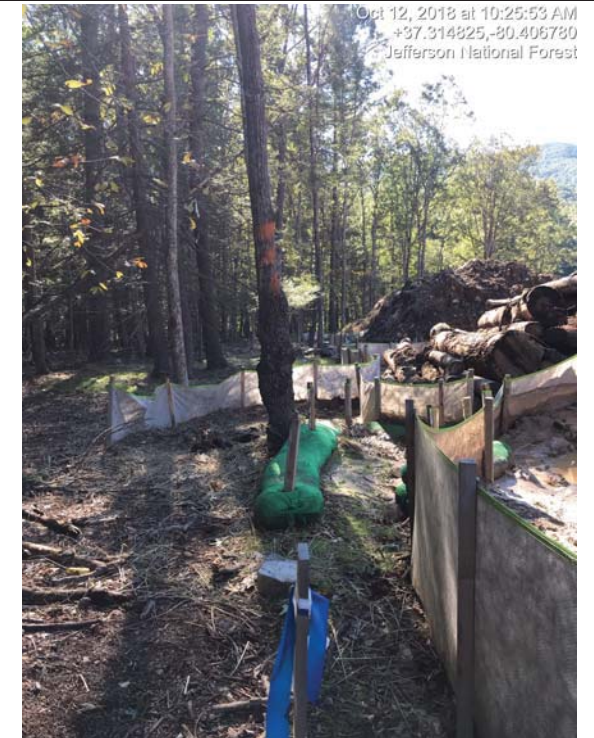
<p>Oct 12, 2018 at 10:25:53 AM +37.314825,-80.406730 Jefferson National Forest</p>	<p>GPS Coordinates: See photo</p> <p>Aspect: Facing Southeast</p> <p>Photo Number: 4</p> <p>Mile Post: 219.35</p> <p>Description: One run of silt fence was installed on 10/11 that was installed outside of the LOD. The silt fence run stretches from inside the LOD to 6' outside of the LOD, and caused disturbance where the silt fence was trenched. See LOD stake in foreground of photo showing that most of the silt fence was installed outside of the LOD.</p>
