# Ephemeral Stream Assessment Form (Form 1a)

Project #	Project Name	Locality	Cowardin Class.	HUC	Date	SAR #	Impact/SAR length	Impact Factor
	Mountain Valley Pipeline	Giles	R6	05050002	8/23/2017		45	1
Name(s) of Evaluator(s)		Stream Name and Information						
James Cook, Emily Foster		S-IJ16-a

# Stream Assessment Form (Form 1)

Project #	Project Name	Locality	Cowardin Class.	HUC	Date	SAR #	Impact/SAR length	Impact Factor
	Mountain Valley Pipeline	Pittsylvania		030101050104	11/16/2016		15	1
Name(s) of Evaluator(s)		Stream Name and Information						
J.Cook, E.Foster		S-H42, Permanent Easement (Transco), Perennial

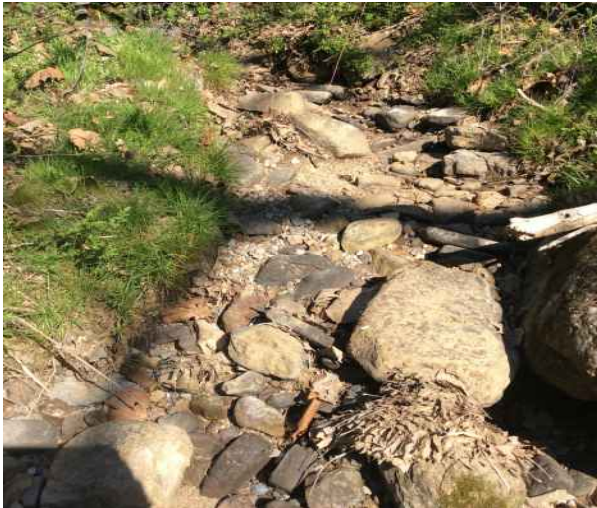
**SJ16a**

Conditional Category								NOTES>> Majority of the impact area is outside of the permanent road, though it does cross perpendicular to the asset. Bed was dry during the early spring. At area of impact, the majority of the canopy is low suboptimal to high marginal, with the right riparian buffer extends into an impermeable road surface.
Riparian Buffers	Optimal	Suboptimal	Marginal	Poor				
	Tree stratum (dbh > 3 inches) present, with > 60% tree canopy cover and an non-maintained understory. Wetlands areas.	High Suboptimal: Riparian areas with tree stratum (dbh > 3 inches) present, with 30% to 60% tree canopy cover and containing both herbaceous and shrub layers or a non-maintained understory.	Low Suboptimal: Riparian areas with tree stratum (dbh > 3 inches) present, with >30% tree canopy cover and a maintained understory. Recent cutover (dense vegetation).	High Marginal: Non-maintained, dense herbaceous vegetation with either a shrub layer or a tree layer (dbh > 3 inches) present, with <30% tree canopy cover.	Low marginal: Non-maintained, dense herbaceous vegetation, riparian areas lacking shrub and tree stratum, hay production, ponds, open water. If present, tree stratum (dbh > 3 inches) present, with <30% tree canopy cover with maintained understory.	High Poor: Lawns, mowed, and maintained areas, nurseries; no-till cropland; actively grazed pasture, sparsely vegetated non-maintained area, recently seeded and stabilized, or other comparable condition.	Low Poor: Impervious surfaces, mine spoil lands, denuded surfaces, row crops, active feed lots, trails, or other comparable conditions.

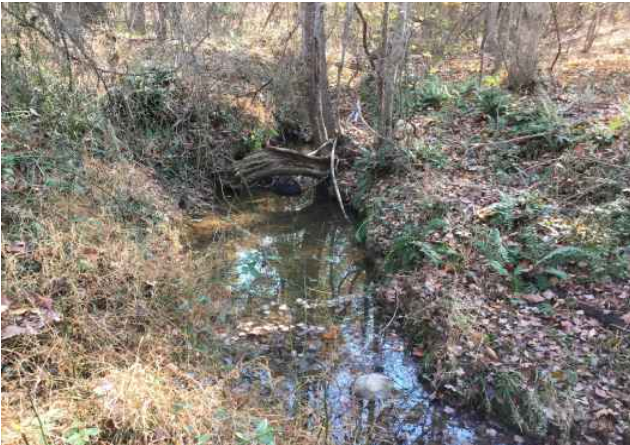
**S-H42**

NOTES>> **Immature forest, some pine saplings, Dense invasive vegetation, tree of heaven and microstegium vimineum**

Undercut banks and roots, stable. Varied water velocity and depths. Riffle-pool complexes.

**No current channel alterations.**
