Baseline Assessment – Stream Attributes

Reach S-B29 (Pipeline ROW) Perennial Spread D Webster County, West Virginia

Spread D Stream S-B29 (Pipeline ROW) Webster County

Client: MOUNTAIN VALLEY PIPELINE, LLC
Title: PROFILE AND CROSS-SECTIONS
BASELINE SURVEY
CROSSING S-B29 - MEADOW FORK
(MP 107.02)
WEBSTER COUNTY, WV

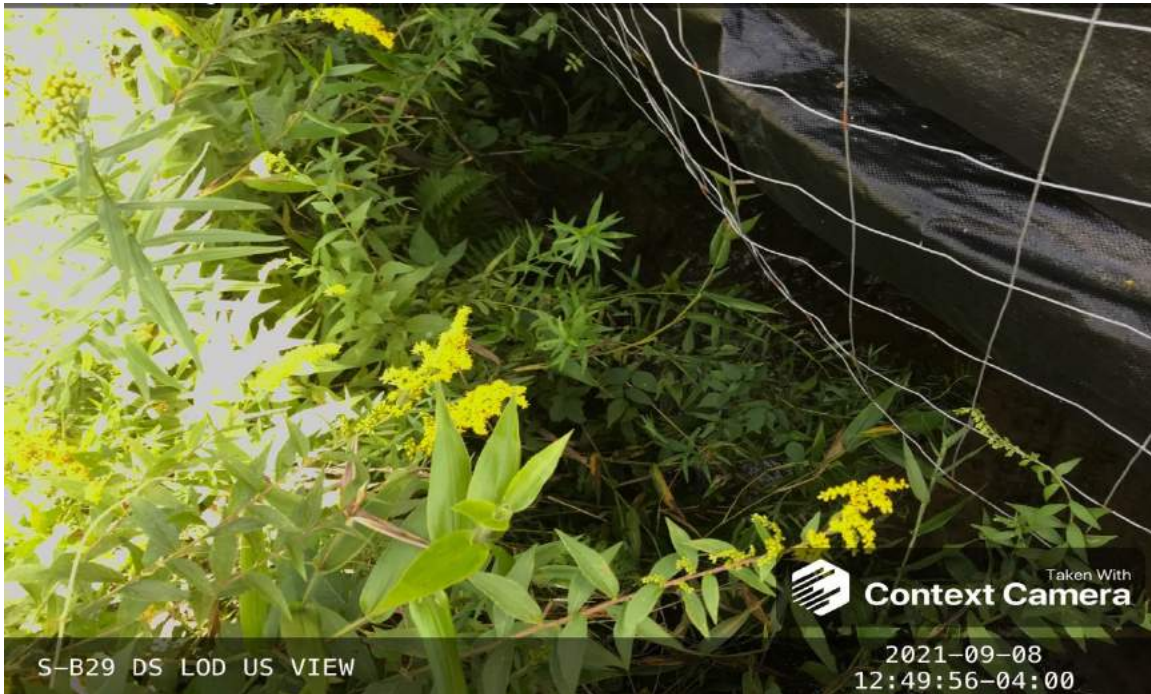
Photo Type: DS, US View
Location, Orientation, Photographer Initials: Downstream Edge of ROW, Upstream View, SM/MW
Lat: 38.399618 Long: -80.597332

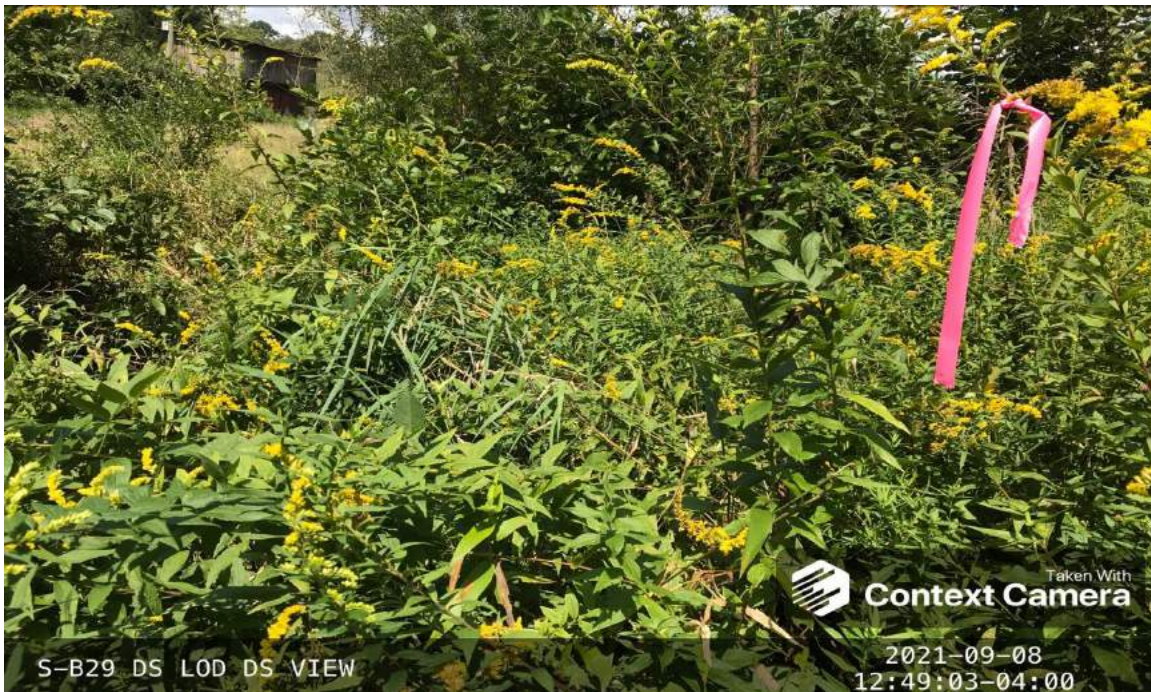
Photo Type: DS, DS View
Location, Orientation, Photographer Initials: Downstream Edge of ROW, Downstream View, SM/MW
Lat: 38.399618 Long: -80.597332

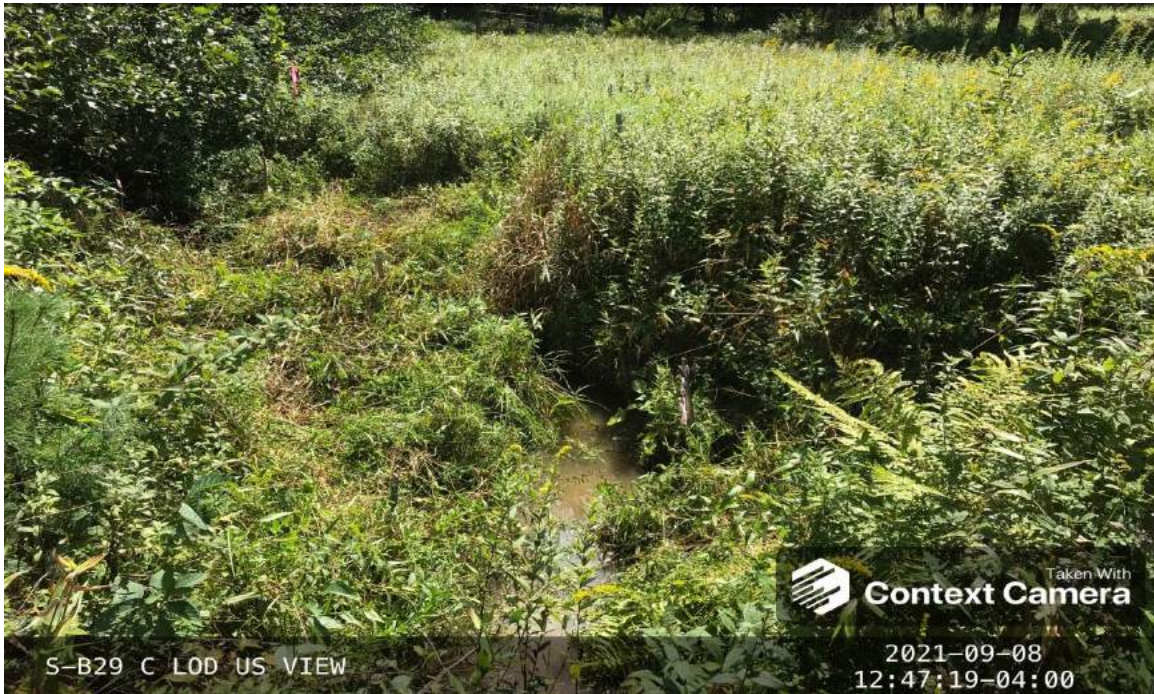
Photo Type: US View at Center
Location, Orientation, Photographer Initials: Center ROW, Upstream View, SM/MW
Lat: 38.399618 Long: -80.597332

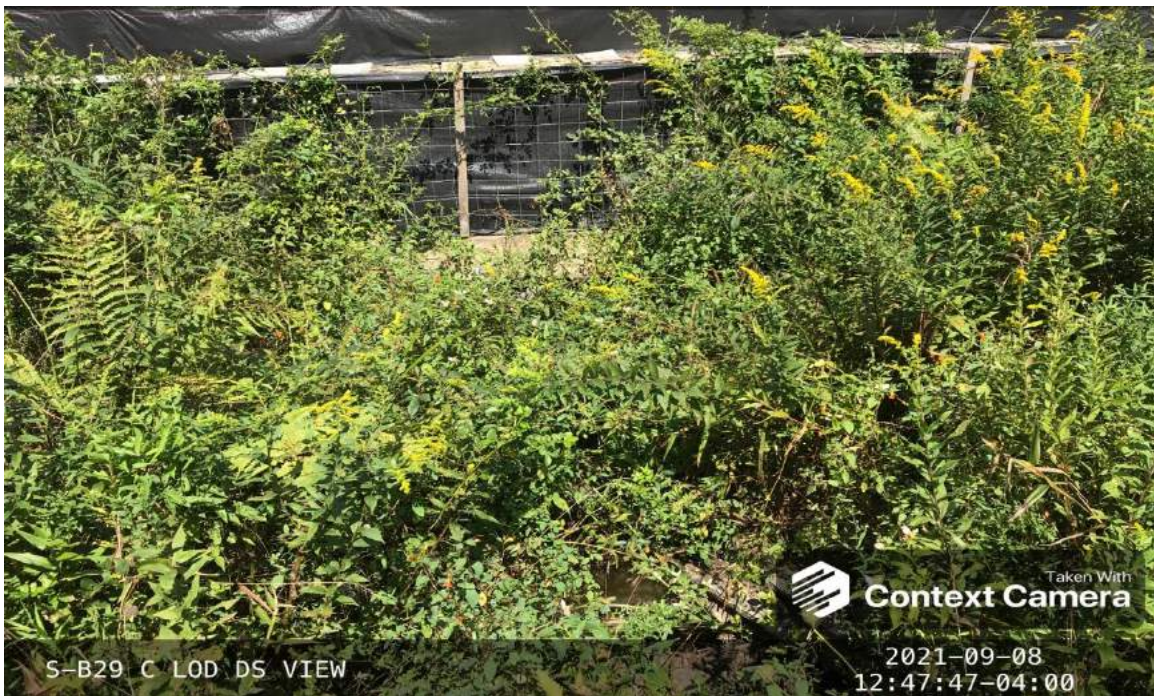
Photo Type: DS View at Center
Location, Orientation, Photographer Initials: ROW Center, Downstream View, SM/MW
Lat: 38.399618 Long: -80.597332

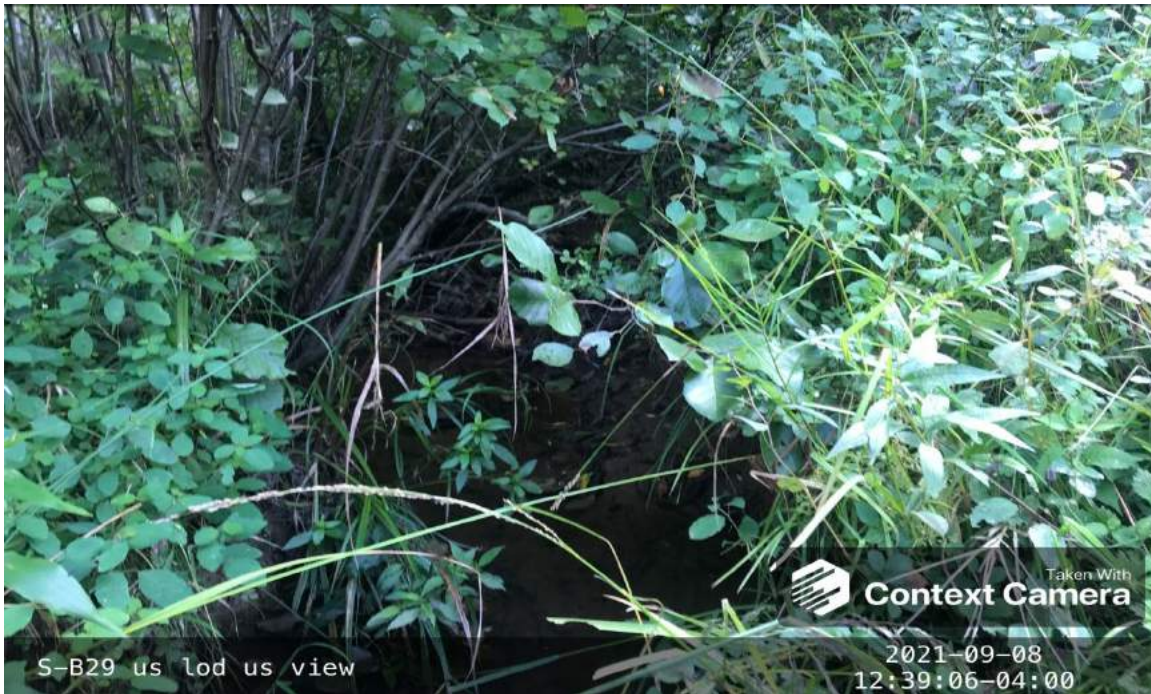
Photo Type: US, US View
Location, Orientation, Photographer Initials: Upstream Edge of ROW, Upstream View, SM/MW
Lat: 38.399618 Long: -80.597332

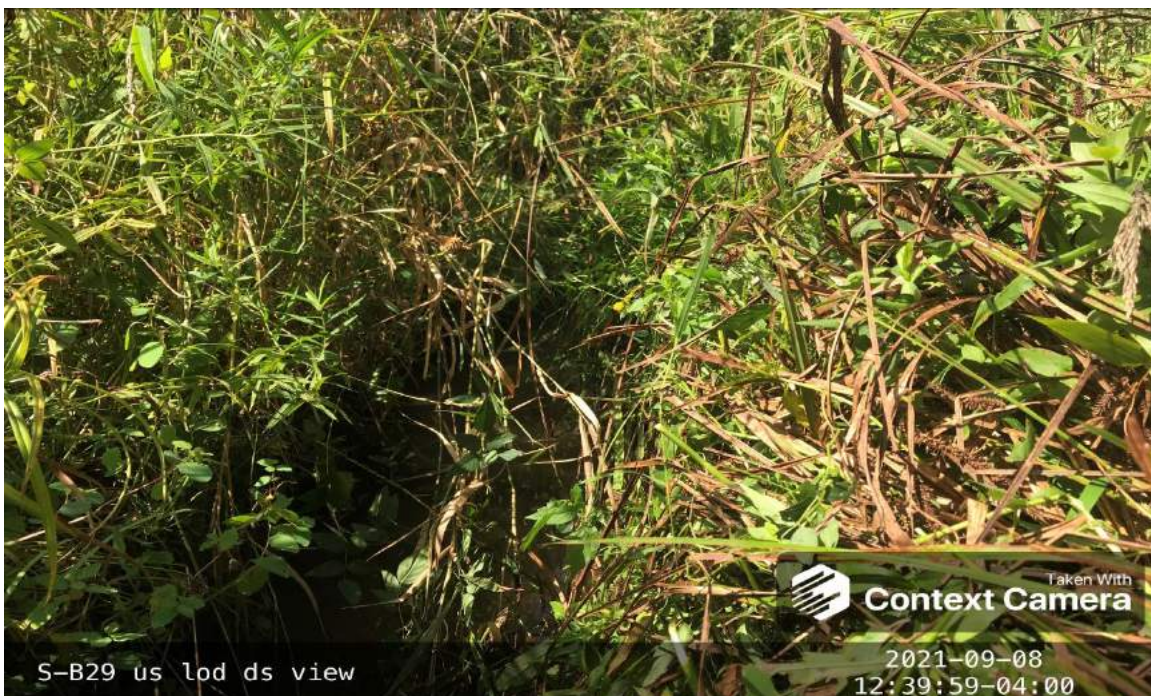
Photo Type: US, DS View
Location, Orientation, Photographer Initials: Upstream Edge of ROW, Downstream View, SM/MW
Lat: 38.399618 Long: -80.597332

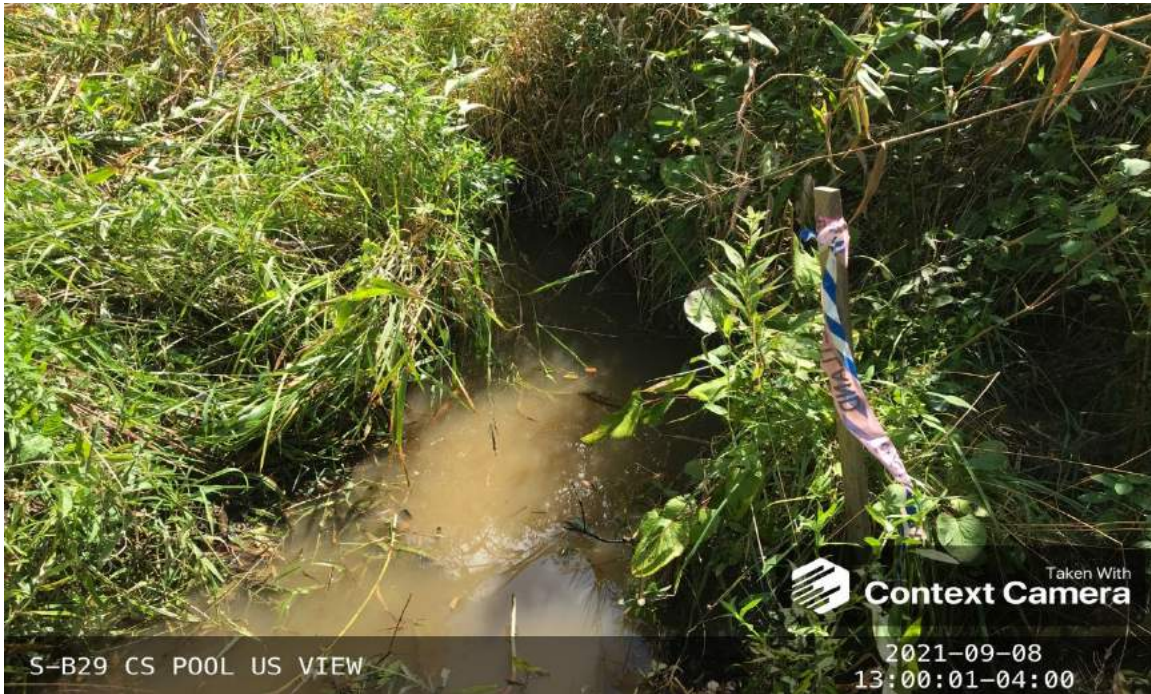
Photo Type: Pool, DS View
Location, Orientation, Photographer Initials: Upstream of Pool, Downstream View, SM/MW
Lat: 38.399618 Long: -80.597332

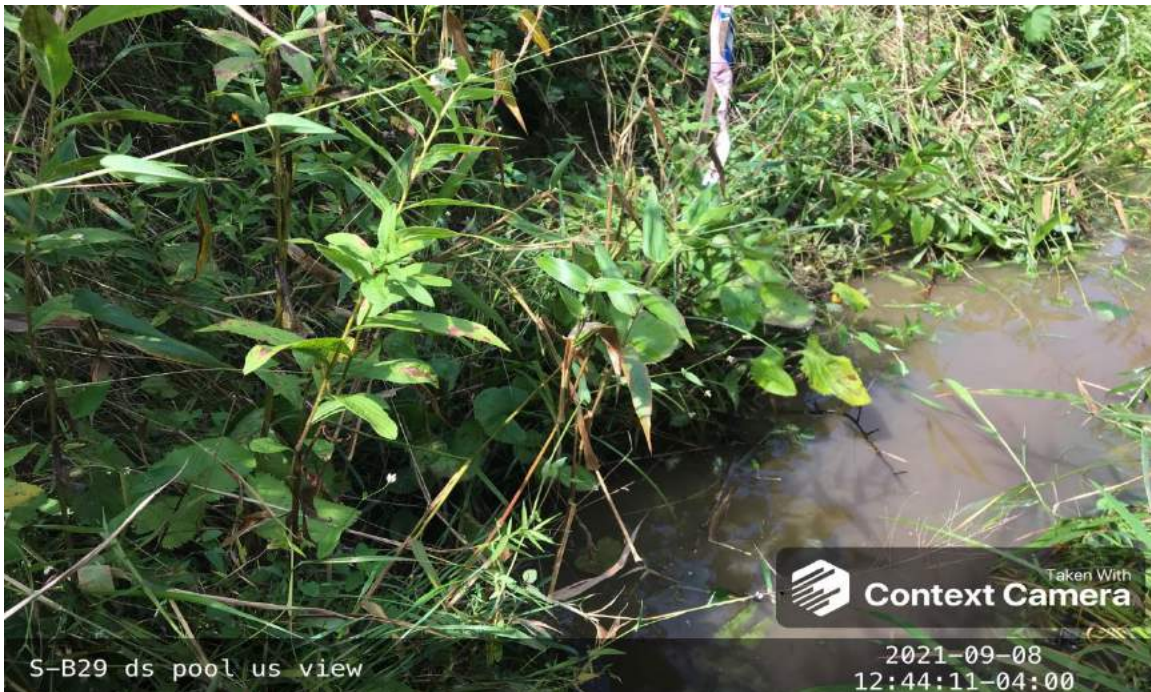
Photo Type: Pool, US View
Location, Orientation, Photographer Initials: Downstream of Pool, Upstream View, SM/MW
Lat: 38.399618 Long: -80.597332

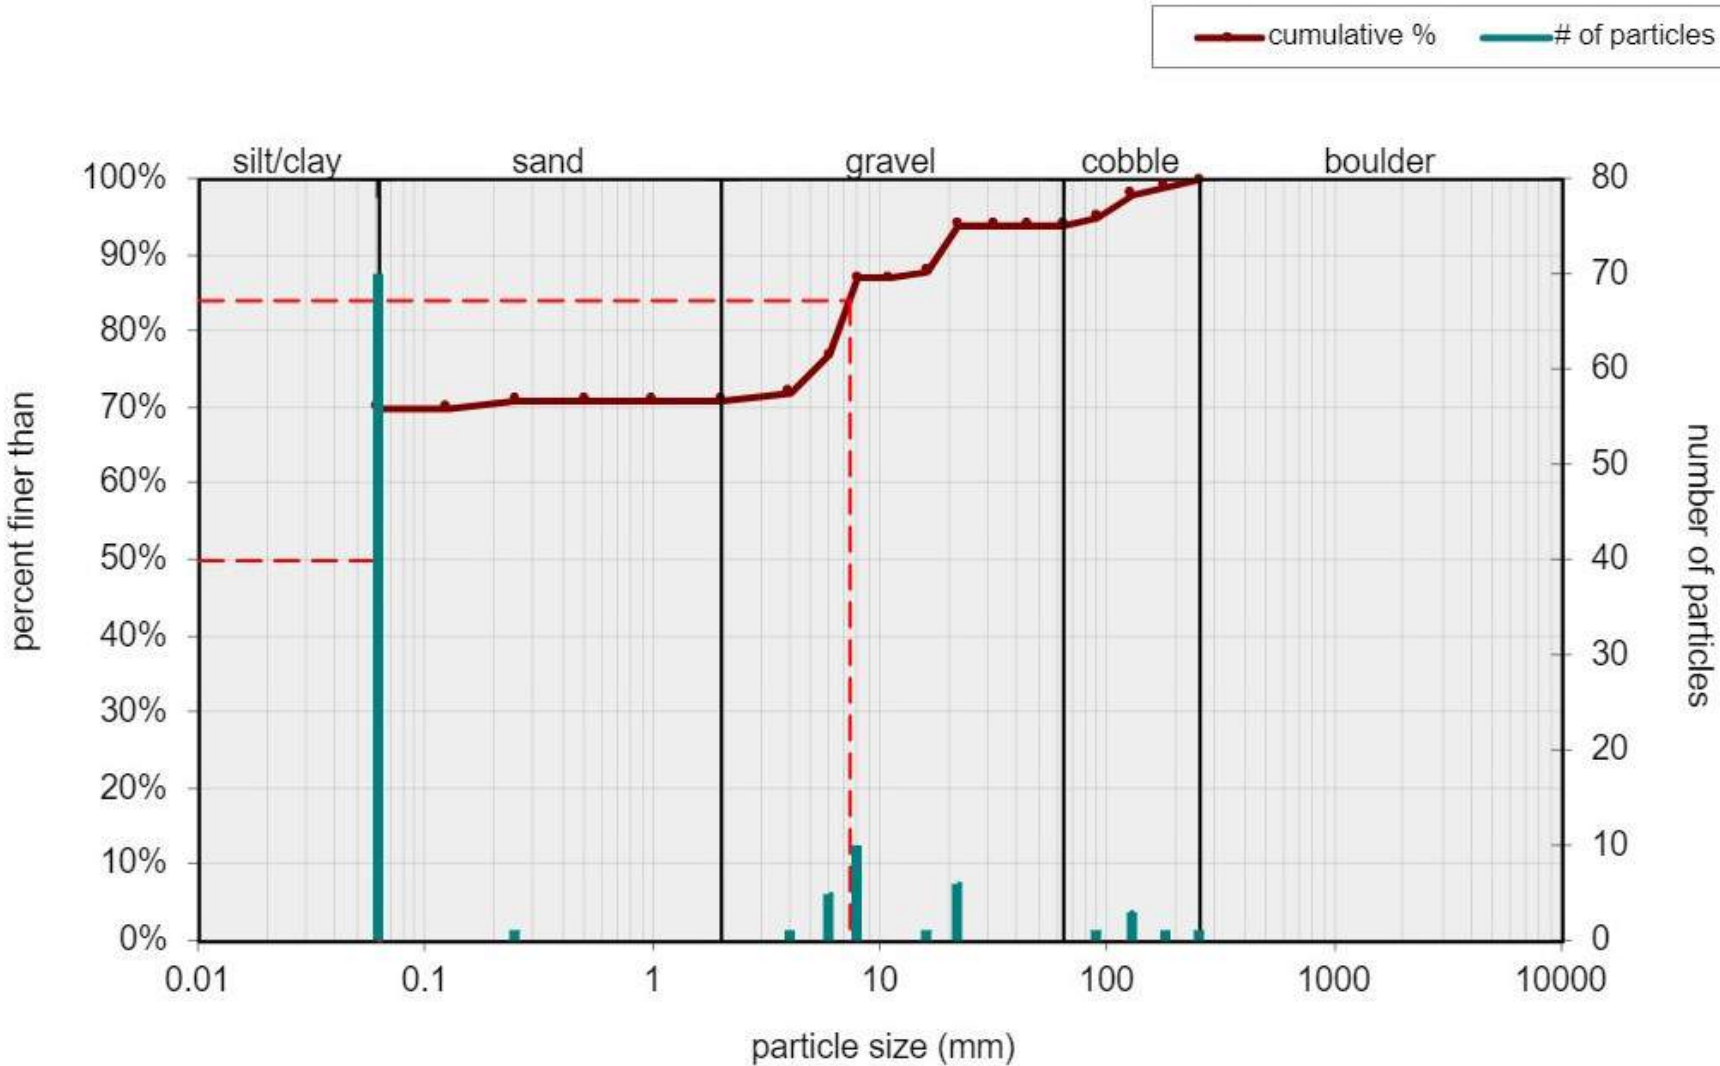
Bankfull Channel Pebble Count, S-B29, Meadow Fork

Size (mm)		Size Distribution		Type	
D16	0.062	mean	0.7	silt/clay	70%
D35	0.062	dispersion	59.4	sand	1%
D50	0.062	skewness	0.72	gravel	23%
D65	0.062			cobble	6%
D84	7.3			boulder	0%
D95	90
