Baseline Assessment – Stream Attributes

Reach S-F20 (Timber Mat Crossing) Perennial Spread D Nicholas County, West Virginia

Spread D Stream S-F20 (Timber Mat Crossing) Nicholas County

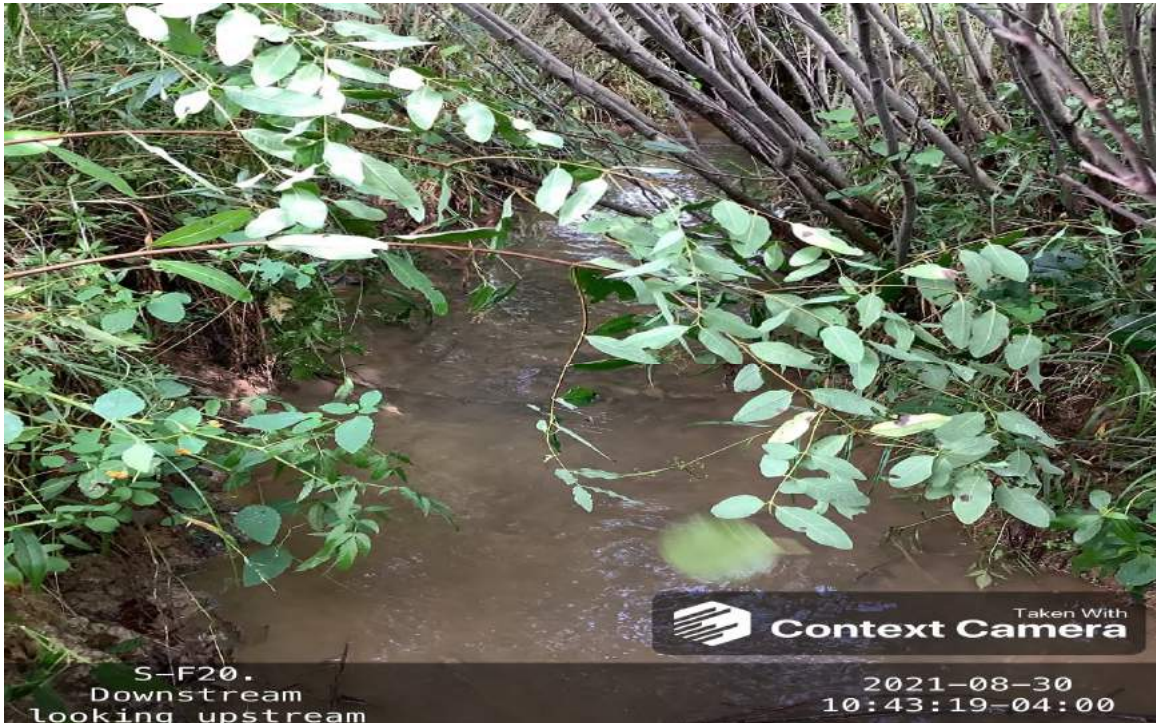
Photo Type: DS, US View
Location, Orientation, Photographer Initials: Downstream Edge of ROW, Upstream View, JR, KP
Lat: 38.3558 Long: -80.633223

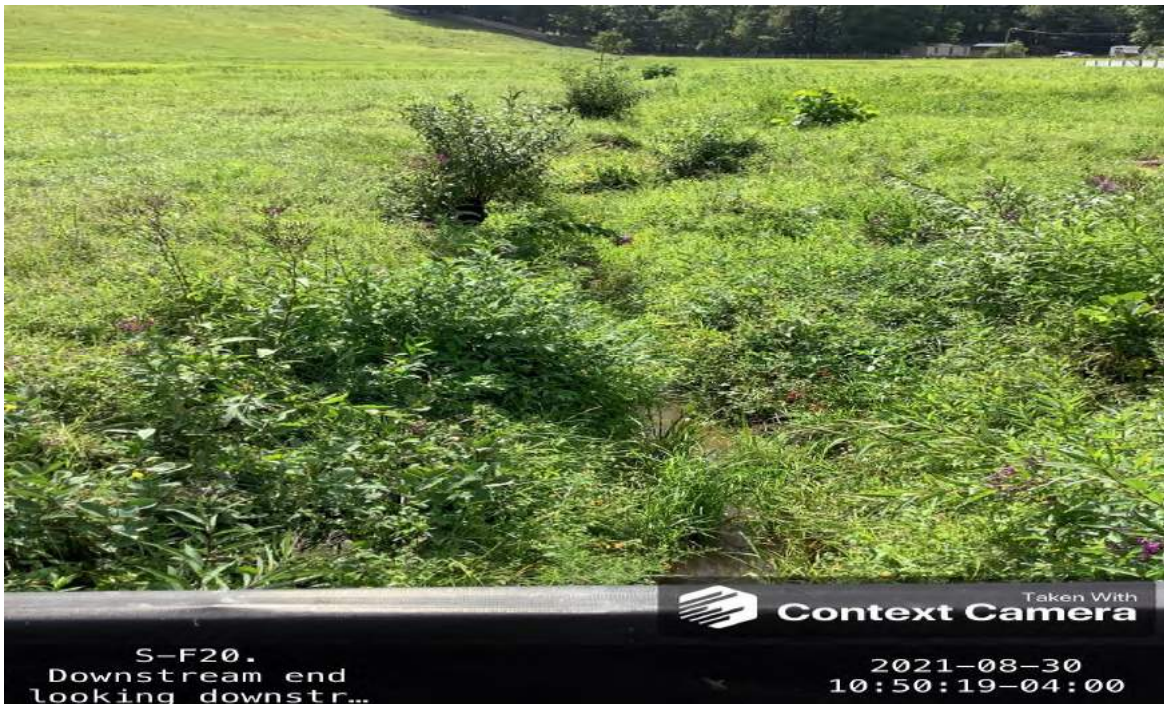
Photo Type: DS, DS View
Location, Orientation, Photographer Initials: Downstream Edge of ROW, Upstream View, JR, KP
Lat: 38.3558 Long: -80.633223

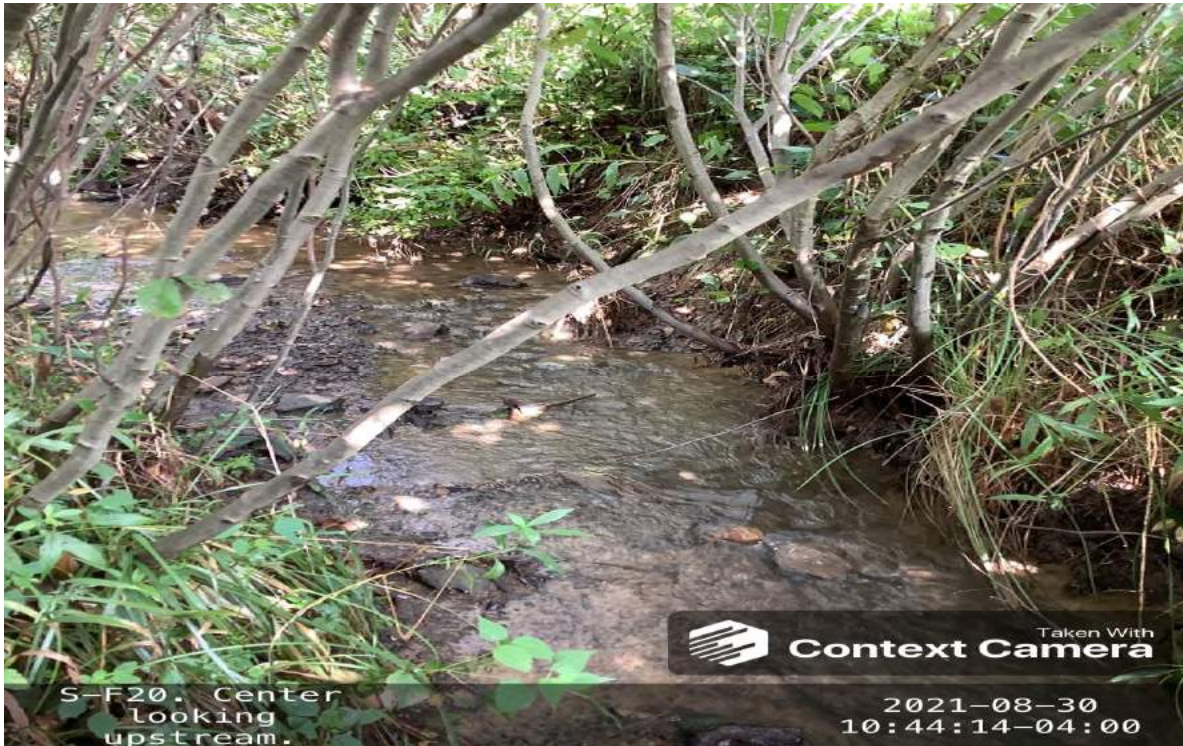
Photo Type: US View at Center
Location, Orientation, Photographer Initials: Downstream Edge of ROW, Upstream View, JR, KP
Lat: 38.3558 Long: -80.633223

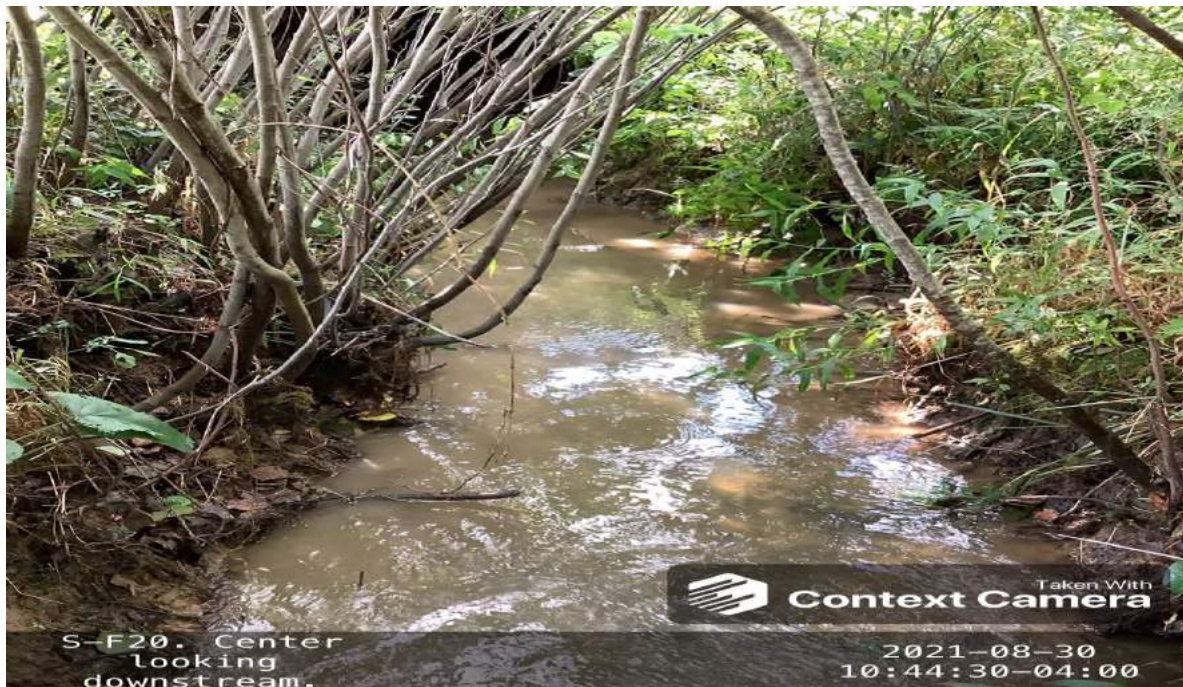
Photo Type: DS View at Center
Location, Orientation, Photographer Initials: Downstream Edge of ROW, Upstream View, JR, KP
Lat: 38.3558 Long: -80.633223

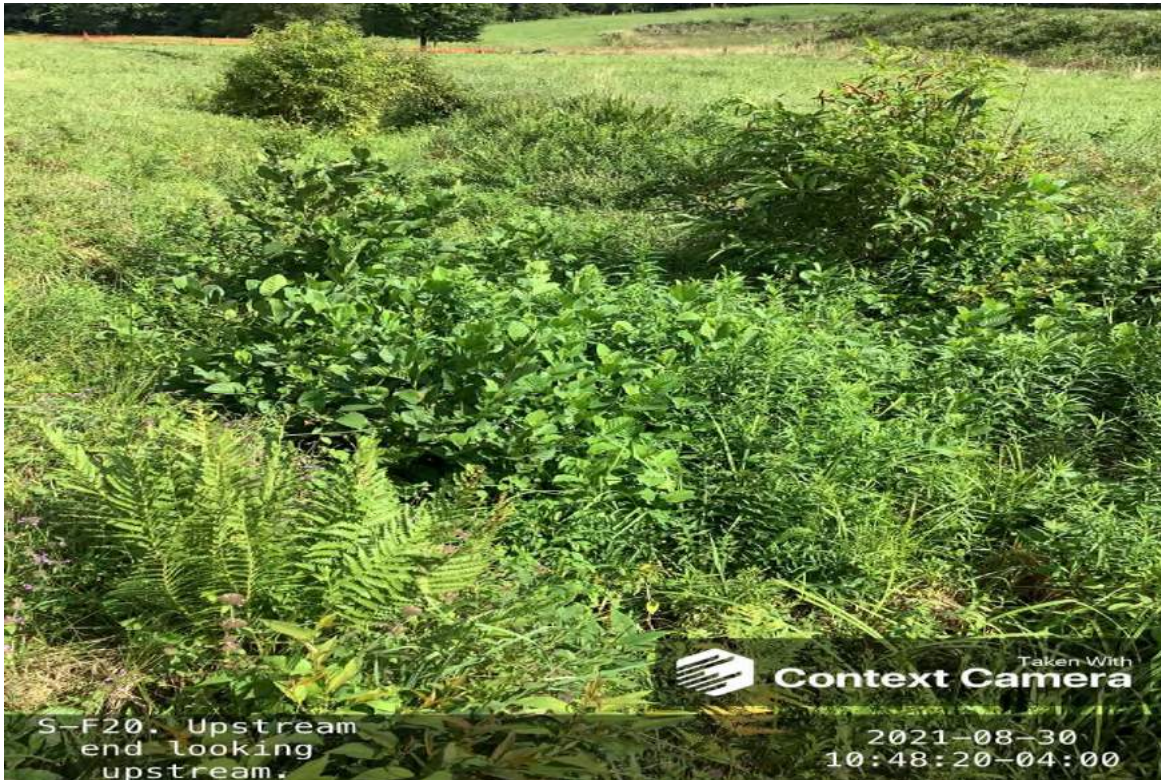
Photo Type: US, US View
Location, Orientation, Photographer Initials: Downstream Edge of ROW, Upstream View, JR, KP
Lat: 38.3558 Long: -80.633223

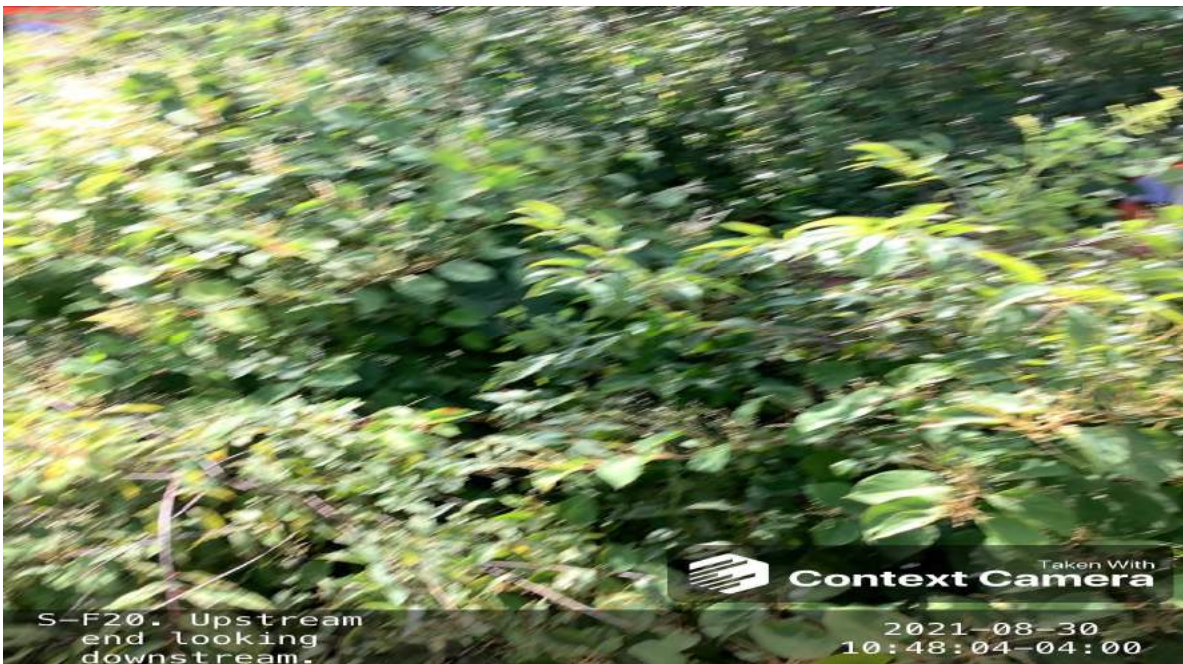
Photo Type: US, DS View
Location, Orientation, Photographer Initials: Downstream Edge of ROW, Upstream View, JR, KP
Lat: 38.3558 Long: -80.633223

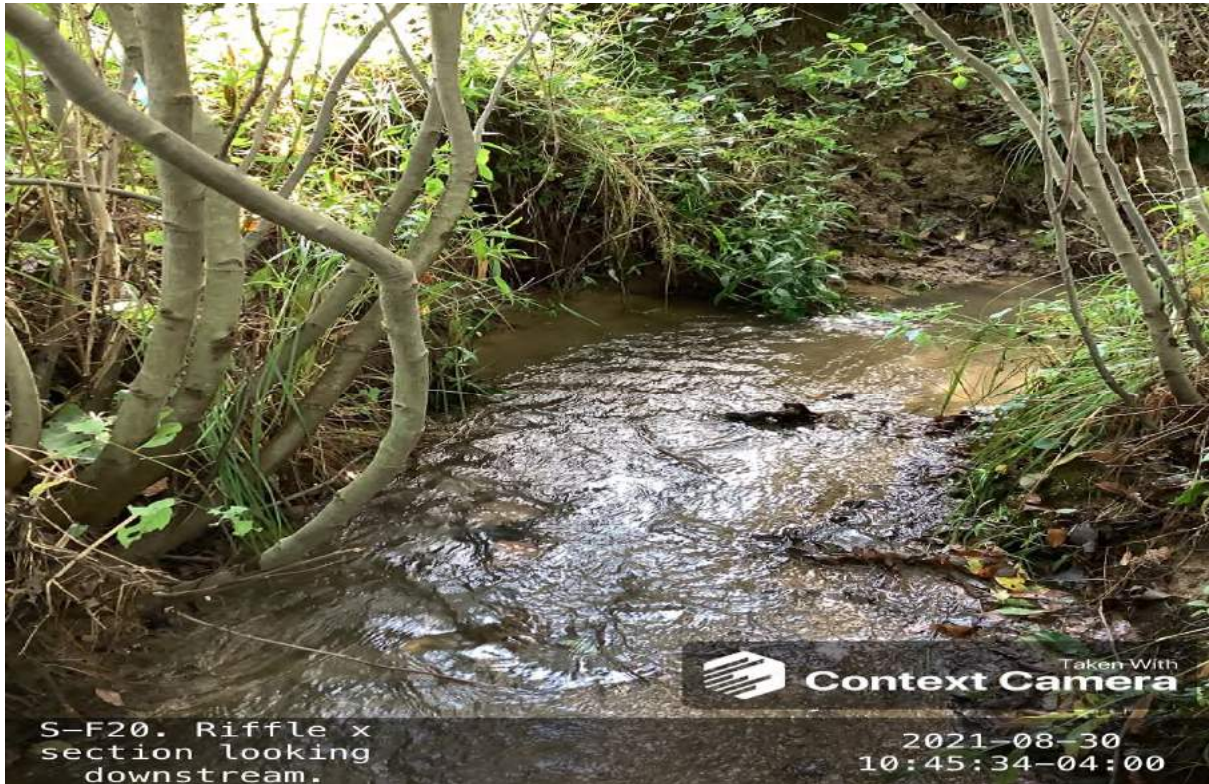
Photo Type: Riffle, DS View
Location, Orientation, Photographer Initials: Upstream of Riffle, Downstream View, JR, KP
Lat: 38.3558 Long: -80.633223

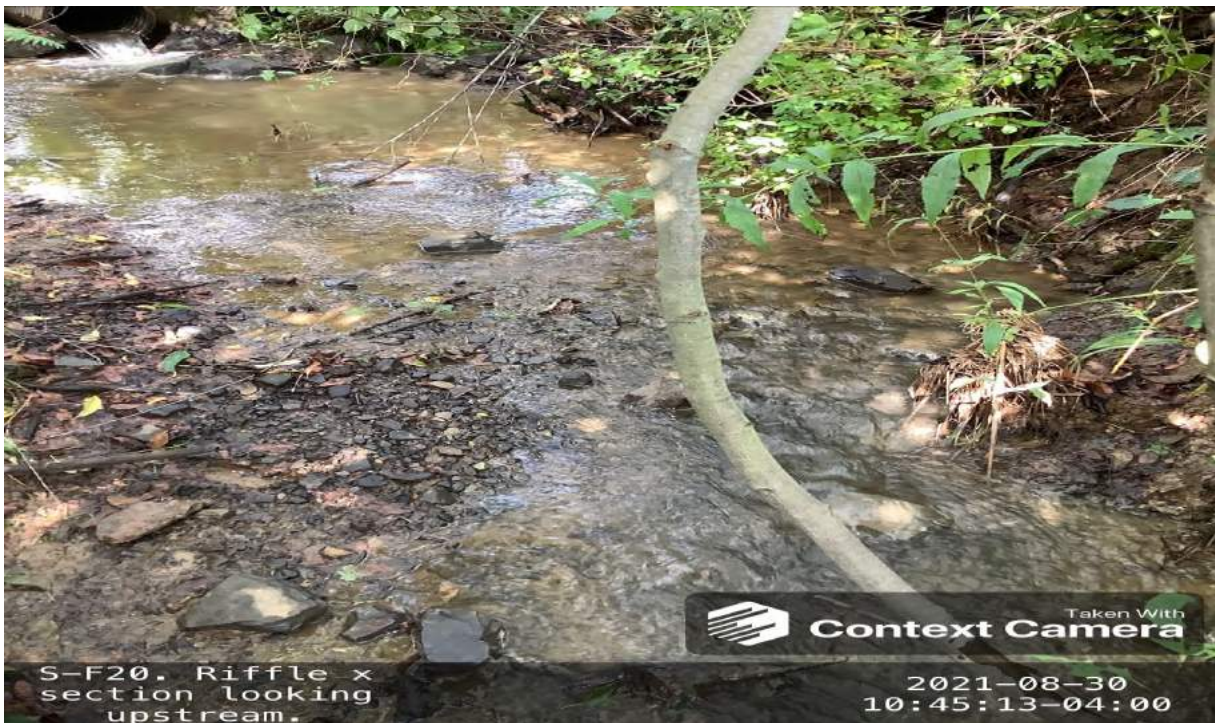
Data	Included
Photos	✓
SWVM Form	✓
FCI Calculator and HGM Form	N/A – Perennial stream (not shadeable, slope <4%)
RBP Physical Characteristics Form	✓
Water Quality Data	✓
RBP Habitat Form	✓
RBP Benthic Form	✓
Benthic Identification Sheet	N/A – Poor riffle habitat
Wolman Pebble Count	✓
Reference Reach Software Pebble Count Data	✓
Longitudinal Profile and Cross Sections	✓

Photo Type: Riffle, US View
Location, Orientation, Photographer Initials: Downstream of Riffle, Upstream View, JR, KP
Lat: 38.3558 Long: -80.633223

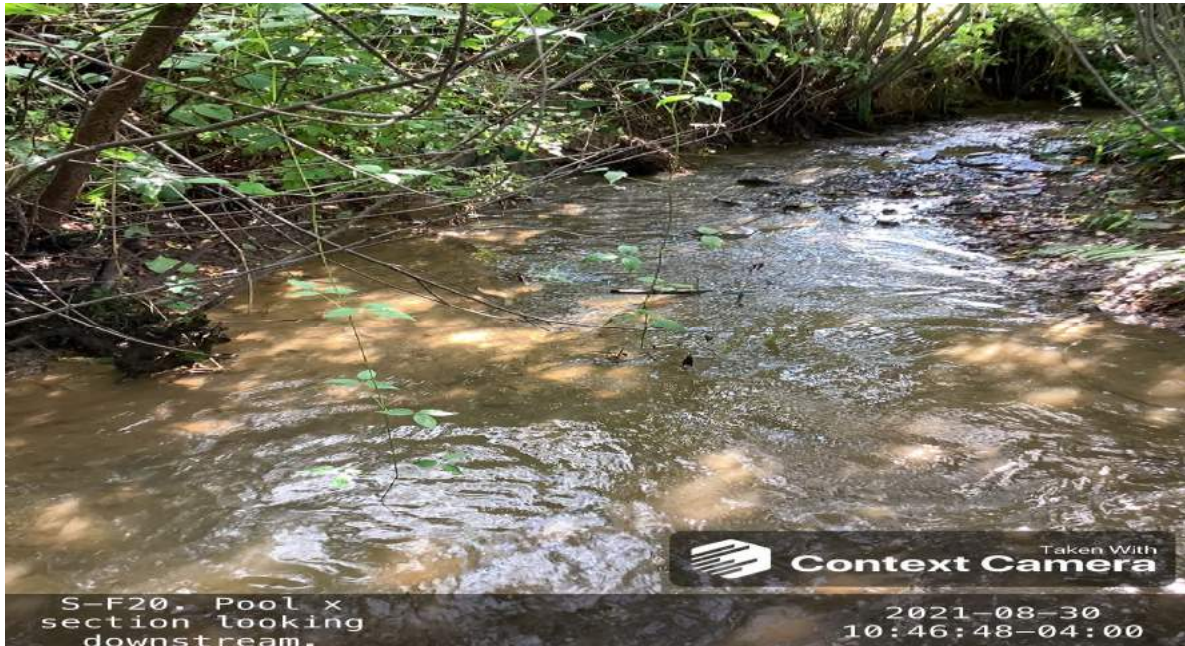
Photo Type: Pool, DS View
Location, Orientation, Photographer Initials: Upstream of Pool, Downstream View, JR, KP
Lat: 38.3558 Long: -80.633223

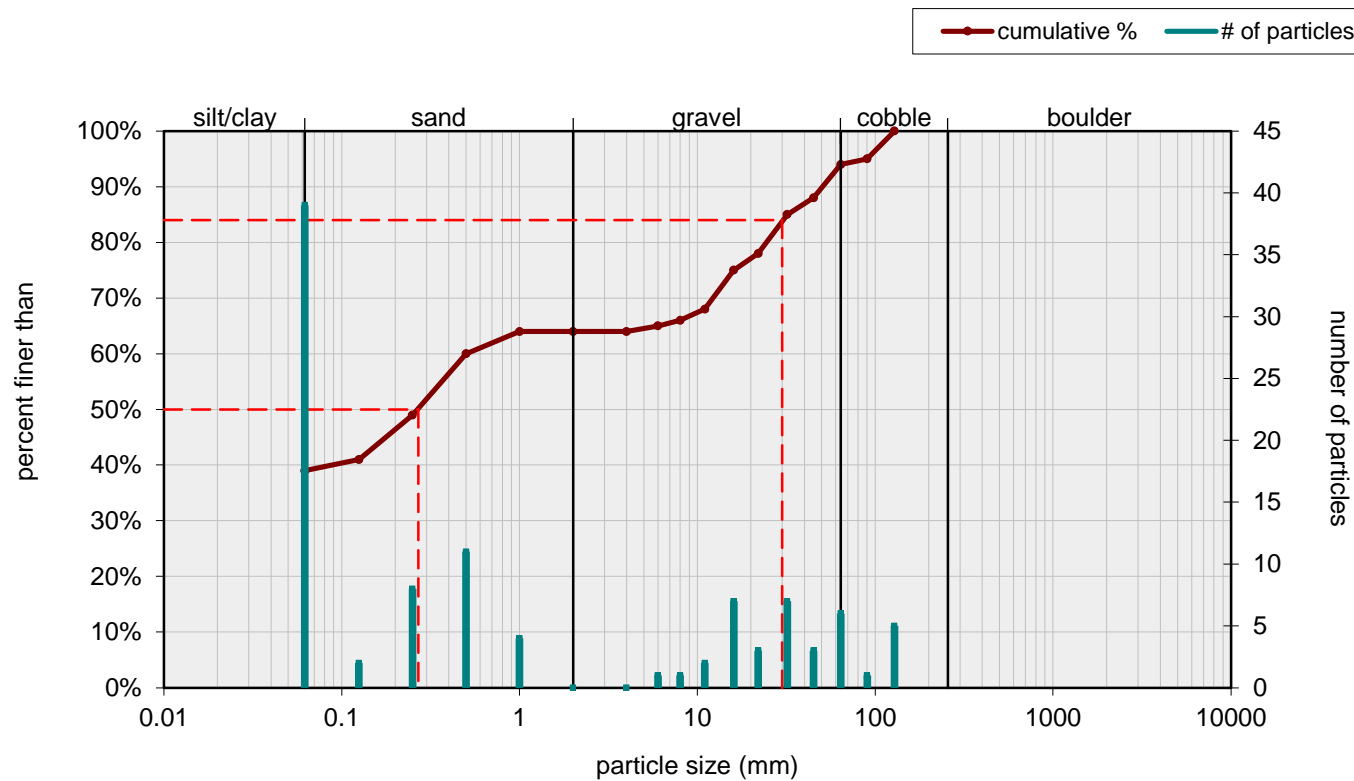
Bankfull Channel Pebble Count, S-F20; Barn Run

Size (mm)		Size Distribution		Type	
D16	0.062	mean	1.4	silt/clay	39%
D35	0.062	dispersion	57.7	sand	25%
D50	0.27	skewness	0.43	gravel	30%
D65	6			cobble	6%
D84	30			boulder	0%
D95	90
