Baseline Assessment – Stream Attributes

Reach S-MN11-Upstream/Downstream (Temporary Access Road) Ephemeral Spread G Giles County, Virginia

Spread G Stream S-MN11-Downstream/Upstream (Temporary AR) Giles County

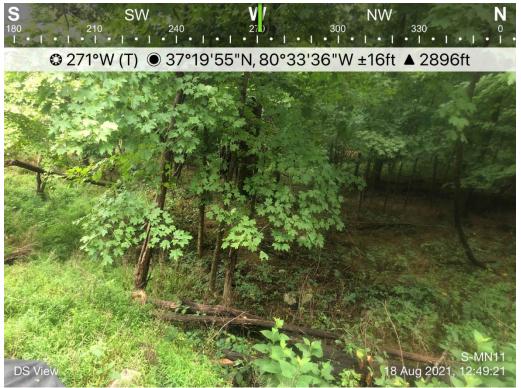
Photo Type: DS View Location, Orientation, Photographer Initials: Upstream at LOD looking SW downstream, KB

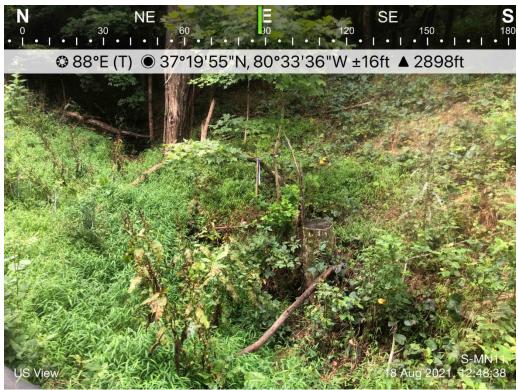
Photo Type: US View Location, Orientation, Photographer Initials: Downstream at LOD looking E upstream, KB

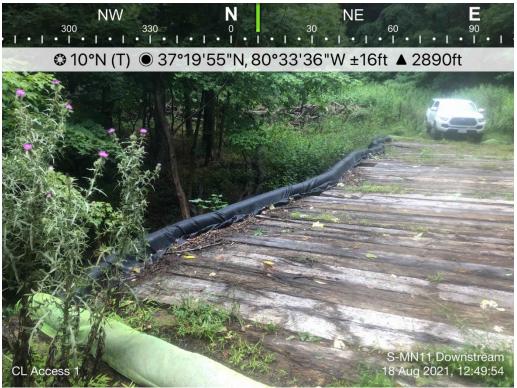
Photo Type: CL ACCESS 1 Location, Orientation, Photographer Initials: Standing in Access Road looking N, KB

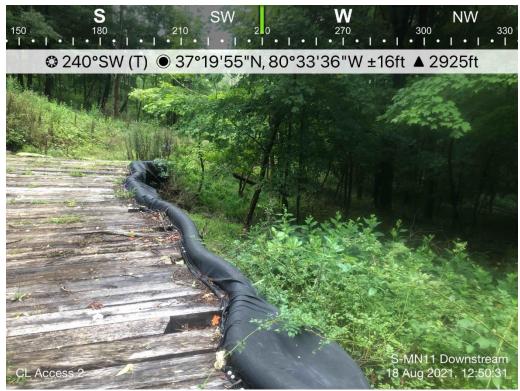
Photo Type: CL ACCESS 2 Location, Orientation, Photographer Initials: Standing in Access Road looking SW, KB

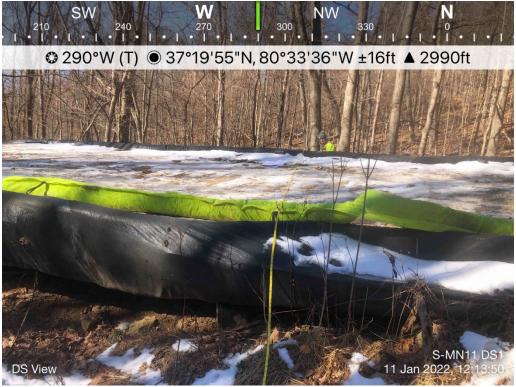
Photo Type: DS VIEW Location, Orientation, Photographer Initials: Downstream view of LOC looking W/NW, KB

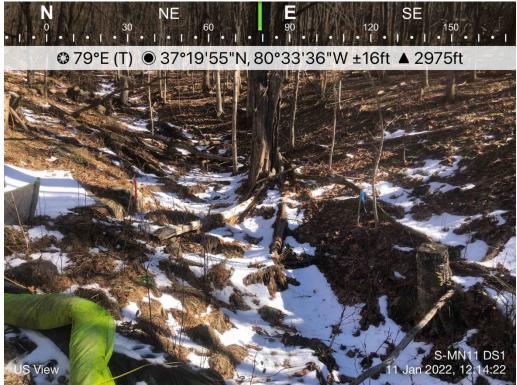
Photo Type: US VIEW Location, Orientation, Photographer Initials: Upstream view of LOC looking E, KB

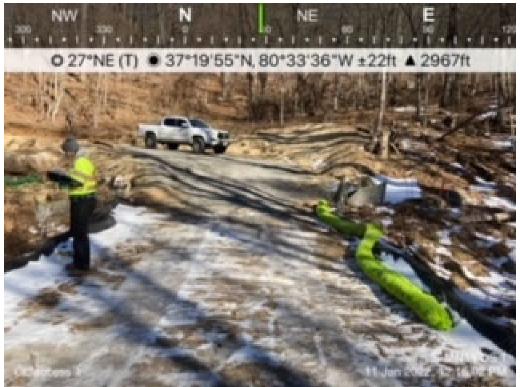
Photo Type: CL ACCESS 1 Location, Orientation, Photographer Initials: Standing in Access Road looking N/ NE, KB

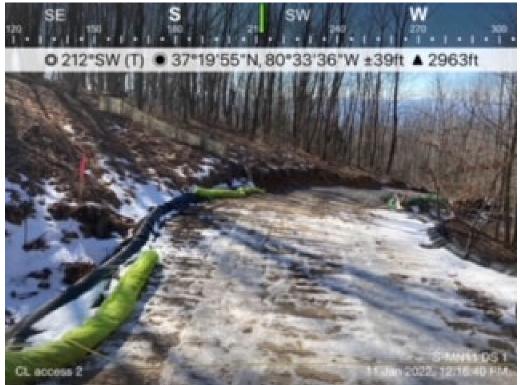
Photo Type: CL ACCESS 2 Location, Orientation, Photographer Initials: Standing in Access Road looking S/SW, KB

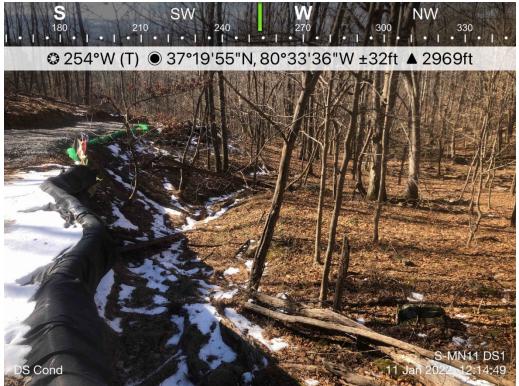
Photo Type: DS COND Location, Orientation, Photographer Initials: Downstream conditions outside of LOC looking W/SW, KB

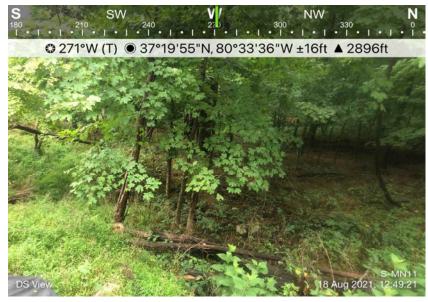
Downsream view looking W. Assessment is limited to areas within the temporary ROW.
